**Wisconsin
Ceded
Territory
Manoomin
Inventory
Ver. 1.0**

**GLIFWC
Project
Report
2010-01
March, 2010**

**Peter David
Wildlife
Biologist**

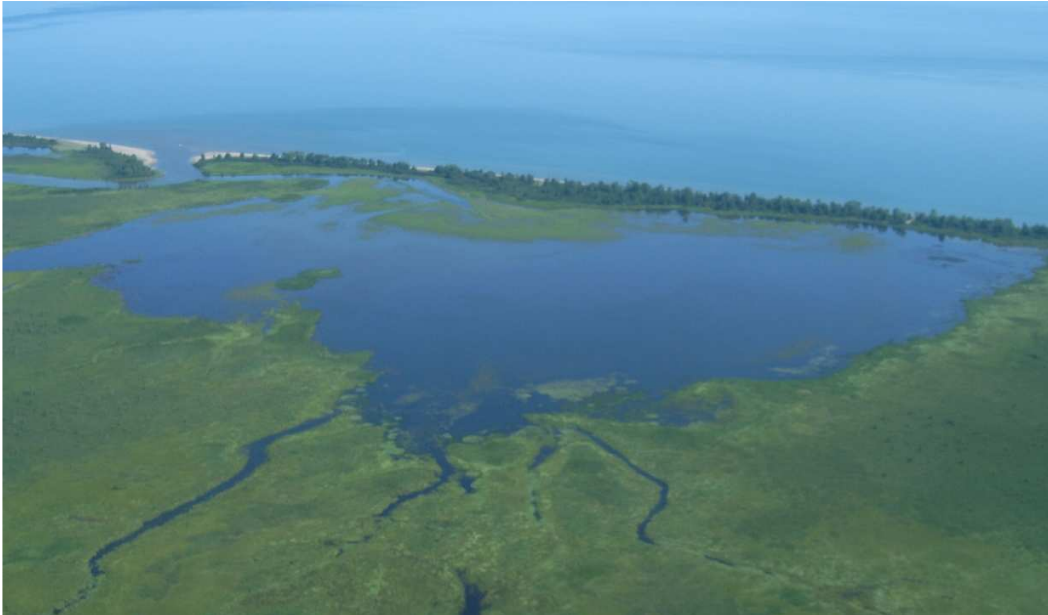
1. Bad River Sloughs (WBIC 2892100).

Figure 1. Bad River Slough, Ashland County, 2009.

The Bad River Sloughs are located on the Bad River Indian Reservation, near the mouth of the Bad River. This site is protected and managed by the Bad River Tribe. Like the Kakagon Sloughs, rice abundance on this site is greatly influenced by water levels on Lake Superior. This undeveloped site is sometimes harvested by tribal members, but does not show up in harvest surveys because of it is an on-reservation water. Watch status is low due to familiarity with site, on-reservation location, and relatively protected condition.

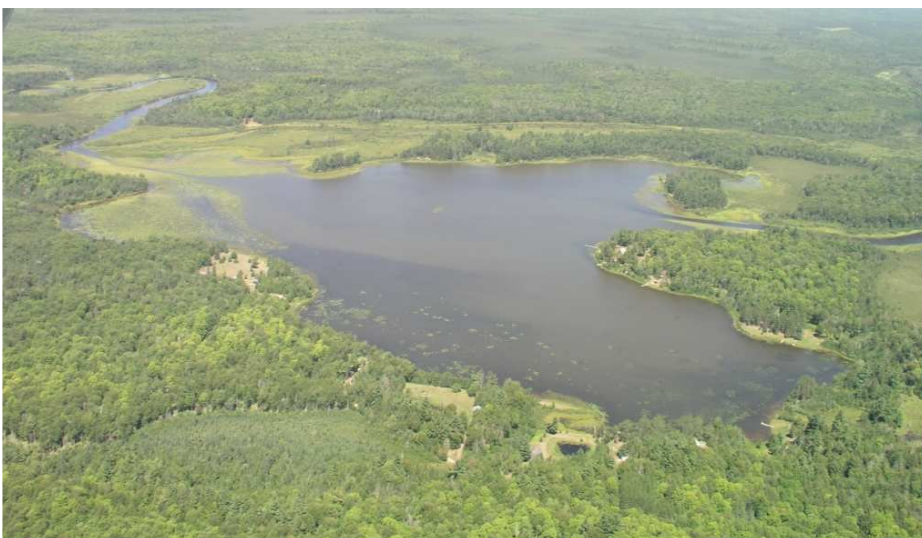
Figure 2. Bear Lake, Ashland County, 2007

Bear Lake is located on the East Fork of the Chippewa River just north of the Ashland/Sawyer county line. Rice beds are located primarily near the inlet, and especially near the outlet. These beds have apparently existed for many years, but do not get much harvesting pressure due to their somewhat limited size, and the limited public access that exists at this site. Watch status is medium low, but it would be preferable to have better annual distribution information.

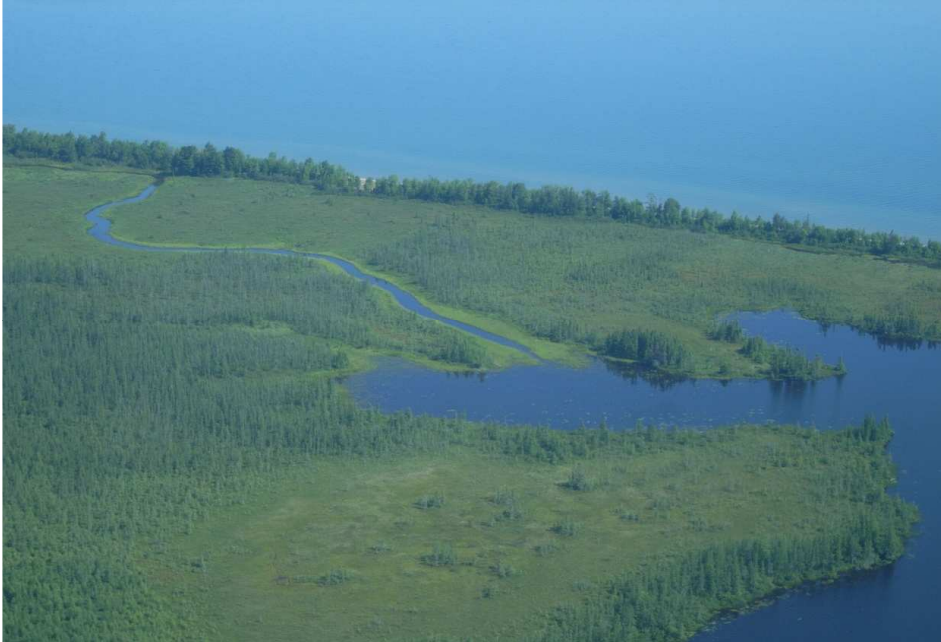
Figure 3. Honest John Lake, Ashland County, 2009.

Honest John Lake is located on the Bad River Indian Reservation, and the site is protected and managed by the Bad River Tribe. It is located just southeast of the Bad River Slough, and like the Slough, is influenced by the level of Lake Superior. This site is not believed to provide much harvest because of its relatively remote location and the presence of larger beds nearby, but in any case it does not show up in harvest surveys because of its on-reservation location. Although the bed shown above appears to be on an outlet stream, this section is still considered part of Honest John Lake on the Surface Water Viewer. Watch status is low due to familiarity with site, on-reservation location, and relatively protected condition, but more annual abundance information is needed.

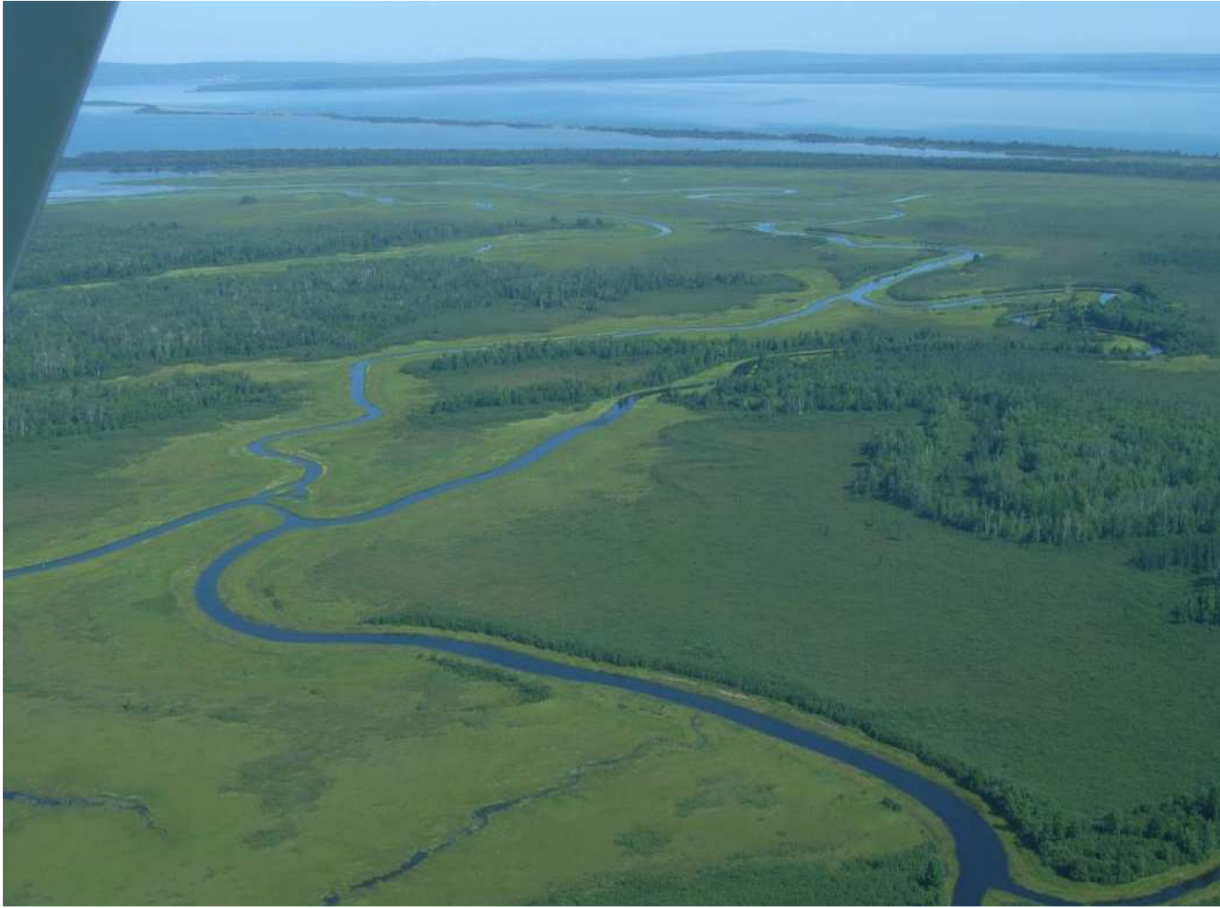
Figure 4. Kakagon Sloughs, Ashland County, 2009.

The name “Kakagon Sloughs” here refers collectively to the slough system on the Bad River Indian Reservation formed collectively by the Kakagon Slough, the Kakagon River, Beartrap Creek, Unnamed (Northeast) Slough and the Wood Creek Slough. It also includes the area of Lake Superior’s Chequamegon Bay known as the “Sandcut Slough”: the notch created at the junction of Oak Point and Chequamegon Point. All of these waters are protected and managed by the Bad River Tribe.

This area contains the largest rice beds associated with the Wisconsin portion of the Lake Superior basin. They have been present for centuries at least, and are unique because they are affected markedly by the levels of Lake Superior. Harvest data is lacking because this is an on-reservation bed, but these beds are heavily harvested under the management of the Bad River Tribe. The Tribe closed the Sloughs to harvesting in 2007 due to low water levels, but this low water period appeared to trigger good growth in 2008 and 2009. Watch status is low due to familiarity with site, on-reservation location, and relatively protected condition.

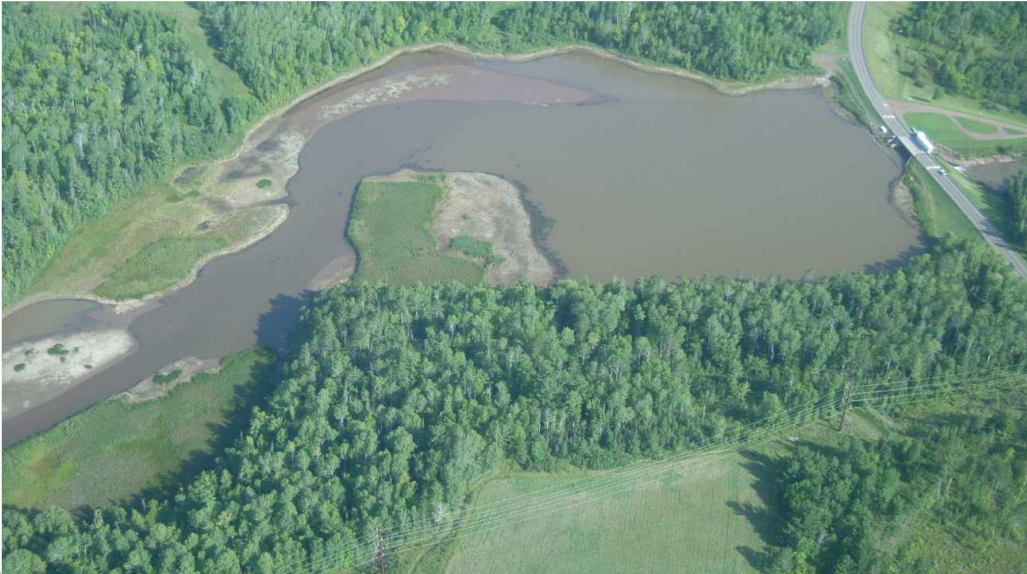
Figure 5. White River Flowage, Ashland County, 2009.

Wild rice was found growing in several patches along the White River Flowage in 2009, possibly as the result of a private seeding effort. Narrow bands were found near the road, the canoe outlet, and the north shore; a wider patch was located towards the west end of the flowage. It is not believed to have been present here for a long period of time, but this is uncertain. The air photo shows the flowage during an emergency drawdown of approximately 6 feet, that took place in 2009; this left the rice beds growing on mud flats (and difficult to discern from the air), but it is not expected that this brief dewatering will cause any long-term negative impacts to the bed. Watch status is medium-high due to the limited data available from the site, and the need to confirm that the site wasn't damaged by the draw-down.

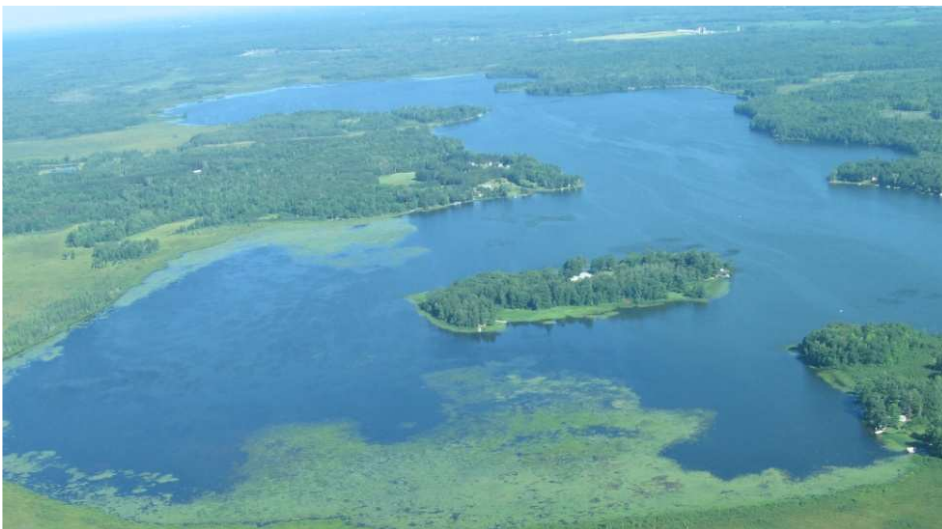
Figure 6. Bear Lake, Barron County, 2008.

Two large rice beds exist on the southernmost bay of Bear Lake, and several smaller beds exist on the far western lobe. These beds are regularly harvested, in part because they have a reputation among harvesters as having particularly high quality seed. However, harvesters also have reported that the large beds have generally been declining over the past 1-2 decades.

This period of decline has been generally associated with a period of above average precipitation, and it is the opinion of the author that in 2009 the beds were likely limited by water depth. I believe these beds could likely be enhanced by relatively small water level modifications, but currently there are many differing opinions about how water levels should be managed on this dam-regulated lake. Watch status is medium-high due to concerns about bed decline.

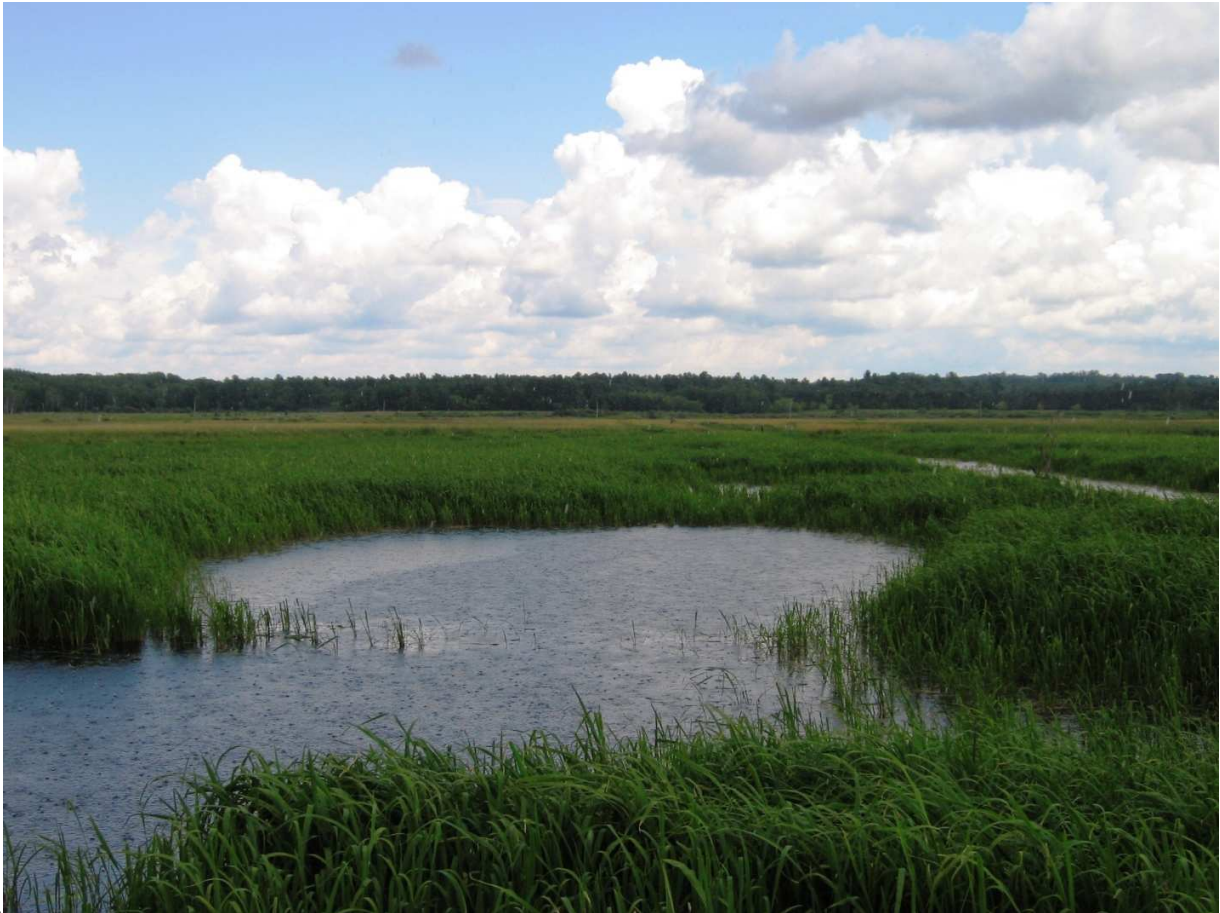
Figure 7. Loon Lake Wildlife Area Flowage, Barron County, 2009.

This is another small flowage that was created to provide waterfowl habitat. It is too new to be included in the Surface Water Viewer, but can be seen in the 2005 air photo layer approximately 1 mile south of Staples Lake. The WBIC that is provided is for the unnamed stream that creates the flowage; immediately upon exiting the flowage, it enters the Apple River. This site was seeded, and a bed has become well established. The site is accessed from a walking trail from a parking area along 1st Street to the west. Watch status is medium-high due to the short history of the site.

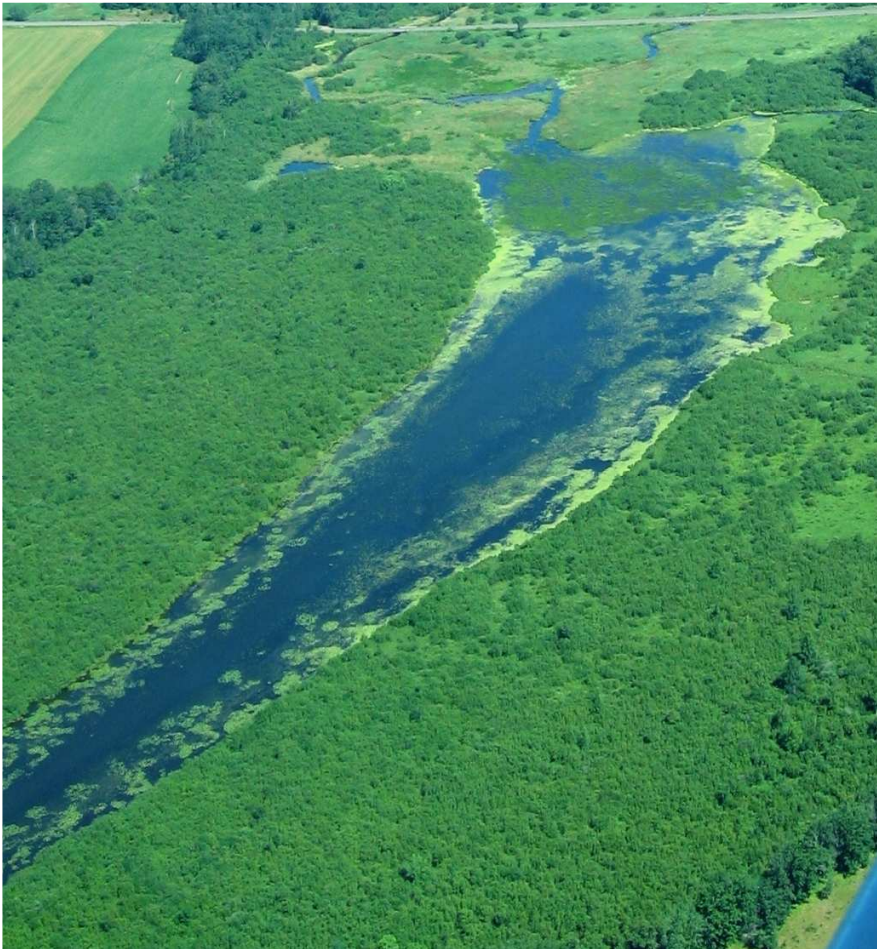
Figure 8. Moose Ear Lake, Barron County, 2008.

Rice was verified on Moose Ear Lake, scattered in small clumps near the south end, and in a thin bed near the north end of the lake. The bed does not appear to be substantial enough to be of great interest to harvesters, but does increase the attractiveness of the site to wildlife and waterfowl hunters. Watch status is medium due to limited annual abundance data.

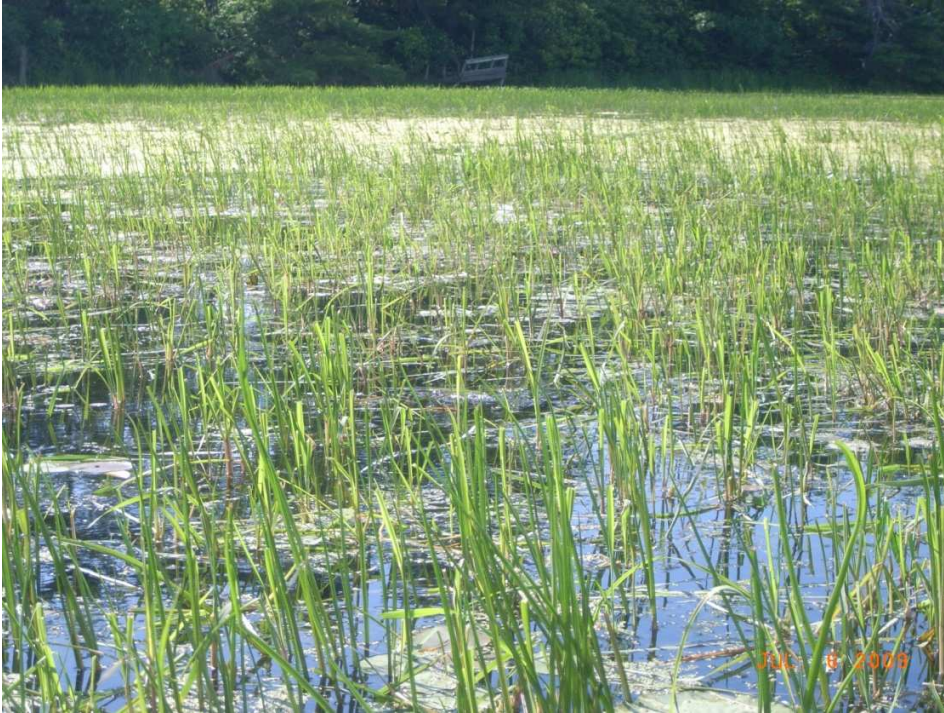
14. Red Cedar River (WBIC 2063500).

Figure 9. Red Cedar River, Barron County, 2009.

Site visits confirmed the presence of rice originally reported by Michael Michaelsen and Russell Fell, both of the DNR. Several acres of sparse-medium density rice were found between HWY 48 and Rice Lake. As is visible in the photo, plants were heavily browsed. Site was surveyed in early July, so stand density estimates may be low. Watch status is medium-high due to management concerns and limited annual abundance data.

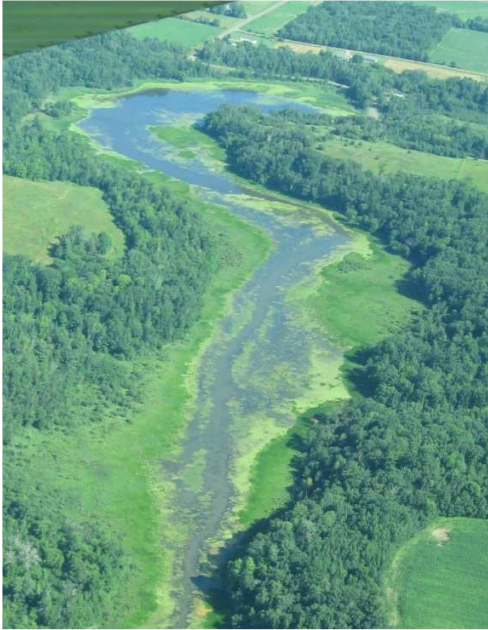
Figure 10. Sweeny Pond, Barron County, 2008.

Sweeny Pond, located in east-central Barron County, has supported wild rice for many years. Annual abundance appears to be more variable for this site than might be expected from its highly riverine nature. Careful management of this state-managed location might improve annual production. Watch status is low due to familiarity with the site.

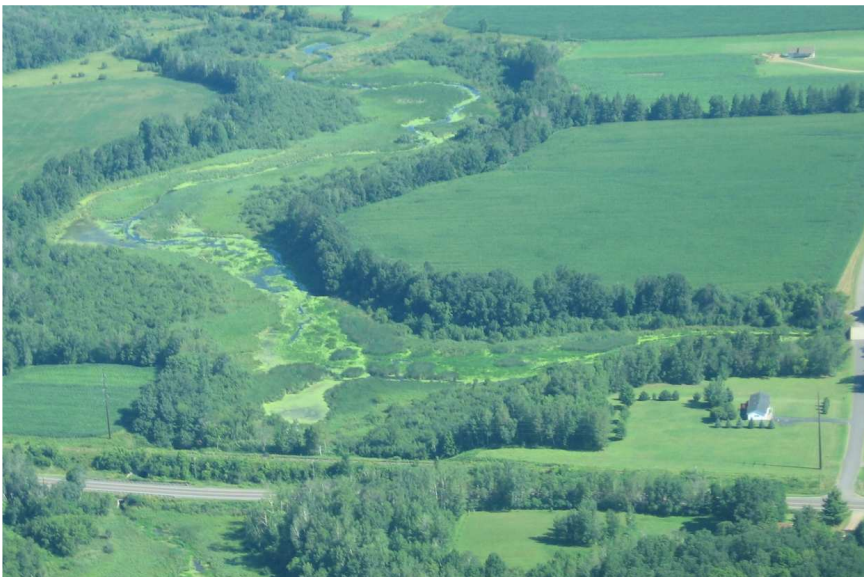
Figure 11. Vermillion River, Barron County, 2008.

The Vermillion River has been known to support rice for many years. Likely the biggest bed is found just north of HWY 8 near the Sweeny Pond Creek inlet (shown in the photo above), while a second bed has been reported approximately three-quarters of a mile south of Lower Vermillion Lake, just north of 20th Avenue. It is likely smaller patches also exist in other sections. Watch status is medium-high, primarily because of the need to better document the northern bed.

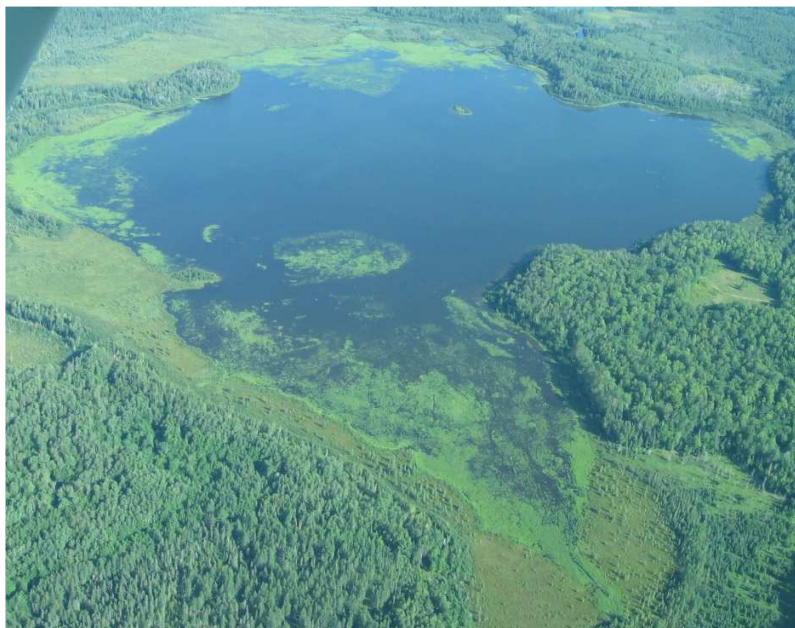
Figure 12. Chippewa Lake, Bayfield County, 2006.

Chippewa Lake, a historic rice lake located near the southeast corner of the county, was restored cooperatively by the USFS and GLIFWC through a combination of seeding and beaver control. This site has responded very well, and has become popular with ricers. However, harvest data indicates that harvest per trip has been relatively poor on this site, likely due to a combination of relatively late maturation and relatively high harvest pressure. As such, this lake might be an excellent candidate to add to the list of date-regulated waters. It is also important to monitor this lake for impacts from beaver since even small increases in the water level can make large areas unsuitable for rice. Watch status (other than for beaver impacts) is low.

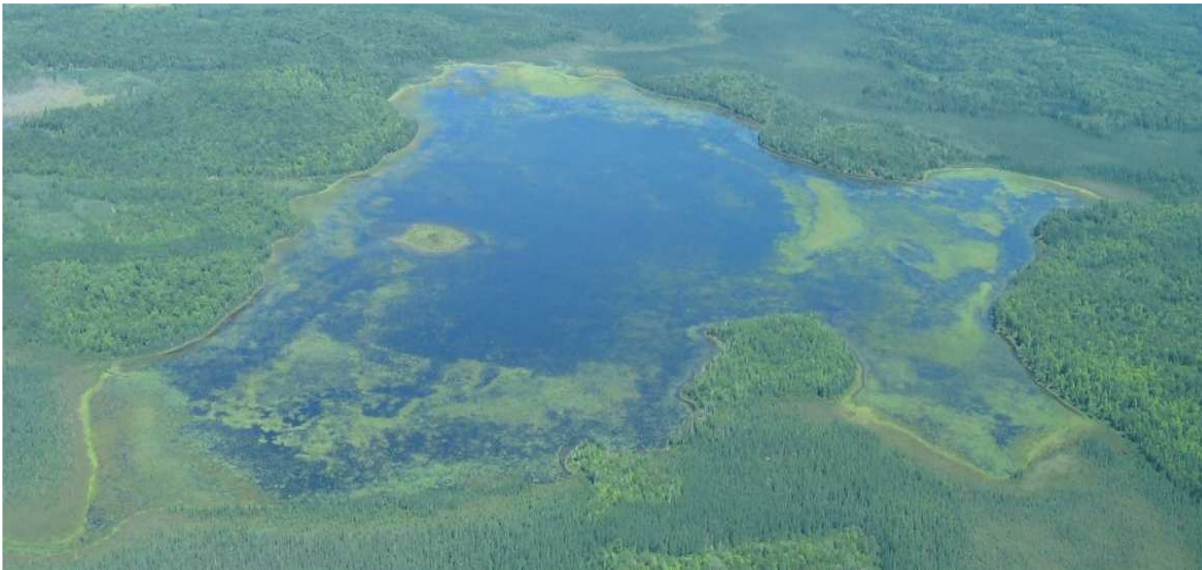
Figure 13. Totogatic Lake, Bayfield County, 2007.

Totogatic Lake has long been one of the mainstay wild rice waters in the state. It is well known and heavily picked, although crop abundance is highly variable (more than half of the lake can be in rice in bumper years). It is a bit unusual in that the densest bed tends to be an “island” located a fair distance off shore. The entire lake is in a state wildlife area. Beaver control on the Totogatic River outlet is sometimes important, since even small increases in the lake level makes much of the basin too deep for rice. (This site should not be confused with the Totogatic Flowage in Sawyer County.) Watch status, other than for beaver impacts, is low.

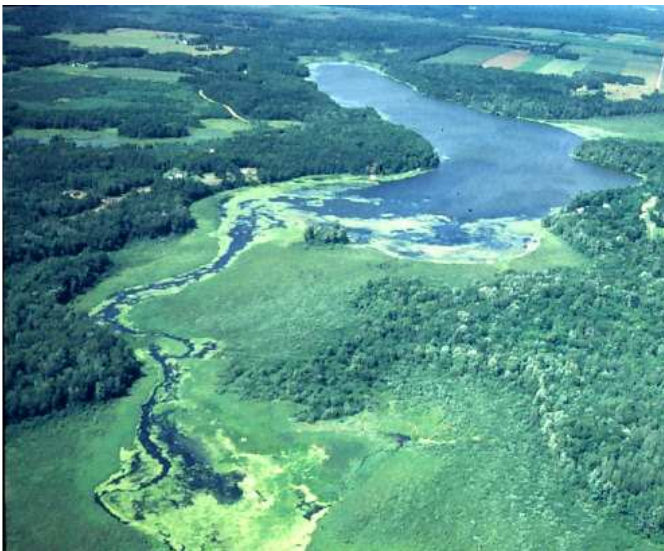
Figure 14. Bashaw Lake, Burnett County, 2002.

Bashaw Lake, located 3 miles SSE of Hertel, has long been considered a rice water, and the lake is among those whose harvest is date-regulated. Traditionally, the most significant stands were found at the inlet and outlet. In recent years,

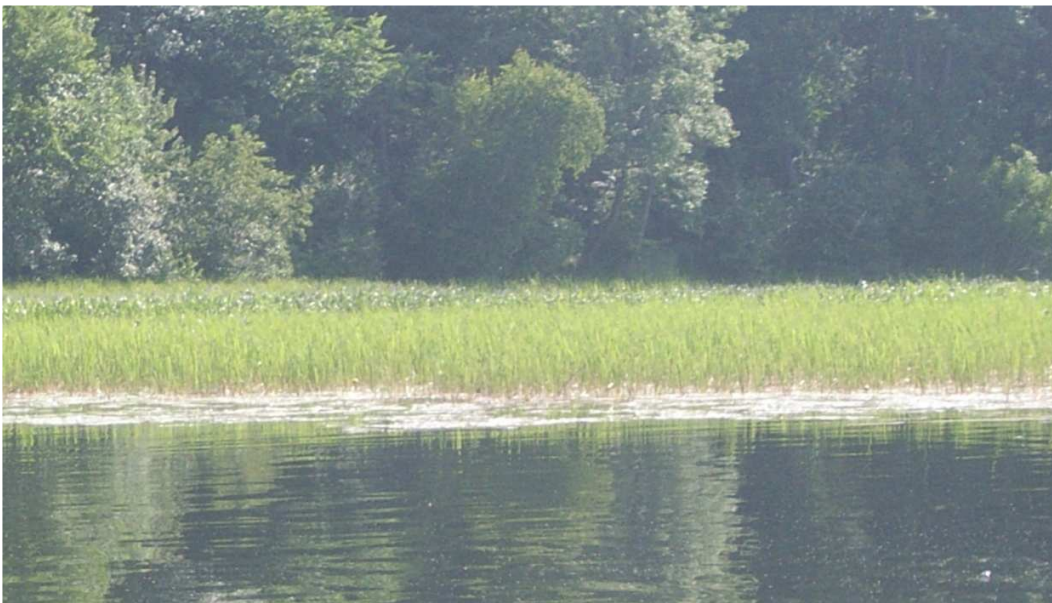
24. Big Sand Lake (WBIC 2676800)(no air photo available).

Figure 15. Big Sand Lake, Burnett County, 2009.

Big Sand Lake is an interesting site. This lake reportedly once supported substantial rice beds, and the lake is among those on the list of waters whose harvest is date-regulated. However, apparently it has been many years since the lake has supported harvestable beds.

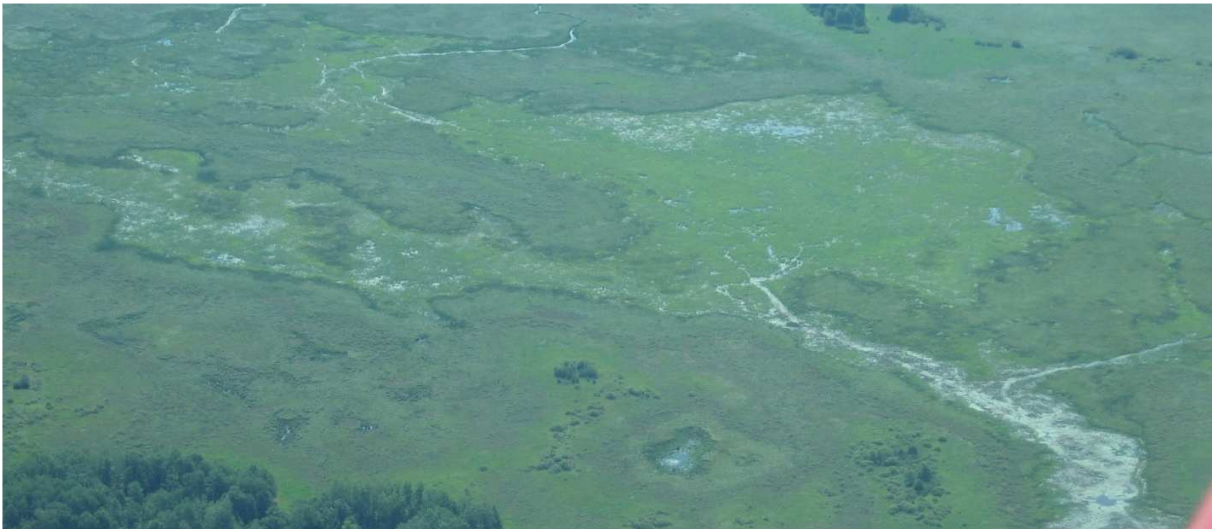
25. Black Brook Flowage (WBIC 2655000).

Figure 16. Black Brook Flowage (South portion), Burnett County, 2006.

Black Brook Flowage on the Amsterdam Sloughs Wildlife Area was successfully seeded to produce a self-sustaining bed. The crop on this site is highly variable, and seems to be unusually sensitive to water level variation. It may have been negatively affected by drought in the 2007-2009 period. Harvesters are beginning to utilize this bed, at least in years when water levels are high enough to permit access. (This site should not be confused with the flowage of the same name in Washburn County.)

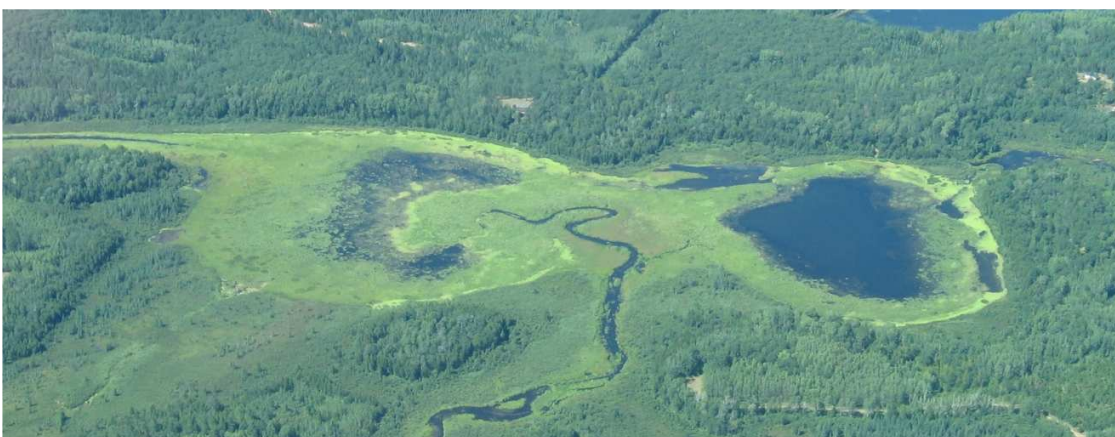
Figure 17. Briggs Lake, Burnett County, 2007.

Briggs Lake is an unusually appealing wild rice water, with a long history of harvest. Harvesting on this largely undeveloped lake is date-regulated. In years with good crops, much of the lake supports rice with the exception of the center of the east lobe. Watch status low due to familiarity with the site.

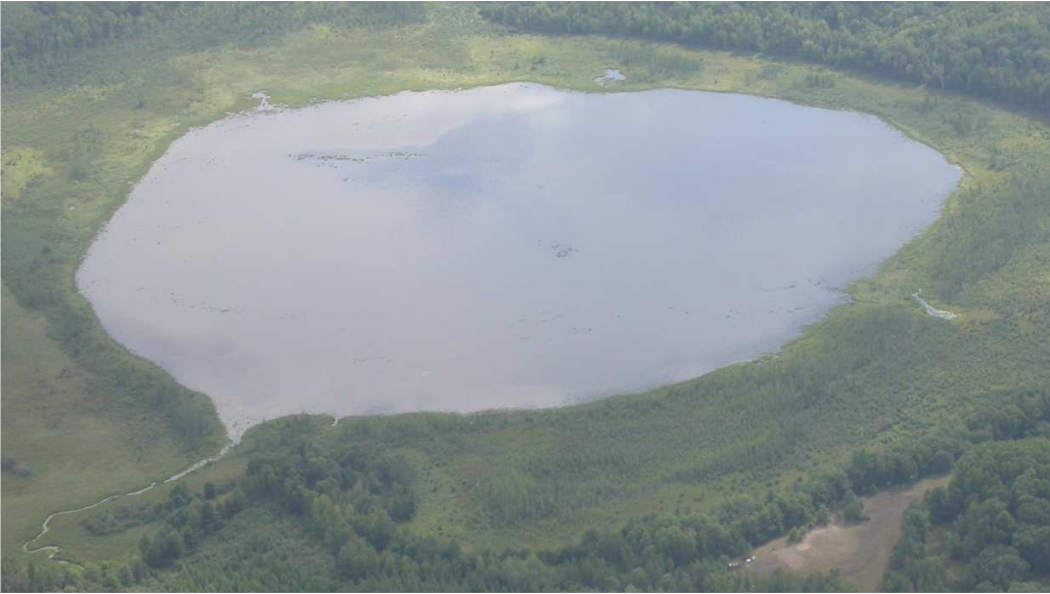
27. Buffalo Lake (WBIC 2674700).

Figure 18. Buffalo Lake, Burnett County, 2006.

Buffalo Lake is an undeveloped lake a mile north of Yellow Lake, with a short outlet that drains into the Yellow River. Our information on this site is fairly limited; small beds have been observed the few years this lake has been flown, and harvest has been reported once. This lake is somewhat difficult to access, and the rice beds seem to be better known to duck hunters than rice harvesters, but there have been anecdotal reports that this lake can support a fair amount of rice when water levels are low. Watch status medium because of the need for better annual abundance information.

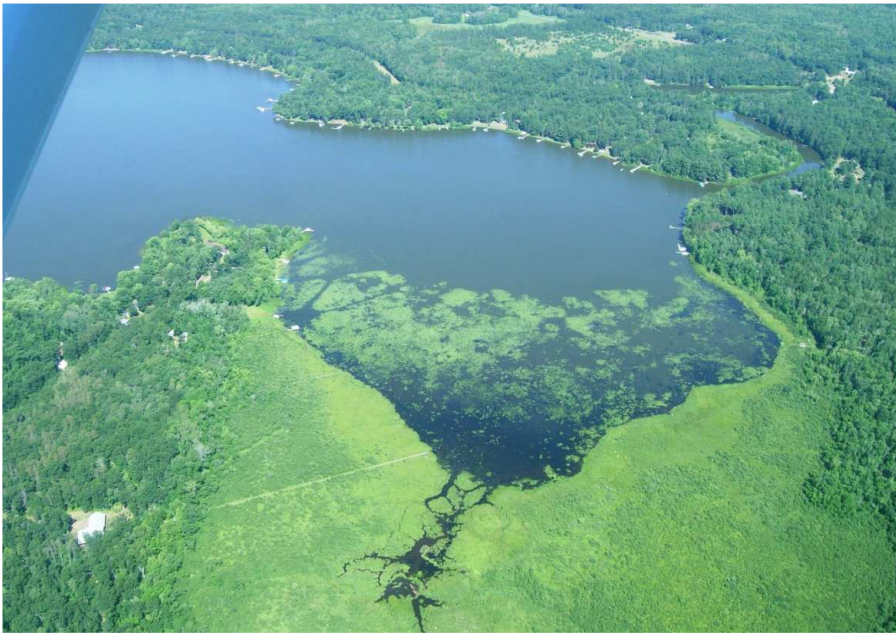
Figure 19. Clam Lake, Lower, Burnett County, 2008.

Although Upper Clam Lake is well known for its expansive rice beds, the smaller beds on Lower Clam tend to be overlooked. The rice on Lower Clam is largely limited to the bay east of the outlet (which is visible at the upper right in the photo above). There are anecdotal reports that these beds were seeded by local residents fairly recently. They are located in an area with little lakeshore development. It remains to be seen if these beds are facing the same decline that has been witnessed on the Upper Clam beds, whose most recent appreciable crop was in 2006. Watch status high due to decline concerns.

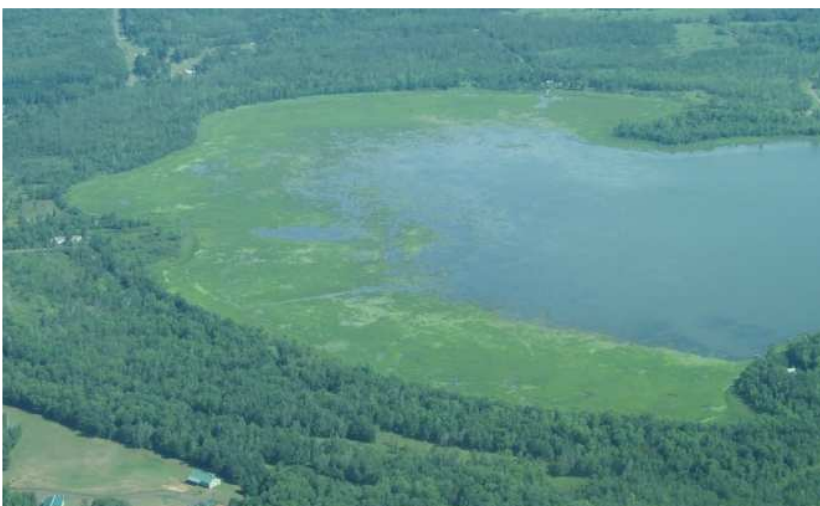
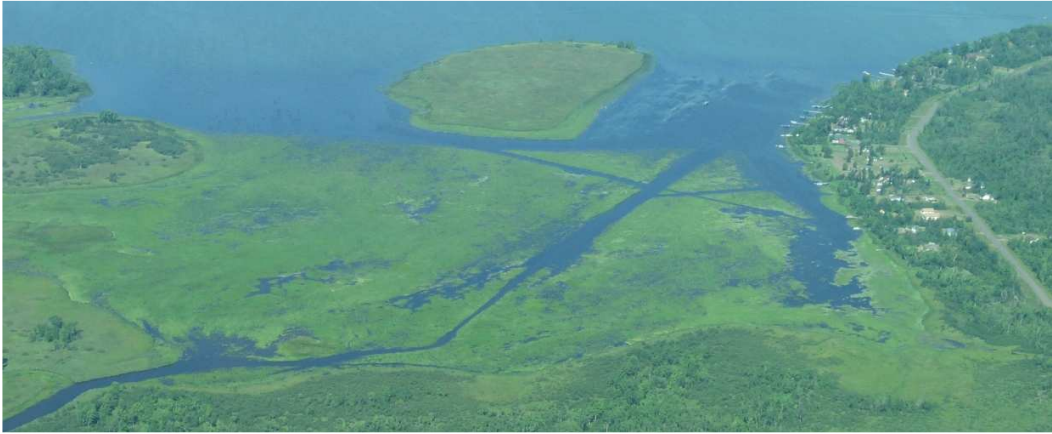
Figure 20. Upper Clam Lake, SW bay, Burnett County, 2007.

Much more needs to be written about Upper Clam Lake than can be addressed here. This lake has been one of the most significant rice waters in the state, with expansive rice beds occurring primarily on the large lobes on the southern half of the lake. Unfortunately, it appears that the rice beds on Upper Clam are currently experiencing an unusually sudden and drastic decline.

The photos above give a sense of the kind of beds Clam is capable of supporting. However, only very small beds have been observed in the 3 years since these photos were taken. Although the causes of this decline have not yet been determined, much of the available evidence suggests an increase in carp populations may be an important factor. (Figure 20 also depicts some of the excessive rice removal that has occurred at times with the weed harvester that operates annually on this lake.)

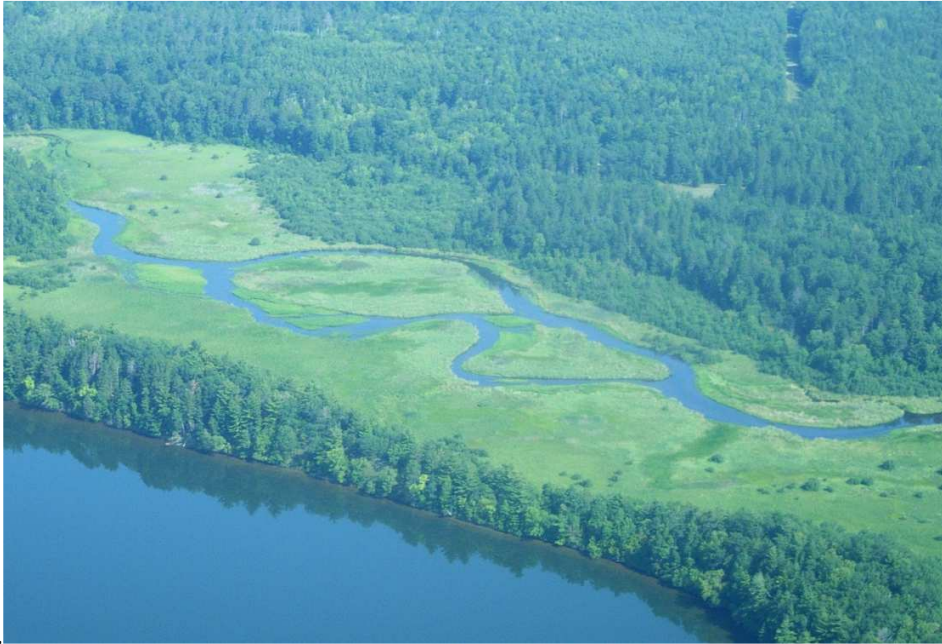
Figure 22. Clam River, North Fork, near Spencer Lake, Burnett County, 2008.

The North Fork of the Clam River holds more rice than the Clam itself. Beds are scattered in various areas, including the section adjacent to Spencer Lake (shown above) and in the open marshlands that are present for 2-3 river miles above and below CTY B. Along the more woodland stretches of the river, rice tends to be limited to sunny, shallow bends. Watch status medium-high, because monitoring of these beds may provide insights into the factors affecting the beds on Upper Clam Lake downstream.

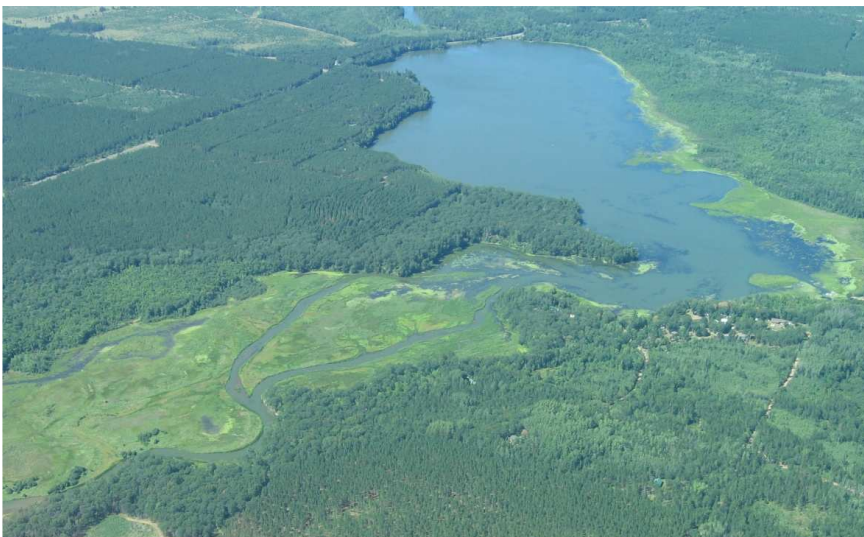
Figure23. Clam River Flowage, Burnett County, 2008.

The Clam River Flowage has supported rice for decades; anecdotal information indicates it was seeded by the members of the Holmes family of the St. Croix Tribe. It is regularly harvested. Most of the rice in is the area of the inlet on the

This flowage reportedly goes through an annual over-winter drawdown of approximately 2 feet. Although this is done solely to create capacity for the capture of spring snow melt, this regime has been very compatible with rice production, likely by reducing competition. However, this site also reportedly has an unusually high prevalence of ergot. It has been suggested that ergot sclerotia can only form spores when resting on mud or plant debris, so perhaps this annual drawdown is also contributing to this prevalence. Watch status is low due to familiarity with the site.

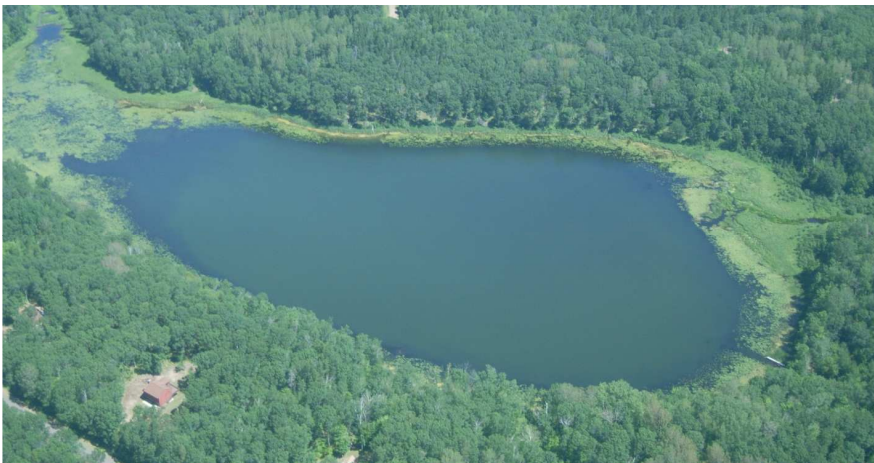
Figure 24. Culbertsen Lake, Burnett County, 2008.

This site was investigated after a small amount of harvest was reported from it, and because it occurs in a watershed with a high rice presence. We were unable to gain access to this small, private lake, but in 2009 we were able to scan the lake from a vantage point on the south shore. A scattering of rice was present, especially along the south shore, near a private lake association dock. It is uncertain if the lake supported larger beds in other years; it is possible the harvest report was erroneous, possibly coming from North Lang Lake just to the north. Rice is considered present on this lake; however, additional surveys should be conducted to better determine typical abundance levels, thus the watch status is medium.

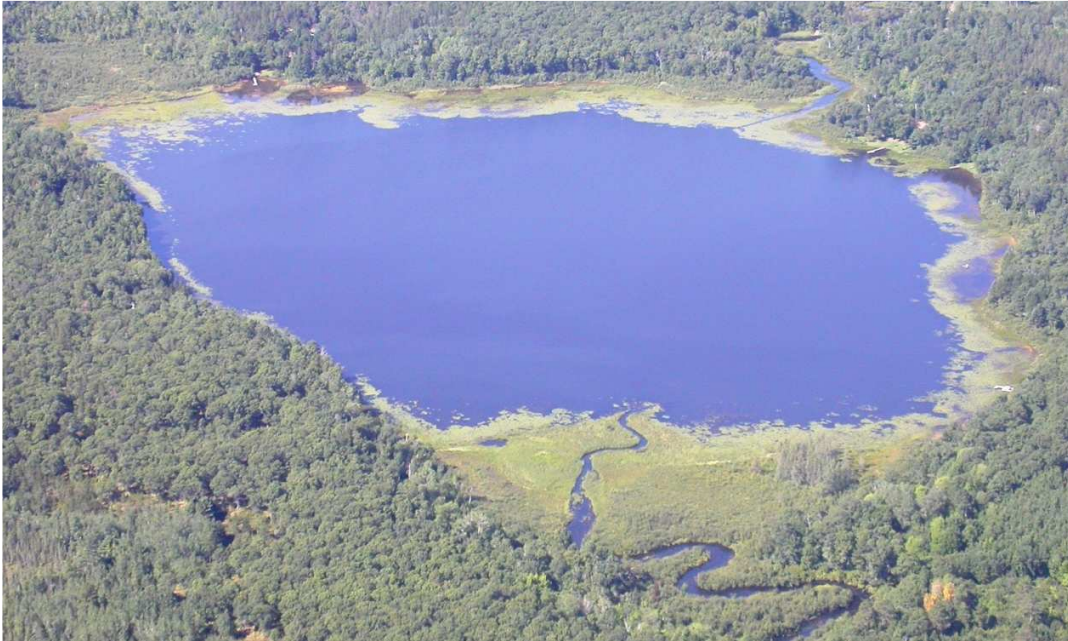
34. Eagle Lake (WBIC 2672100).

Figure 25. Eagle Lake, Burnett County, 2008.

Eagle Lake is part of a chain of rice waters which can be found along Loon Creek. The biggest bed is located at the Loon Creek inlet (shown at the bottom of the photo above) with smaller amounts sometimes occurring near the outlet and on the southern most bay. Small amounts of harvest have been reported occasionally. Watch status is low because of familiarity with the site.

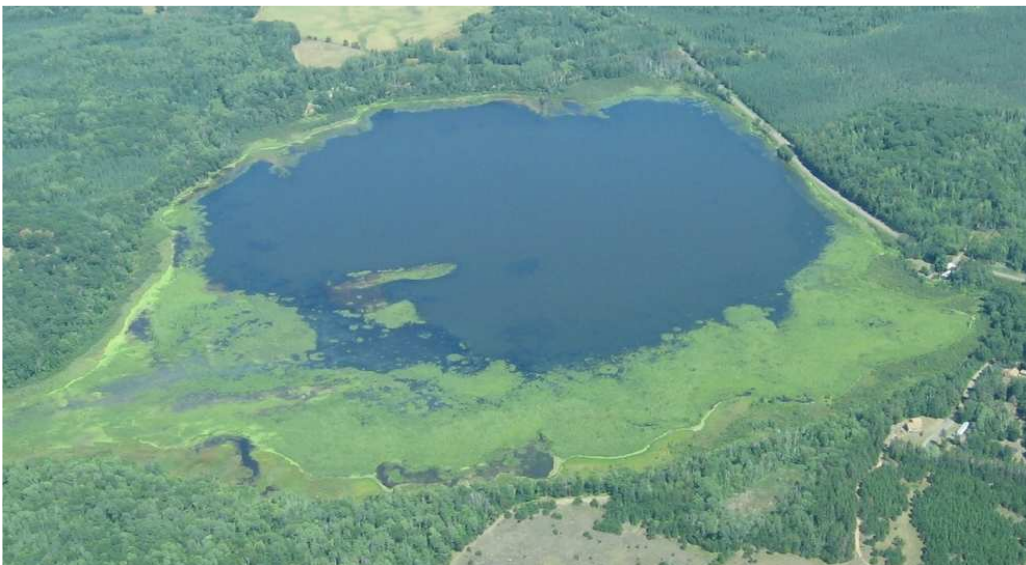
Figure 26. Gaslyn Lake, Burnett County, 2007.

Gaslyn Lake has long been recognized as an important rice water, and is on the list of sites whose harvest is date-regulated. It shows up in harvest surveys whenever the bed is large enough to support picking. Most of the rice is limited to a band along the southern half of the lake. Watch status is low because of familiarity with the site.

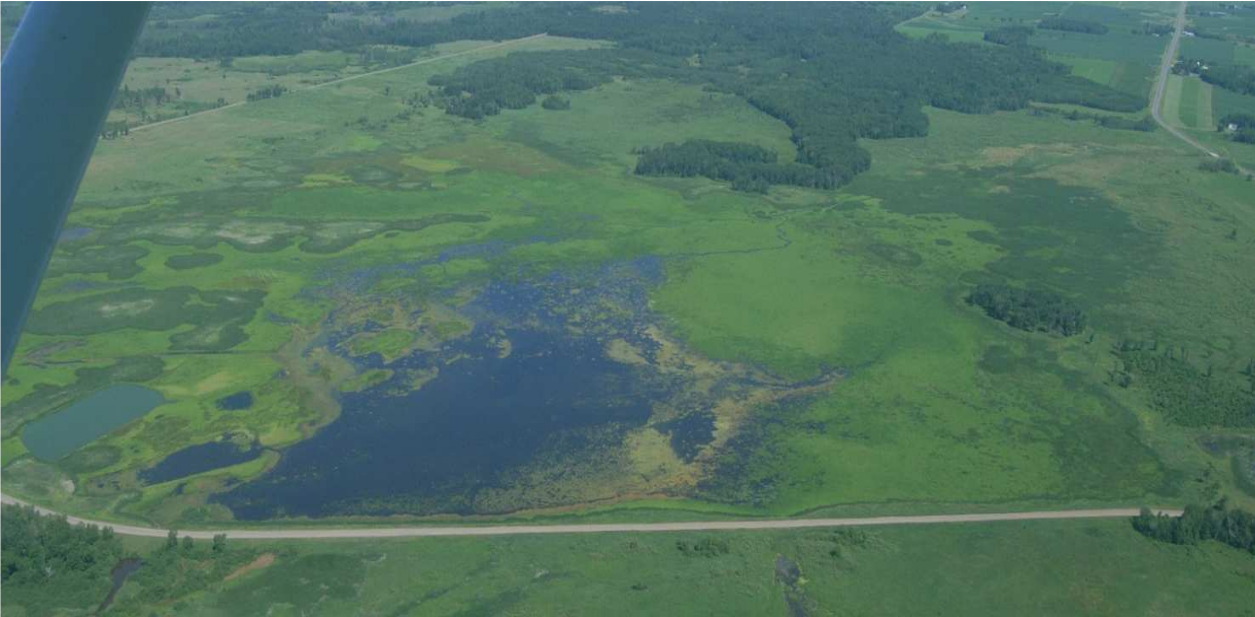
36. Grettum Flowage (WBIC 2637800).

Figure 27. Grettum Flowage, Burnett County, 2008.

Grettum Flowage, located on the Fish Lake State Wildlife Area, has been a very successful seeding establishment. However, the site is closed for most of the fall to provide refuge to wildlife, and so the site has not turned up in harvest surveys. According to local DNR staff, this bed has expanded significantly in the past few years, while the site was in drawdown to facilitate repairs on the water control structure. From a human harvesting perspective, it would be beneficial to create a wider time period during which ricing would be allowed. This could be done by allowing harvesting during the early Canada goose season, when the area is currently closed. Watch status is medium-low because of interest in monitoring possible impacts from a recent drawdown on the site.

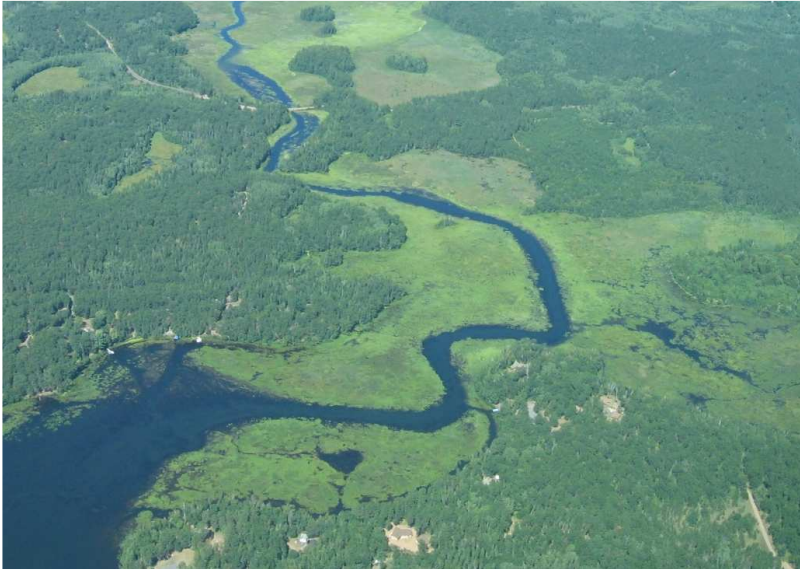
Figure 28. Gull Lake (East end), Burnett County, 2007, (Loon Lake at top of photo).

Gull Lake has long supported rice beds. Although regularly harvested when stands are substantial, it rarely turns up specifically in harvest surveys because this lake, together with Loon Lake to the north, is usually collectively reported on harvest surveys as “Carters Bridge”, the roadway which separates them. (Loon Lake, however, typically has the better beds and likely accounts for most of the harvest.) The harvest on these waters is not date-regulated, and this tends to be one of the first sites harvested in the area. Rice on Gull occurs primarily on the eastern part of the lake. Watch status is low because of familiarity with the site.

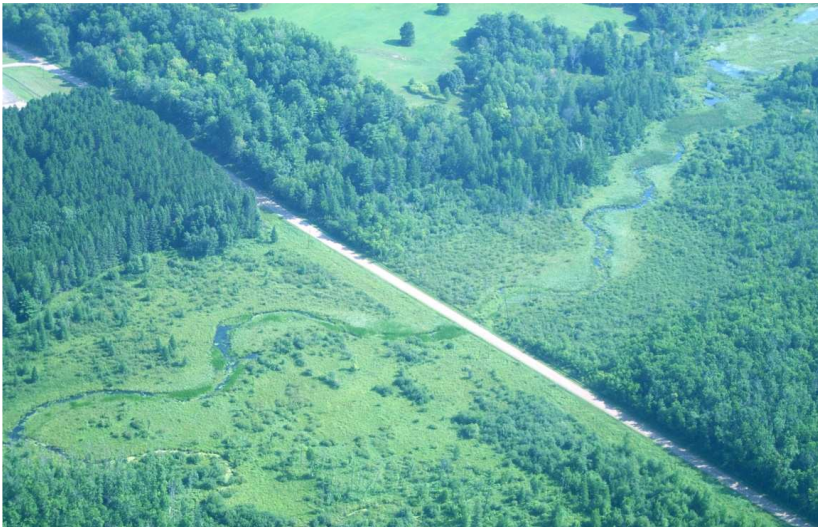
Figure 29. Kent Creek, Burnett County, 2009.

Kent Creek is a short stream (less than 2 miles) connecting Kent Lake to the North Fork of the Clam River. Rice can be found in scattered patches along much of its length. The photo above shows the crossing at Kent Lake Road. Watch status is medium due to a lack of annual abundance data.
