**Wisconsin
Ceded
Territory
Manoomin
Inventory
Ver. 1.0**

**GLIFWC
Project
Report
2010-01
March, 2010**

**Peter David
Wildlife
Biologist**

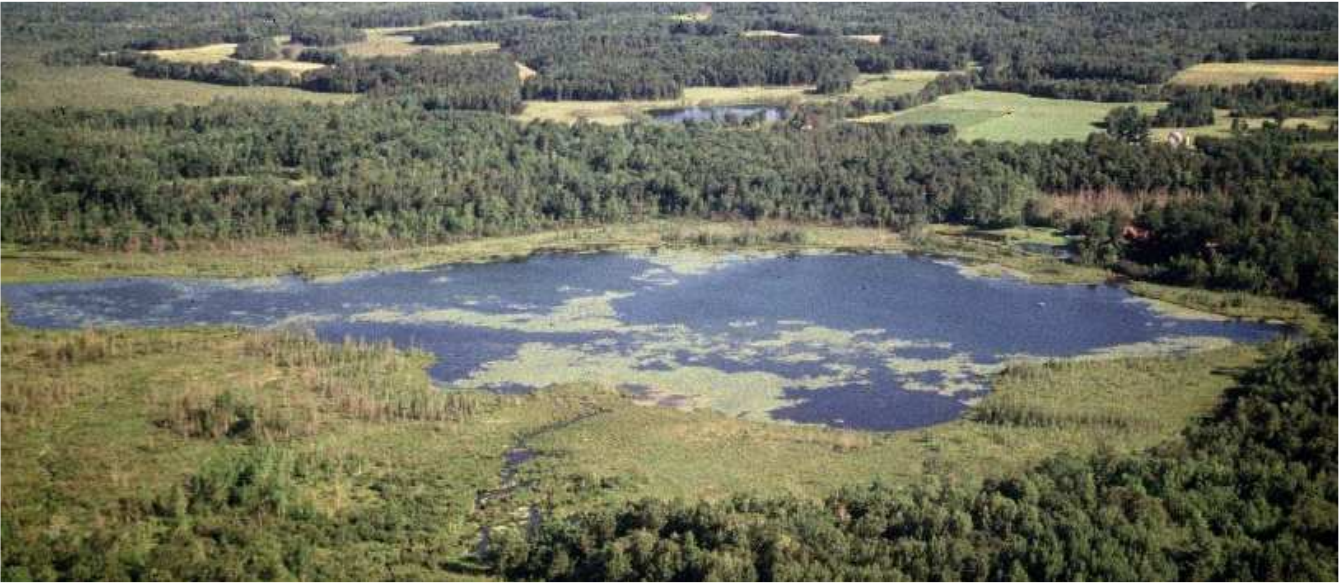
39. Kent Lake (WBIC 2656900).

Figure 30. Kent Lake, Burnett County, 1998.

Kent Lake is the headwaters of Kent Creek. This small, undeveloped lake has not been surveyed regularly, and relatively little information is available on abundance, but there are some anecdotal reports that rice production has been generally poor for the last decade or so. Very little rice was apparent in air surveys in 2009. Watch status is medium-high due to a lack of annual abundance data.

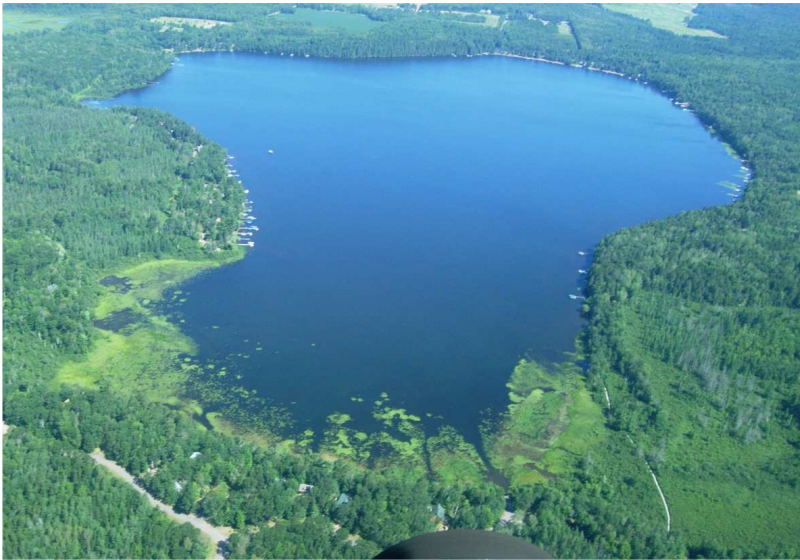
Figure 31. Lipsett Lake, Burnett County, 2008.

There are well established rice beds on the south end of Lipsett Lake. This lake has some problems with invasive aquatic species, and it will be important to try to ensure that control efforts, if made, do not negatively impact rice in the long-term. A small amount of rice removal appears to be going on by lake owners to maintain access to open water, but this probably does not pose a significant threat to the beds. Watch status is medium-low, but could increase if invasive impacts become apparent.

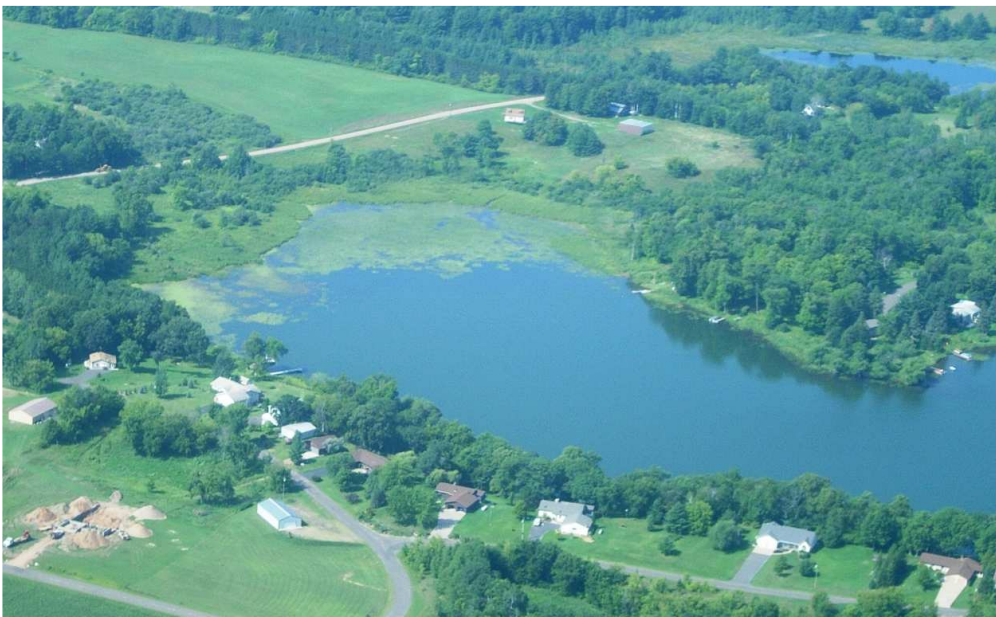
41. Little Wood Lake (WBIC 2650900).

Figure 32. Little Wood Lake, SE bay, Burnett County, 2009.

We have little information on the abundance of rice on Little Wood Lake, but a DNR Sensitive Area Report available for this lake reports a presence of rice in Area A (on the north end near the Wood River inlet and outlet) and Area C (the southeastern bay shown above). Only sparse beds were visible from the air in 2008 and 2009. Watch status is medium-high due to lack of annual abundance data.

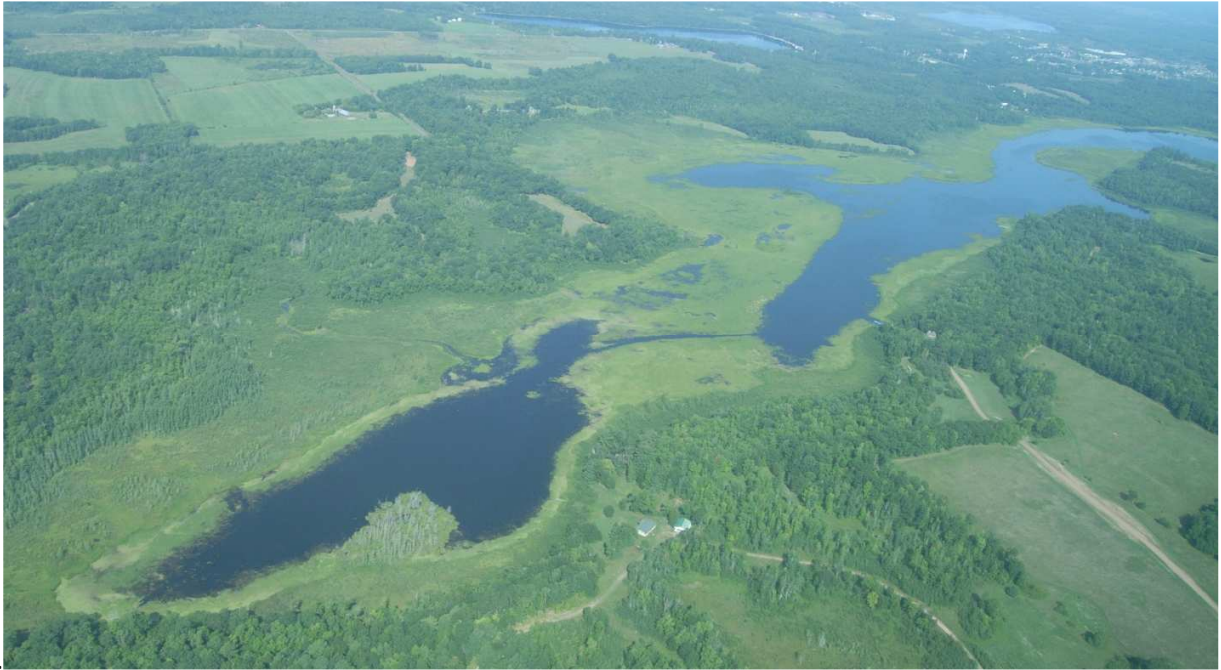
42. Long Lake (WBIC

Figure 33. Long Lake, Burnett County, 2009.

Long Lake is another one of the major rice lakes in the state. It is regularly harvested, and is a date-regulated water. It had one of its best crops in recent years in 2009 (while adjacent Upper Clam Lake experienced a failure). Rice can be found on most shorelines of this lake. Since this lake drains into Upper Clam, there is some concern that whatever is causing the recent failures at Clam might also come to affect Long Lake. Watch status is medium primarily because of the hydrological link to Upper Clam Lake.

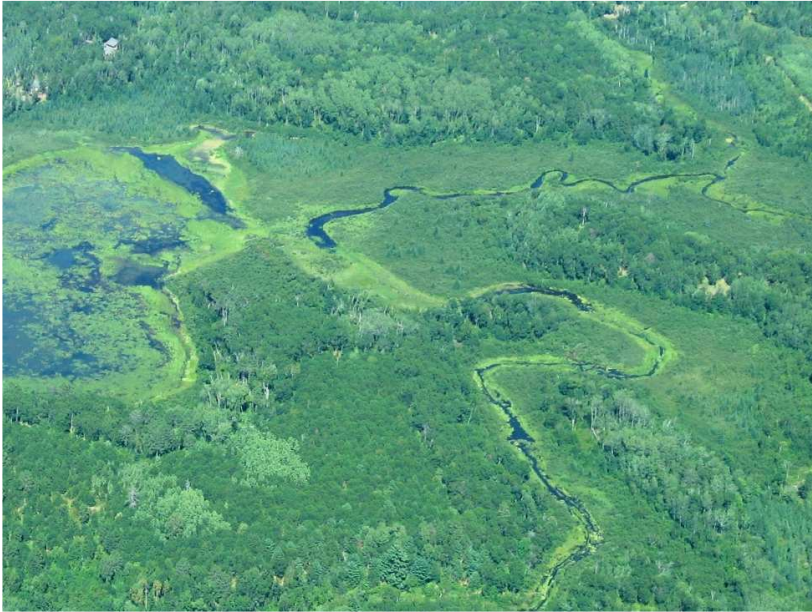
Figure 34. Loon Creek, near Mud Lake, Burnett County, 2007.

Rice can be found in many areas on Loon Creek, and the lakes it passes through. One example is shown in the photo above, in the area east of Mud Lake (partially visible on the left). The full distribution of rice on the river is poorly documented, but it likely exists in most sections with suitable habitat. Watch status is low because of the relatively protected condition of most sections of this creek.

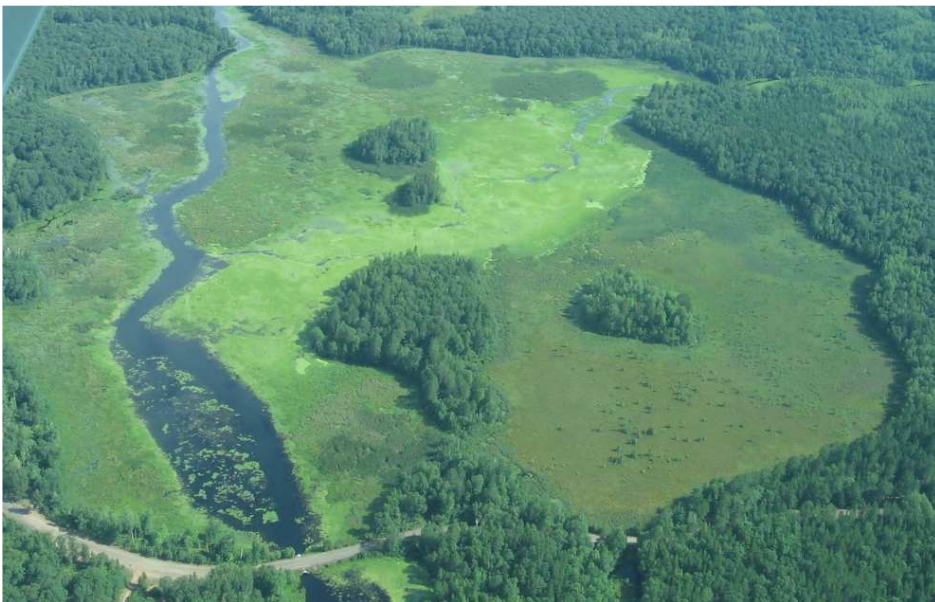
Figure 35. Loon Lake, Burnett County, 2006.

Loon Lake has long supported rice beds. Although an important harvest water, it rarely turns up specifically in harvest surveys because this lake, together with Gull Lake to the south, is usually collectively reported on harvest surveys as “Carters Bridge”, the roadway which separates them. (This bridge is visible near the bottom of the photo above.) Of the two, Loon Lake typically has the better beds and likely accounts for most of the harvest; in a year with a good stand,

much of this small lake looks more like a prairie than a lake. The harvest on neither Loon nor Gull is date-regulated, and this site tends to be one of the first harvested in the area. Watch status is low because of familiarity with the site.

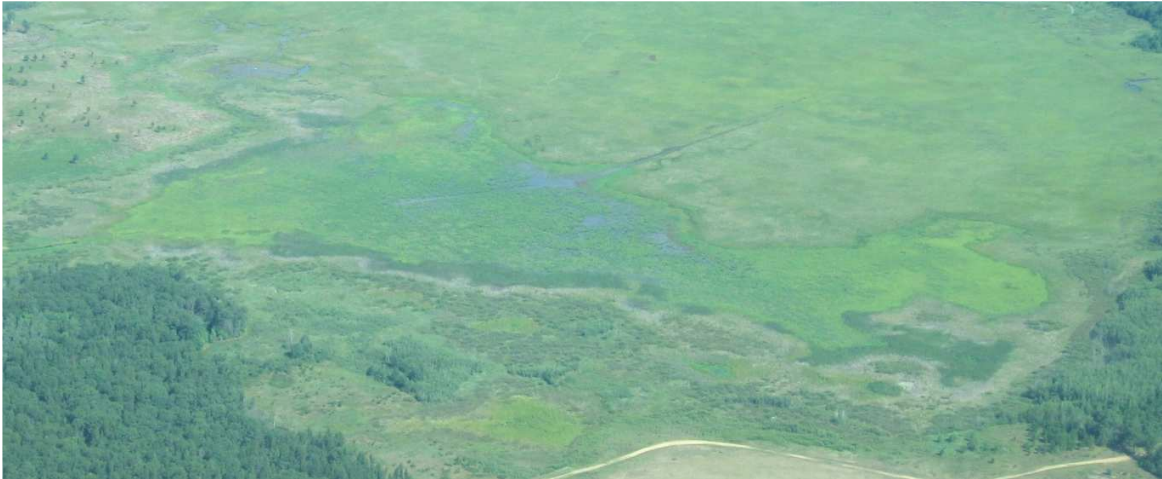
Figure 36. Lower Hay Creek Flowage, Burnett County, 2006.

Hay Creek Flowage is another one of the very successful sites that was seeded on the Crex Meadows Wildlife Area. As shown in the photo above, nearly the entire flowage can support rice in a bumper year. Watch status is low because of familiarity with the site, and it's protected location on a wildlife area.

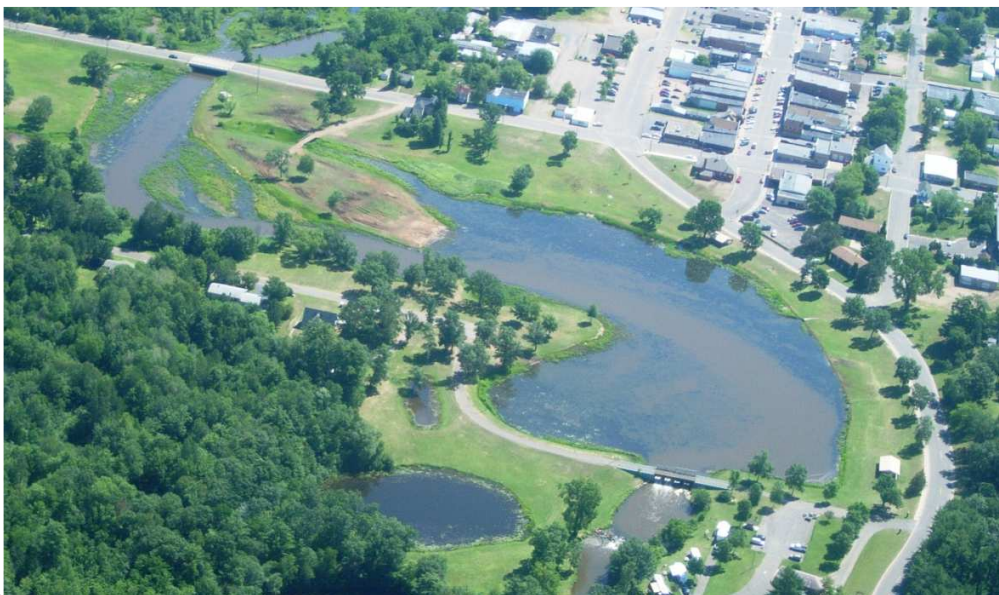
Figure 37. Memory Lake, Burnett County, 2008.

Some of the rice on Memory Lake is probably negatively impacted by an odd threat: snowmobiles. An annual contest is held on this lake that involves skipping and racing snowmobiles on the open water in the summer. Direct impacts are thought to be fairly minor, but are poorly documented; impacts on water quality may also be occurring. Watch status medium because of possible negative impacts from the snowmobile event.

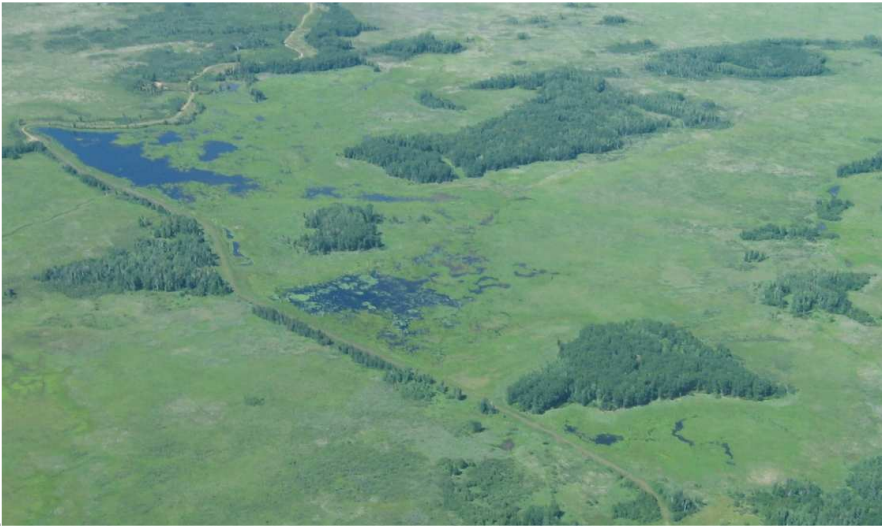
Figure 38. Middle North Fork Flowage, Burnett County, 2007.

This flowage on the Crex Meadows Wildlife Area is apparently too new to be recognized in the Surface Water Viewer, but can be seen in the 2005 air photos just northeast of North Fork Flowage. It was formed by damming the unnamed ditch listed above. This site was also seeded, and while the response has been very limited compared to what occurred on the adjacent North Fork Flowage, the presence of several acres of rice has been confirmed by Crex staff. Watch status is medium because it is possible these beds are still expanding.

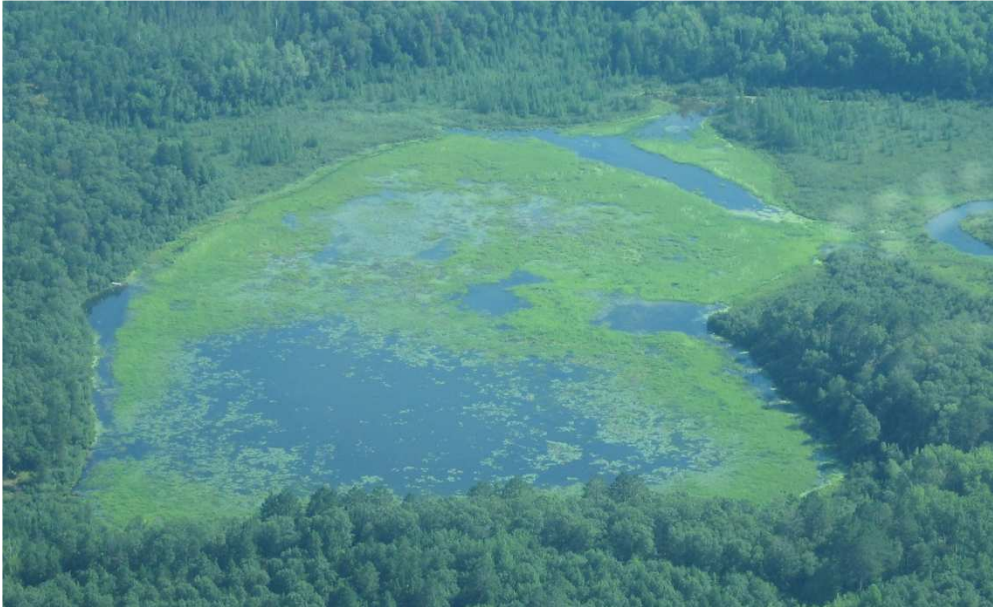
Figure 39. Mud Lake, Swiss Township, Burnett County, 2006.

Mud Lake in Swiss Township has long supported rice, and harvest on this lake is date-regulated. However, in harvest surveys it is difficult to separate harvest reported for this lake from what is reported for the other Mud Lake in the county that supports rice. With the exception of 2009, this lake likely accounted for most of the harvest in recent years due to poor crops on the other Mud Lake, but historically (and perhaps in the future if restoration efforts on the other lake are successful) the other Mud Lake likely accounted for more harvest. Watch status is low because of familiarity with the site and relatively undeveloped status.

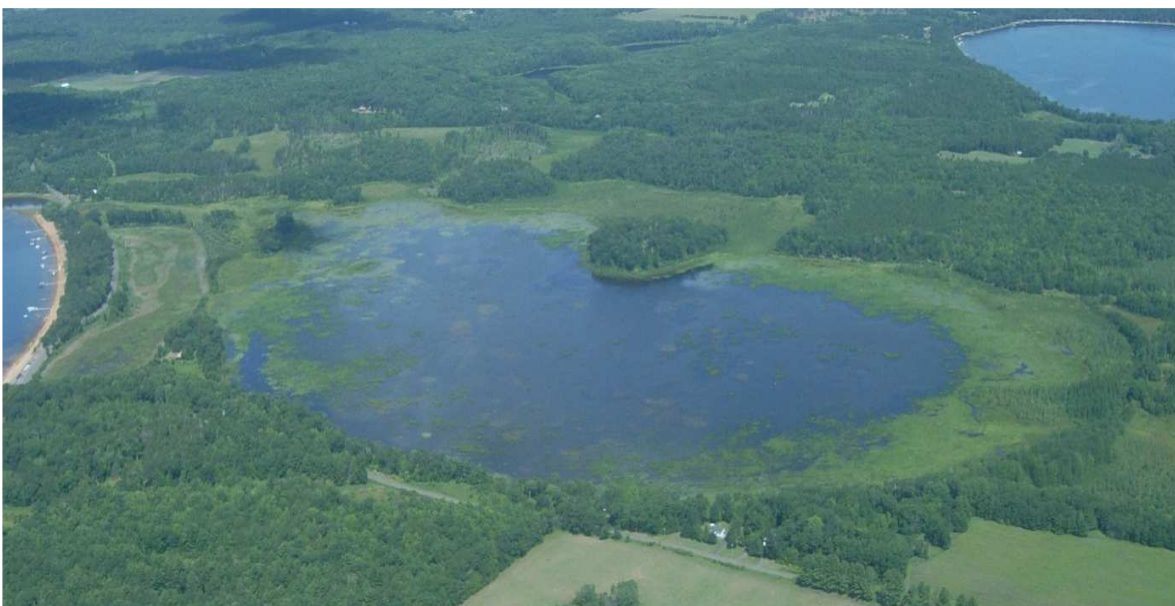
49. Mud Lake (2) (Oakland Township) (WBIC 2484400).

Figure 40. Mud Lake, Oakland Township, Burnett County, 2009.

Mud Lake has a long history of supporting rice beds, but production has been poor in the past 2 decades, apparently primarily due to the lake level being raised when a culvert on the outlet to Devils Lake (visible in the far left of the photo

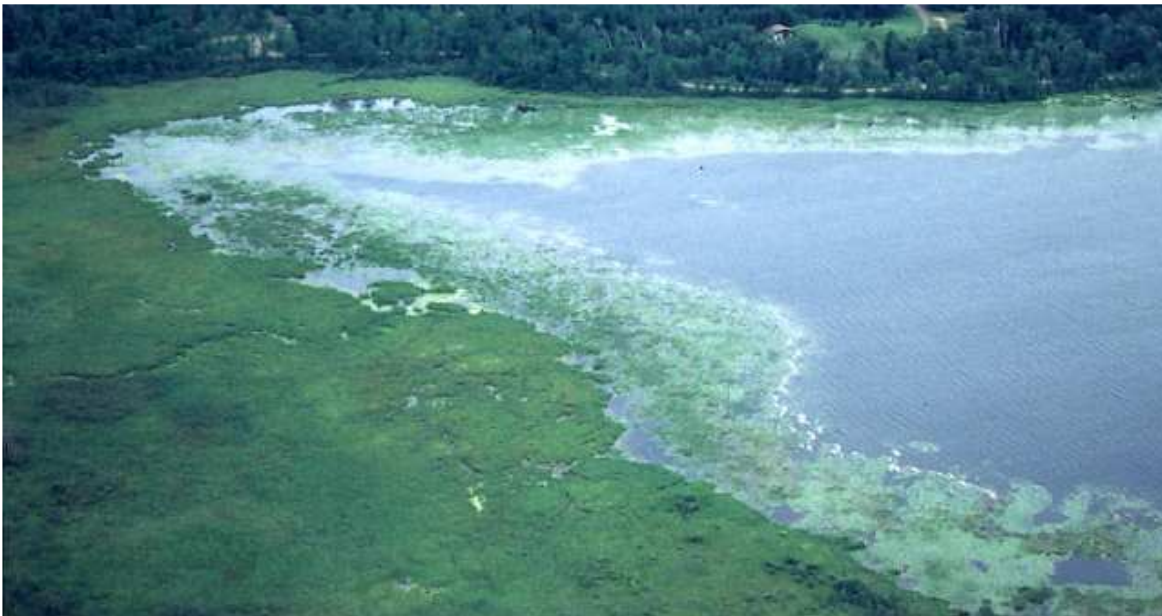
50. Mud Hen Lake (WBIC 2649500).

Figure 41. Mud Hen Lake, NE bay, Burnett County, 2002.

Mud Hen Lake has a long history of supporting rice, and this lake is included in the list of waters whose harvest is date-regulated. However, harvest reports have been sporadic, and anecdotal reports suggest that rice abundance may be in decline. Rice appears to be limited primarily to the northeast bay (shown above) and a smaller area near the Wood Creek outlet on the west side of the lake. Watch status is medium due to limited annual abundance data.

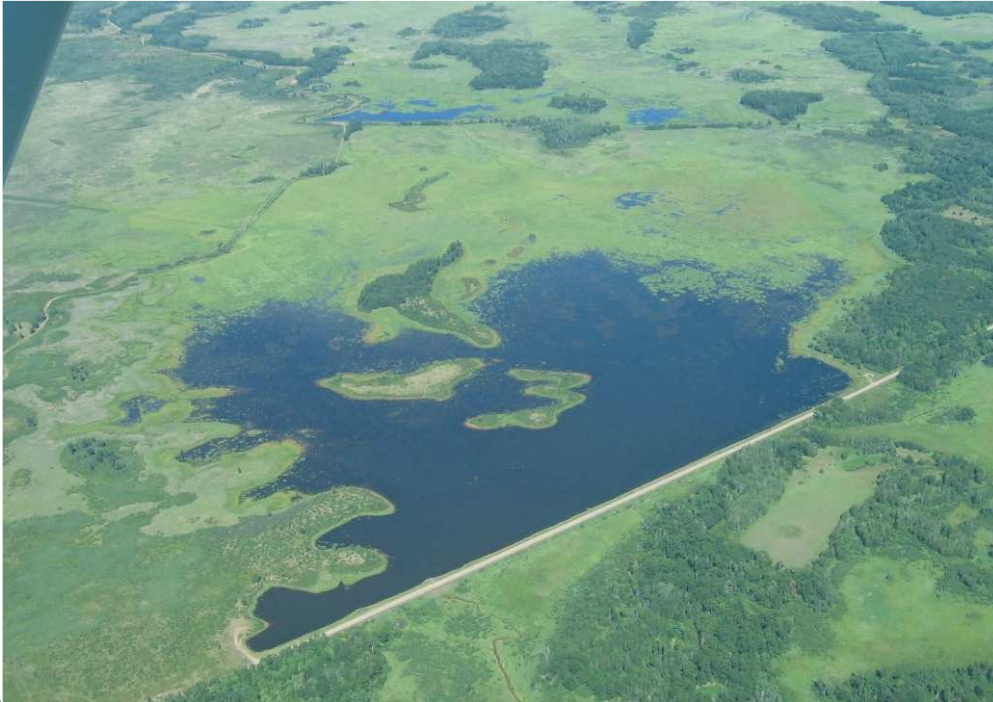
Figure 42. North Fork Flowage, Burnett County, 2007.

North Fork Flowage represents one of the most successful seedings conducted on the Crex Meadows Wildlife Area. Beds here are substantial, self-sustaining, and of growing importance to harvesters. Harvest is not date-regulated. Watch status is low because of familiarity with the site.

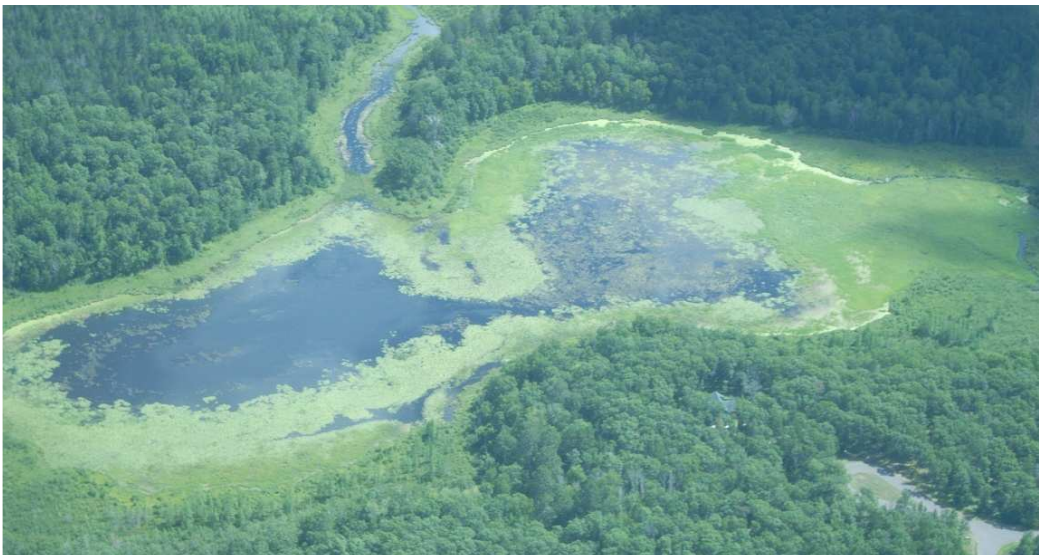
Figure 43. North Lang Lake, Burnett County, 2008.

but is limited by the relatively small size of the bed, somewhat difficult access, and reportedly a very soft bottom. Watch status is low because of familiarity with the site.

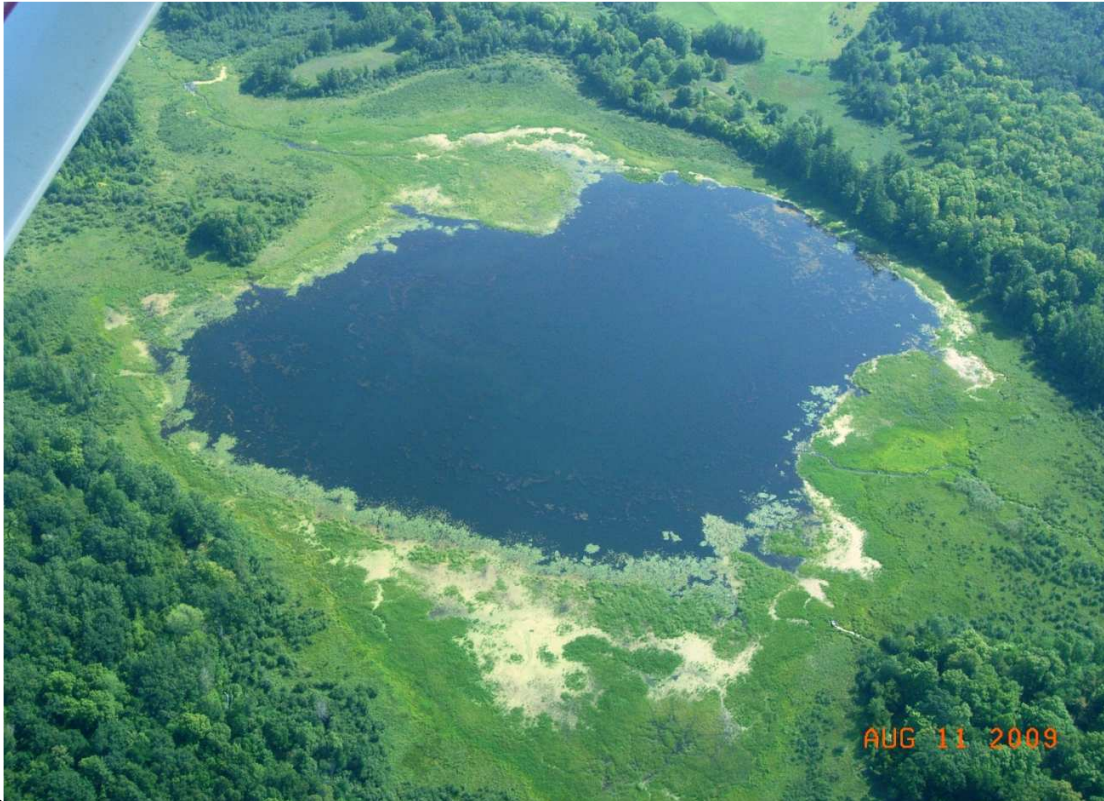
Figure 44. Peterson Lake, Burnett County, 2009.

This small, undeveloped lake is located on an unnamed creek south of Wood Lake. Rice can ring the lake in a good year, but it rarely shows up in harvest surveys because of limited access. Watch status is medium-low, but additional annual abundance data would be useful.

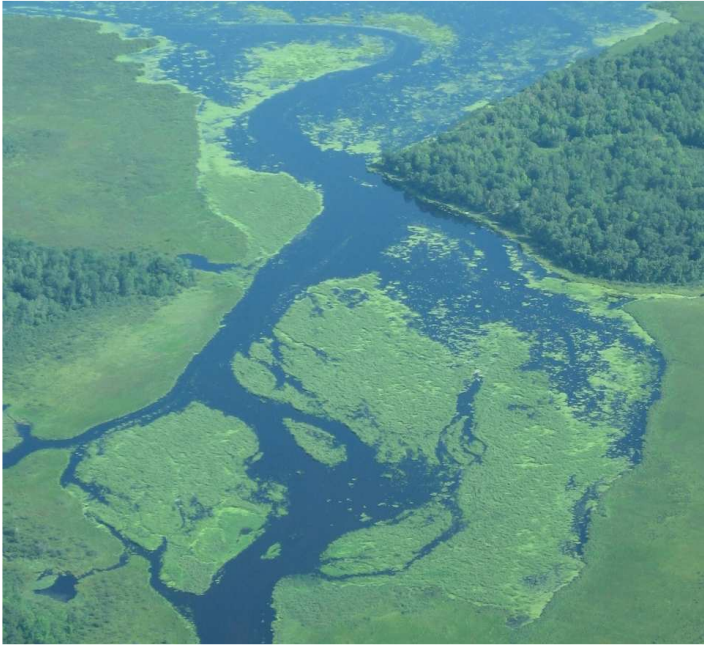
Figure 46. Rice Lake (1), South end, Burnett County, 2006.

This Rice Lake is one of 3 carrying the name in Burnett County. This one is located approximately 6 miles northeast of Hertel. It has a long history of supporting rice, but anecdotal information suggested the bed had done relatively poorly over much of the last two decades. However, beds in the primary location on the south end of the lake, at the Yellow River inlet, have improved in the last few years, and the St. Croix Tribe did some seeding on this lake in 2008, along the east shore, south of the boat landing. No appreciable amount of rice has been found on the northern half of the lake. Watch status is medium because of interest in monitoring recent seeding results.

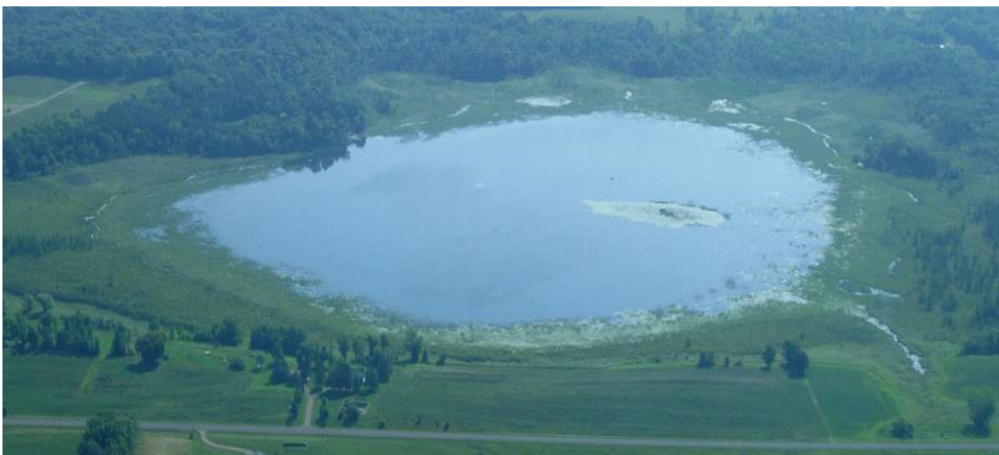
Figure 47. Rice Lake (2), Burnett County, 2009.

This Rice Lake is one of 3 carrying the name in Burnett County. This one is located just west of Spirit Lake. There is no public access to this lake, and so it has not been an important harvest water, but it is very valuable to wildlife. In good rice years, the lake is ringed with a band of rice. Watch status is low because of familiarity with the site.

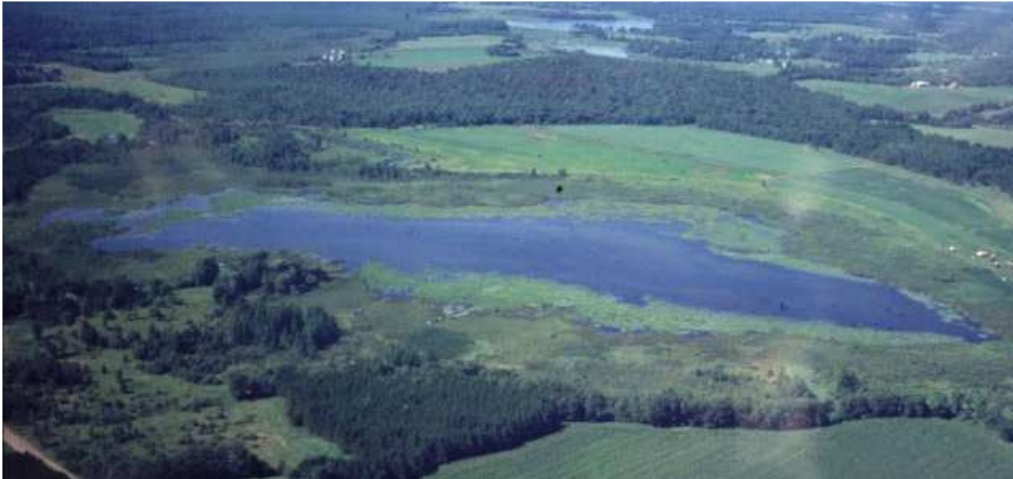
Figure 48. Rice Lake (3), Burnett County, 2001.

This Rice Lake is one of 3 carrying the name in Burnett County. This small lake is located just south of HWY 48, 3.5 miles west of Frederick. With no public access, this has not been an important harvest water. Intermittent air surveys suggest this bed has not been very productive in recent years. Watch status is medium-high because of decline concerns.

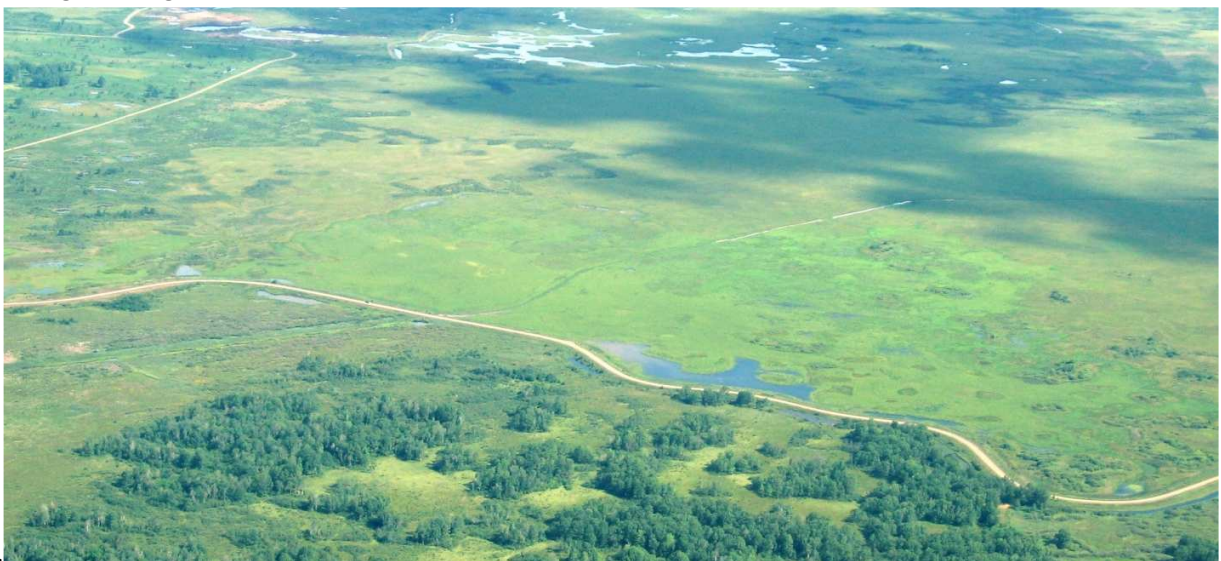
Figure 49. South Refuge Flowage, Crex Wildlife Area, Burnett County, 2006.

Also known as Refuge Extension, South Refuge Flowage on the Crex Meadows Wildlife Area is another example of the great seeding success that has taken place at Crex. This site is within a refuge, and is not open to human harvesting, but provides a tremendous benefit to wildlife. Rice can cover most of surface area in a good year, but the stand was greatly reduced and growing on mud flats in 2009 due to extended drought. This should not have a long-term negative impact on the rice. Watch status is low because of familiarity with the site.

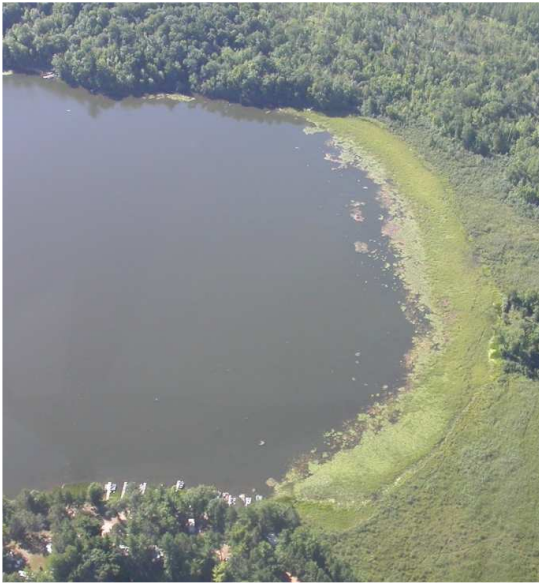
Figure 50. Spencer Lake, West end, Burnett County,

Spencer Lake has a long history of supporting rice, although the beds are not large. Harvest is date-regulated, but the amount of harvest reported is fairly small. Rice is located primarily on the west and east ends of the lake, with little if any along the more developed shorelines. Watch status is medium-low because of familiarity with the site, but some additional abundance information would be useful.

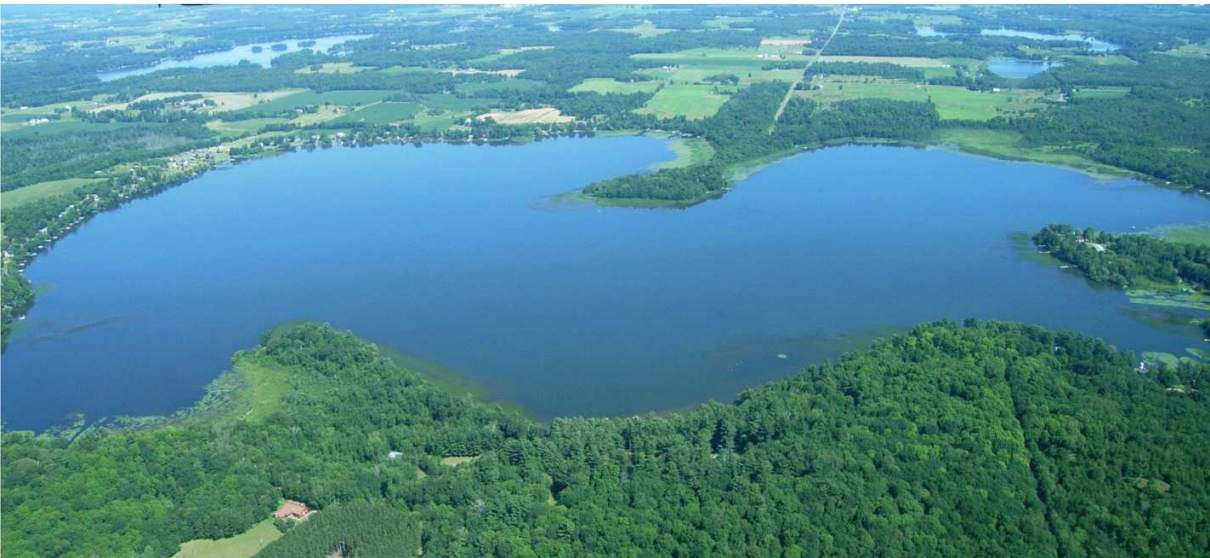
62. Spirit Lake (WBIC 2650300).

Figure 51. Spirit Lake, Burnett County, 2008.

Spirit Lake has not been regularly surveyed, and little rice was apparent in an aerial survey in 2008, though there appears to be sparse beds on both sides of the south-central bay. This correlates with a 1998 DNR Sensitive Area Report that indicates that rice is present in 2 areas on the southern half of the lake (Sensitive Areas A and B). This lake should receive additional monitoring to ensure the rice is continuing to thrive, particularly because of recent reports that the land adjacent to the rice beds, which had been owned by a Methodist Church, has recently been sold to a developer looking to subdivide the parcel into 38 lots, including 18 waterfront lots. Watch status is medium-high because of possible development concerns.

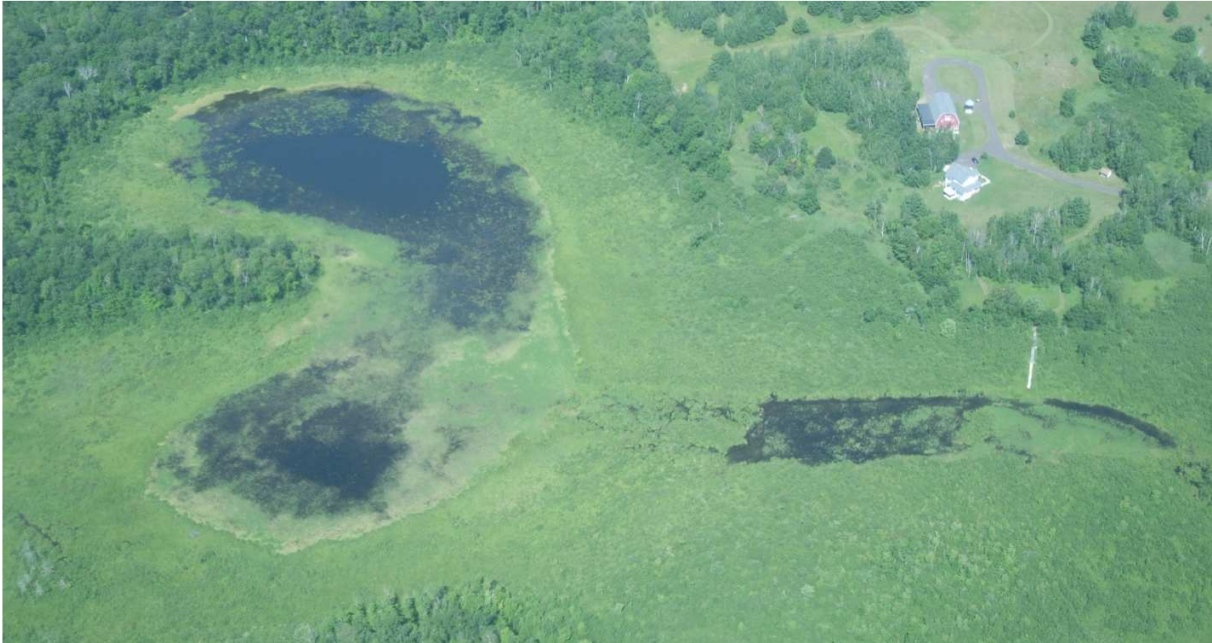
64. Unnamed (Duckshot) Lake (WBIC 2665100).

Figure 53. Unnamed (Duckshot) Lake, Burnett County, 2008.

Rice has long been present on this small waterbody , which is located less than a half mile south of Long Lake, but which drains to the east into the Clam River. However, because this site is surrounded by private land, it has been surveyed only infrequently, and annual variation in abundance is not known to GLIFWC. Watch status is medium because of limited annual abundance information.

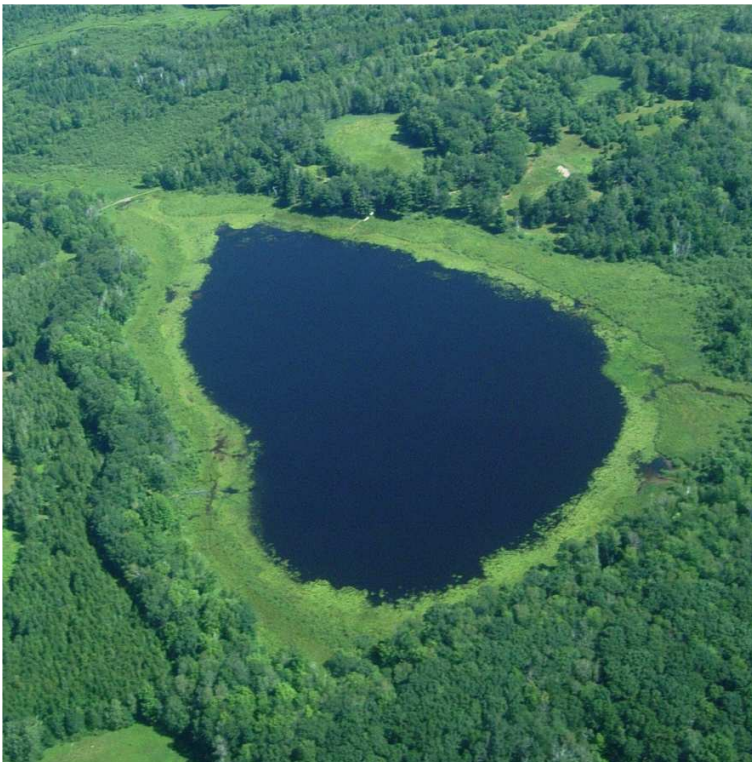
Figure 54. Unnamed (Jackson) Lake, Burnett County, 2008.

This small, private lake along Sand Creek, north of Big Sand Lake, is unnamed on the Surface Water Viewer, but locally known as Jackson Lake. A 1985 GLIFWC survey reported 1.5 acres of rice, but we were unable to gain ground access in 2008 or 2009. In the 2008 photo shown above, a small patch of rice appears to exist near the Sand Creek inlet on the southeast corner of the lake. Suggest recognizing this as a rice water, while continuing to attempt gaining ground access for better confirmation. Watch status is medium because of limited annual abundance information.

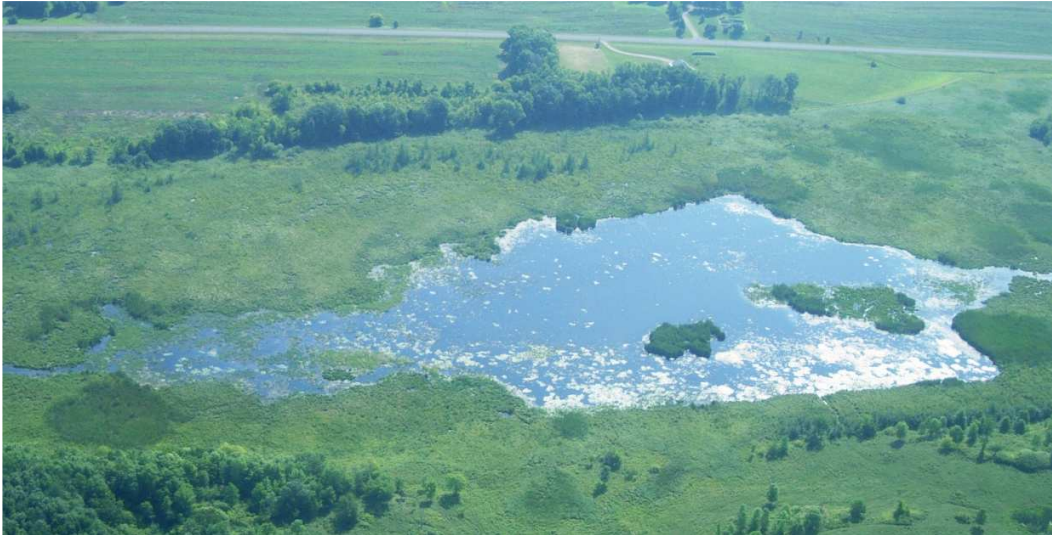
Figure 55. Unnamed Pond South of Peterson Lake, Burnett County, 2009.

This small, undeveloped pond has not been surveyed regularly, but anecdotal reports suggest it has supported rice for a long time. Relatively small amounts of rice were observed in 2008 and 2009 air surveys, but it is not known how typical these stands were compared to other years. Watch status is medium-low because of limited annual abundance information.

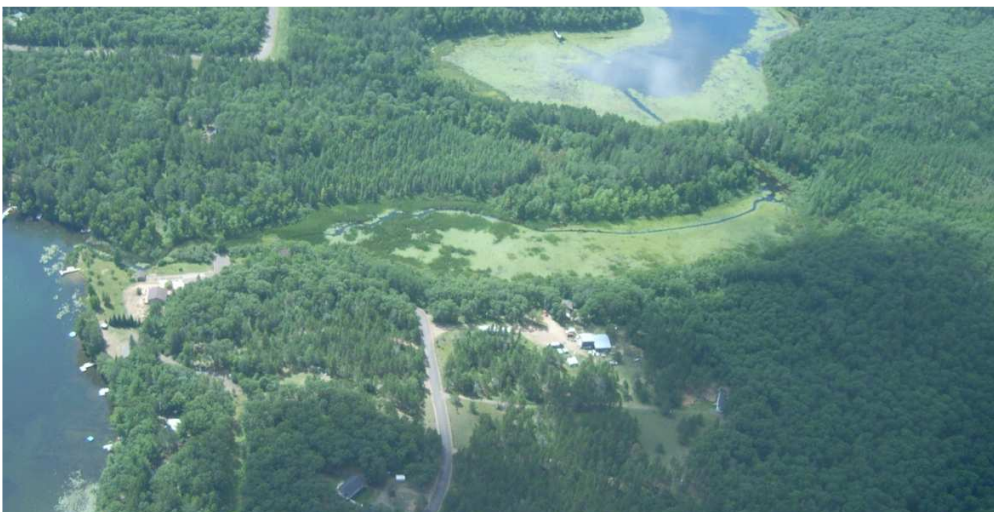
Figure 56. Bradshaw Slough, Burnett County, 2009.

Although this location is unnamed on the Surface Water Viewer, locals refer to the waterbody that connects Robie and Tabor Lakes as Bradshaw Slough. Due to their small size, the beds here are not frequently surveyed, and they are not important to harvesters, but the rice can be abundant enough to be attractive to waterfowl, and the site is used by some waterfowl hunters. Rice can grow in small scattered beds here, but most of the vegetation visible in the 2009 air photo consists of other species. Watch status is medium because of limited annual abundance information.

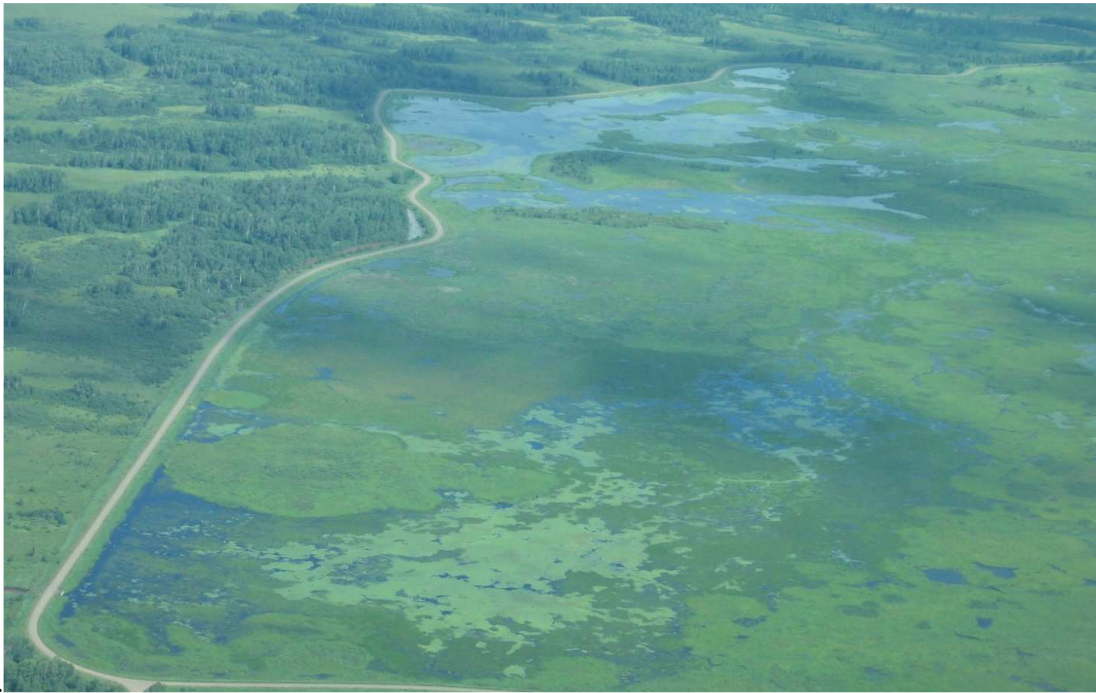
Figure 57. Upper North Fork Flowage, Burnett County, 2006.

A relatively small amount of rice has been reported to have been established on this flowage on the Crex Meadows Wildlife Area. While the area has been flown several times, better air photos are needed. A small amount of harvest has been reported from this flowage, but it's possibly an erroneous report for the North Fork Flowage, which supports much larger beds. Most of the vegetation visible in the air photo is other species. Watch status is medium because these beds may still be expanding.

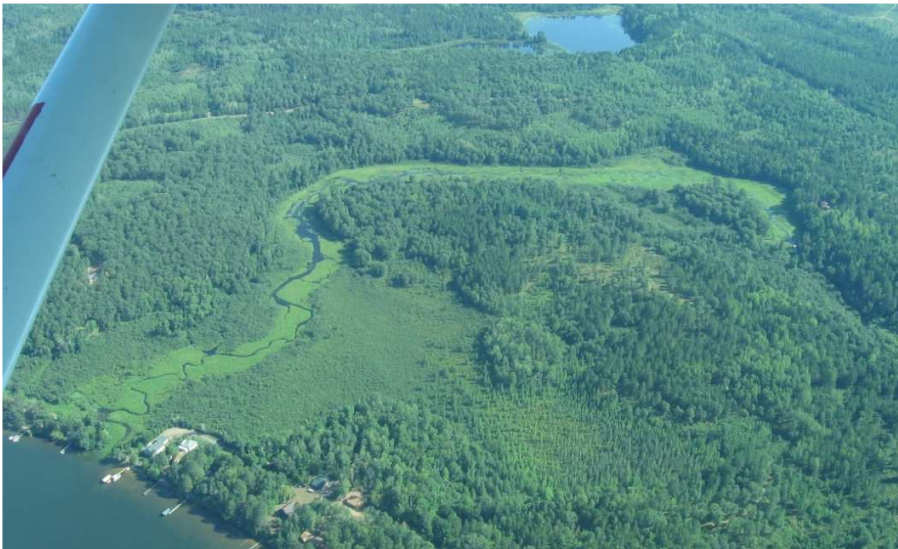
Figure 58. Webb Creek, West, Burnett County, 2006.

Webb Creek has two large, well defined beds. The better known of these is found at the outlet of Webb Lake, a portion of which is visible in the lower-left of the first photo shown above. The other bed occurs roughly a mile and a half further east, and shown in the second photo. The rice on Webb is harvested regularly, but by a limited number of individuals since the beds are not extensive. Watch status is low because of familiarity with the site.

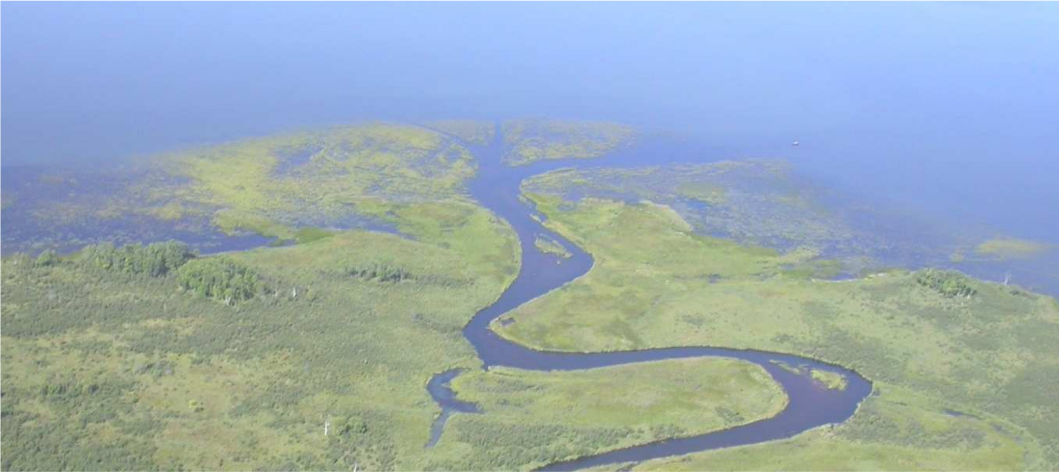
Figure 60. Yellow Lake, Burnett County, 2005.

The rice beds on Yellow Lake are some of the most interesting visually in the state, growing on the delta that has formed where the Yellow River enters the lake. This bed is well established and has been present for a long time, but seems to do better in years with relatively low water. No appreciable amount of rice is known to exist elsewhere in the lake. Watch status is low because of familiarity with the site.

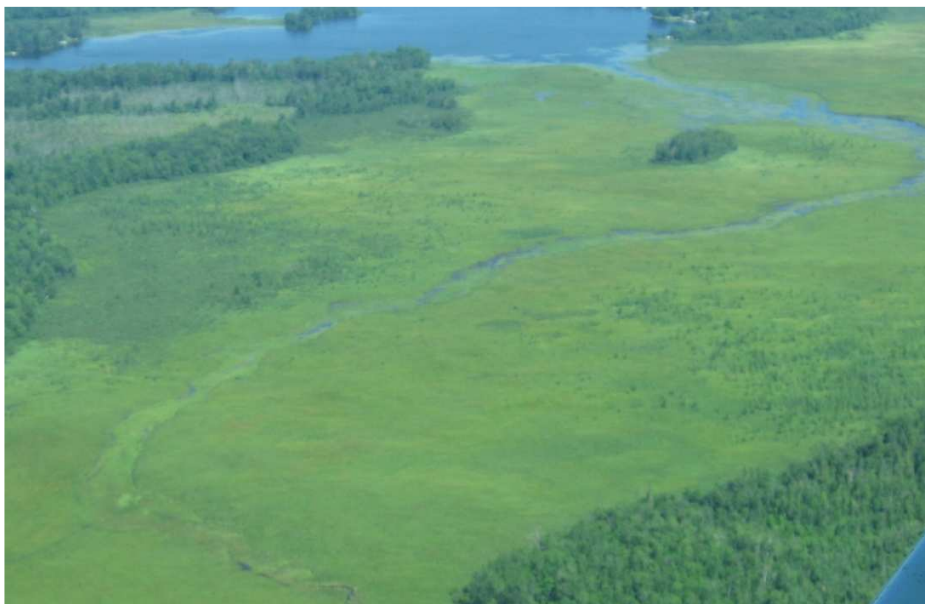
Figure 62. Cedar Creek, Chippewa County, 2008.

A fairly substantial rice bed can be found along Cedar Creek in the section between Long and Chain Lakes (the latter lake is visible in the top of the photo). This is one of the larger beds in Chippewa County, and might make an interesting selection for future genetics studies because of its relative isolation from other substantial beds. This site has only been flown once, and better air photos would be valuable. Rice is located both in the upper part of the creek (visible in the lower left in the photo) and in the wide area just south of Chain Lake (less apparent in the photo). Watch status is medium-high because of limited annual abundance information.

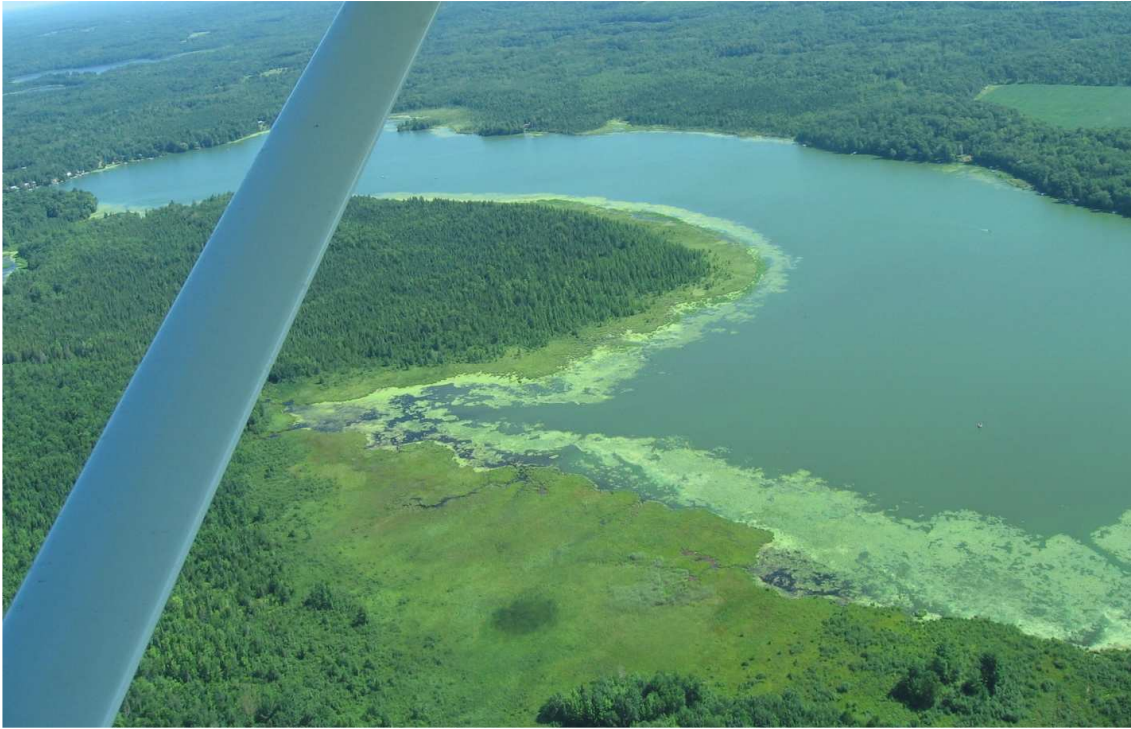
75. Marsh Miller Lake (WBIC 2171200).

Figure 63. Marsh Miller Lake, Chippewa County, 2008.

Several acres of rice of sparse to medium density were found on Marsh Miller Lake (incidental to doing surveys of O'Neil Creek) in 3 different beds along the northeastern and west-central shores. The history of these beds is unknown. The rice observed was fairly heavily browsed, but still appeared likely to produce seed. Field staff felt this lake may have potential to support larger beds with seeding, but it would be important to determine how the dam on this site is currently being used to manage water levels before proceeding. This lake has only been flown once, and better air photos are needed. Watch status is high because of limited annual abundance information.
