**Wisconsin
Ceded
Territory
Manoomin
Inventory
Ver. 1.0**

**GLIFWC
Project
Report
2010-01
March, 2010**

**Peter David
Wildlife
Biologist**

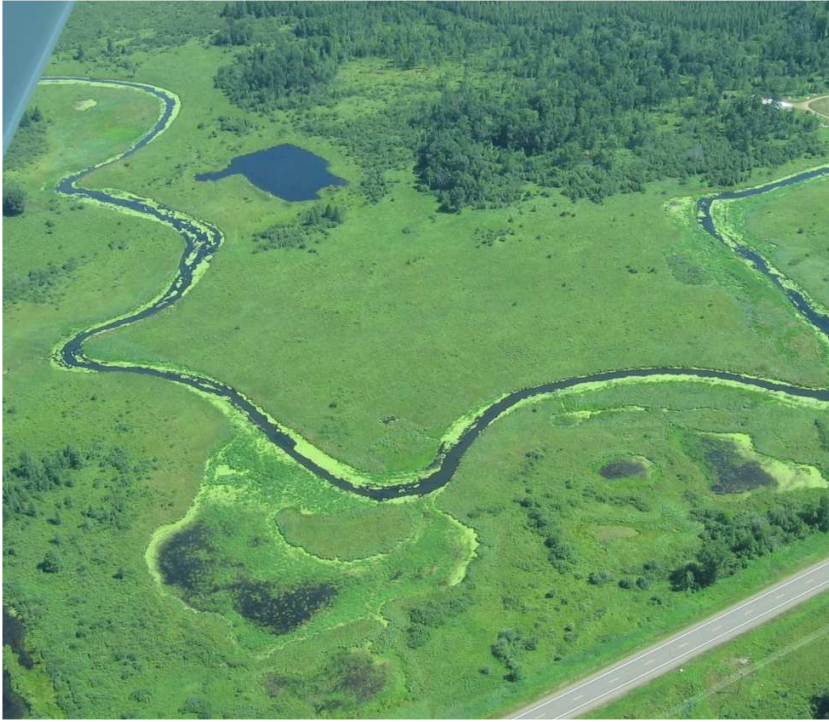
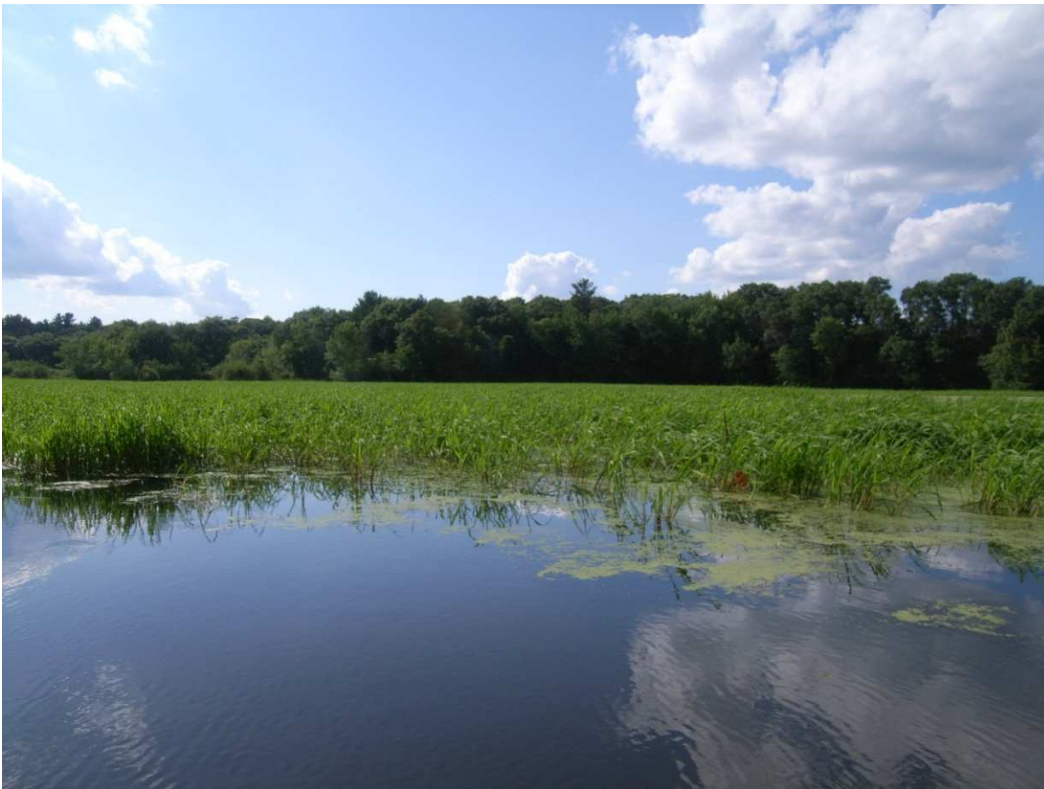
Figure 64. O'Neil Creek, North of HWY 64, Chippewa County, 2006.

Figure 65. O'Neil Creek Sloughs above Lake Wissota, Chippewa County, 2009.

Rice beds were confirmed in at least 3 different locations on O'Neil Creek. The smallest consists of a scattered distribution of plants upstream for roughly half mile from the 153rd St. crossing, or about 2 miles northeast of Marsh Miller Lake. A large bed is found in the wide areas just upstream from the HWY 64 crossing (shown in the air photo). The biggest beds occur in the wide slough area just upstream from where the creek enters Lake Wissota. It is likely that rice also exists in other areas with suitable habitat. Watch status is medium-high because of limited annual abundance information.

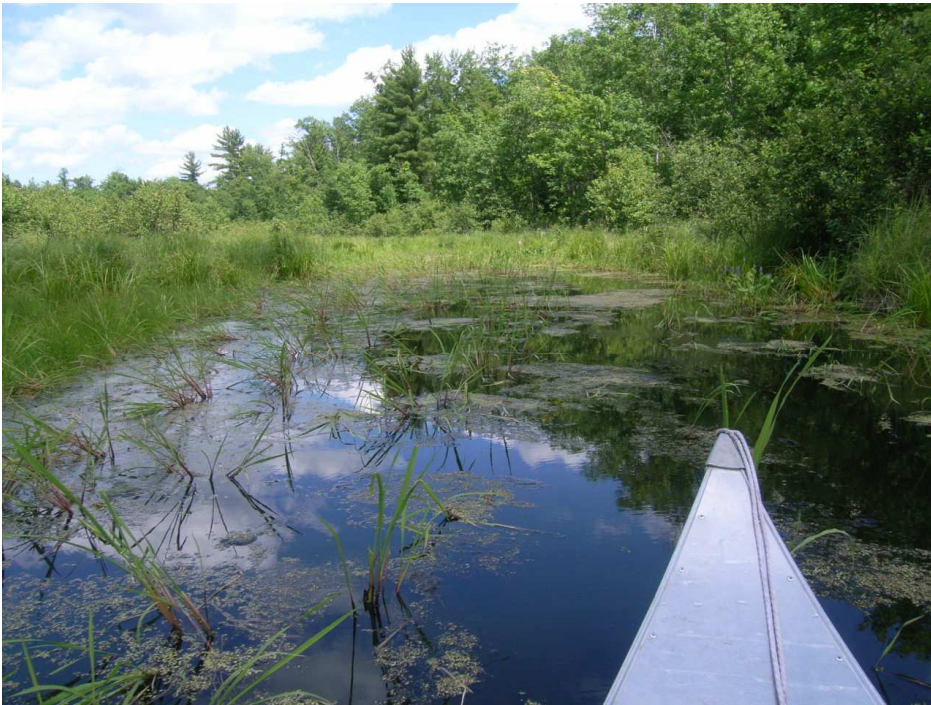
Figure 66. O'Neil Creek, half a mile above 153rd Street, Chippewa County, 2009.

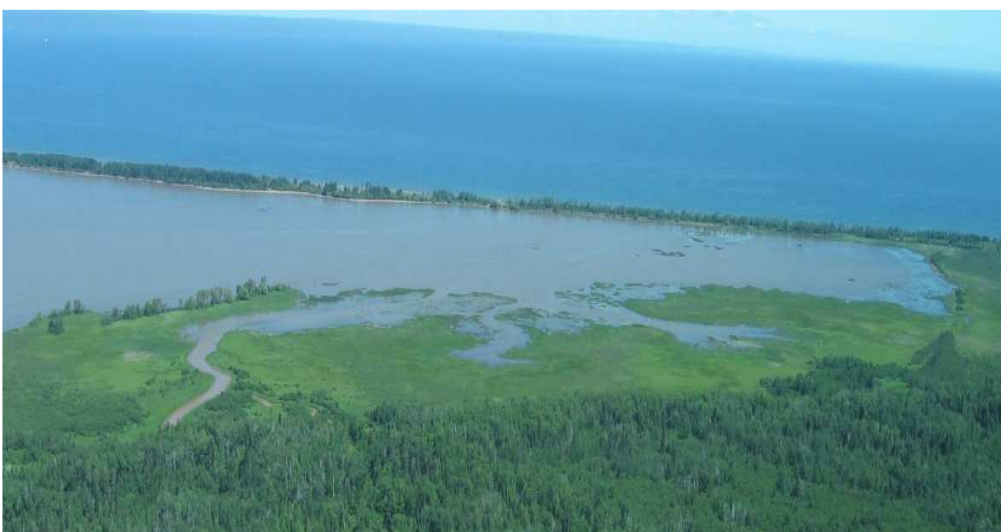
Figure 67. Allouez Bay, Douglas County, 2007.

Allouez Bay is an interesting site in that it apparently once had enough rice to merit being included in the list of waters whose harvest is date-regulated, yet in recent year has been nearly devoid of rice. No harvest has been reported from this site, and no rice had been reported in many years, but surveys in 2008 and 2009 found small remnant beds; the 2009 beds were also confirmed by Dr. Anthony Kern of Northland College. (Note that the photo above includes the area where rice was found, but the rice remnants are not large enough to be clearly identified in this image.)

Superficially, water quality in this system appears quite poor, being negatively impacted from run-off from the clay plain. However, more intensive investigation of this site might indicate if restoration efforts would make it possible to regain some of the historic rice abundance. Watch status is high because of limited annual abundance information and interest is possible restoration.

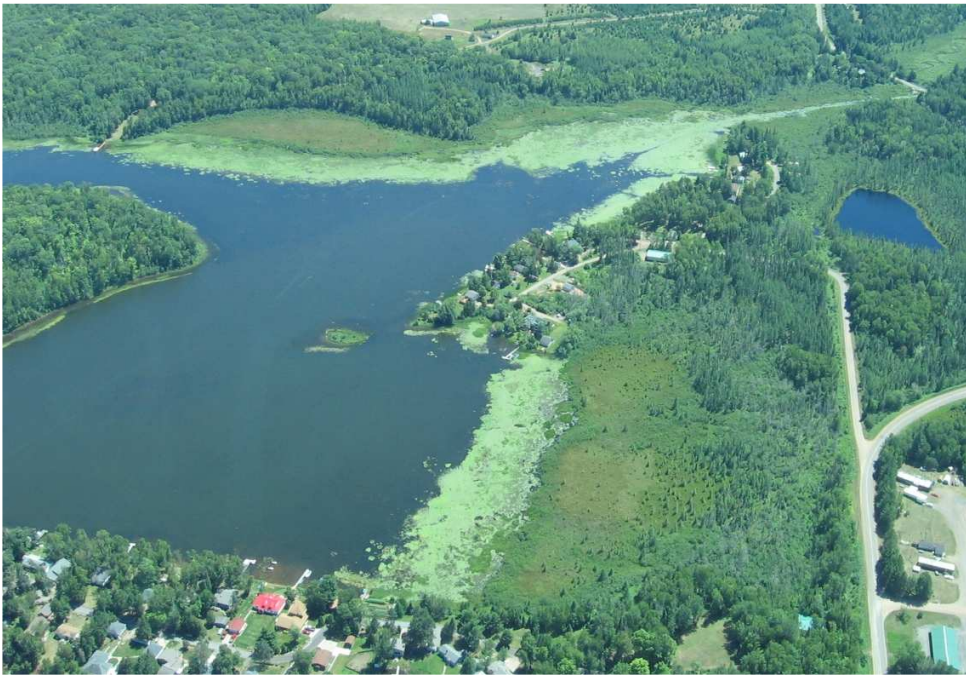
Figure 68. Amnicon Lake Outlet, Douglas County, 2007.

The amount of rice at Amicon Lake is fairly modest, and it appears to be limited to the area near the outlet, on the southwest corner of the lake. Should additional lakeshore development occur in this area, this bed could be impacted. Watch status is medium-low, but some additional annual abundance information would be helpful.

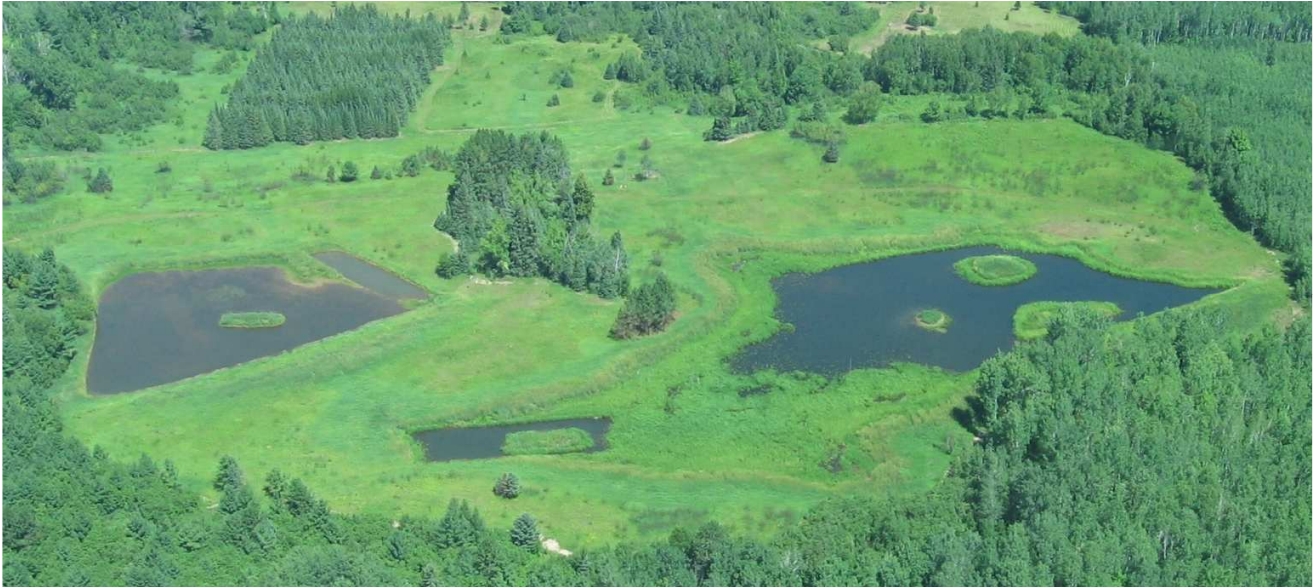
Figure 69. Fasteland Road Ponds, Douglas County, 2007.

The 2 ponds shown in the photo above are relatively new and do not show up on the Surface Water Viewer, except in the 2005 aerial photos. These highway mitigation ponds are located a short distance north of HWY 2, several miles west of Brule, just east of the north end of Fasteland Road. When first seeded, both ponds supported rice, but the smaller bed on the western pond seems to have disappeared, perhaps as a result of heavy goose browsing. The larger bed on the eastern pond has continued to exist, but has suffered in the last two years from very low water that has left some areas dried out. This bed is interesting in that it may not have year-round water flow most years, so it may represent the lower limit of water flow that rice requires. Watch status is medium-low, but it will remain interesting to monitor the long-term productivity on this site.

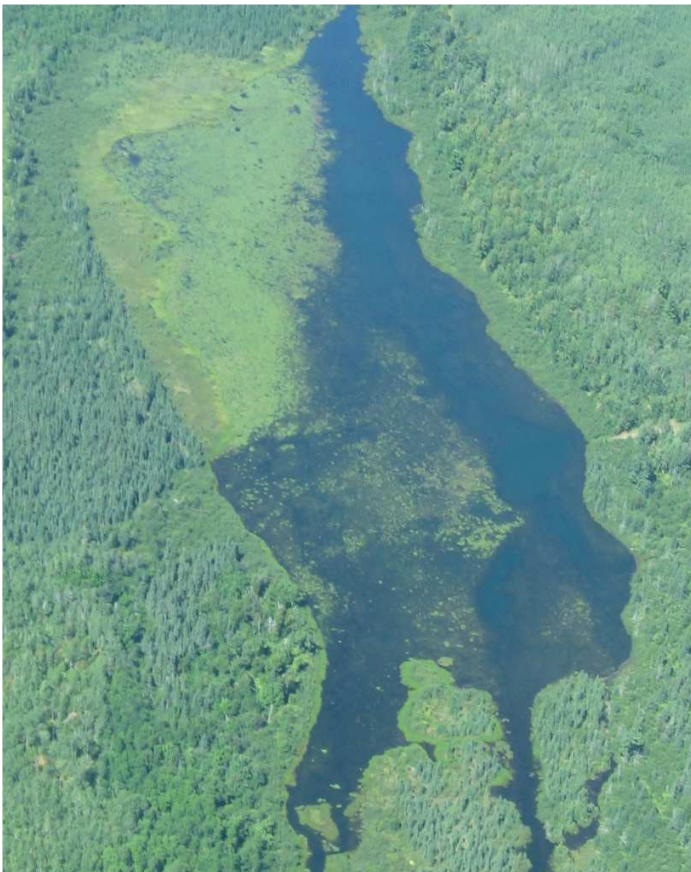
Figure 70. Lower Ox Lake, Douglas County, 2007.

Lower Ox Lake has long supported rice, particularly in the northwest quarter of the lake. In recent years, there has been some indication that the rice may be becoming more abundant near the outlet. Lower Ox is harvested regularly, but by a limited number of individuals. The entire shoreline is owned by Douglas County, and as long as this continues the lake is fairly protected from direct human-caused negative impacts. Watch status is low because of site familiarity.

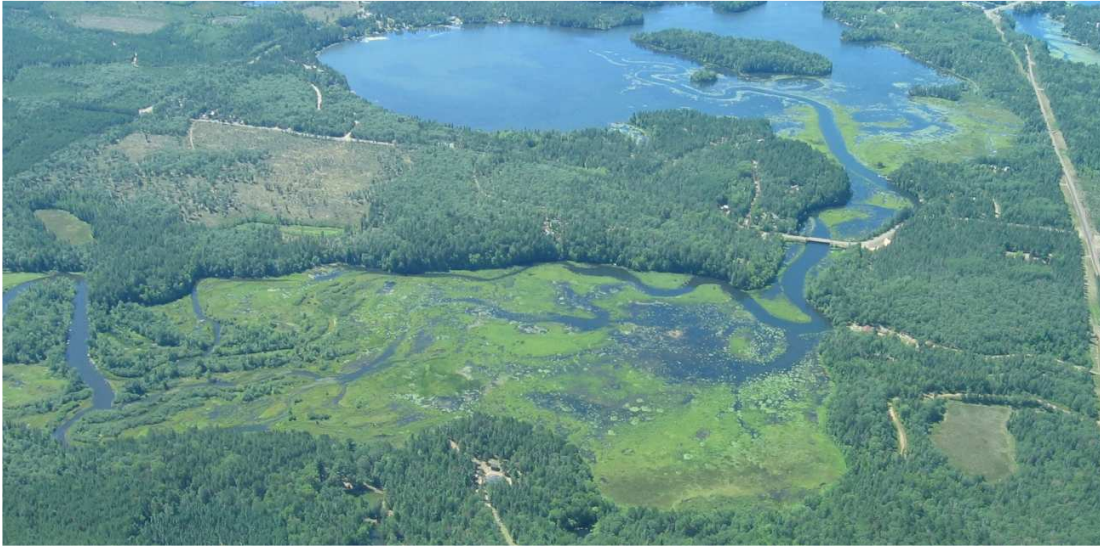
Figure 71. Minong Flowage, Douglas County, 2007.

Although the majority of the Minong Flowage is in Washburn County, the existing rice beds are on the far northeast portion of the flowage, which is in Douglas County. This is a significant bed with a long history. This site is heavily harvested, but not date-regulated because it is a flowage rather than a natural lake. The harvest location is often reported as “Smiths Bridge” by respondents to the harvest survey. The Smiths Bridge access point is visible in the photo above; most of the rice occurs east of the bridge (at the bottom of the photo) but in recent years the bed has increased in size west of the bridge. Eurasian water milfoil was recently located in close proximity to the Minong Flowage rice beds, and at present likely represents the greatest threat to the beds; this will be an important site to monitor and perhaps to study in an effort to determine treatments which might control the milfoil while having the least impact on the rice. Watch status is medium-high because of the need to monitor both the possible expansion of the bed, and the possible negative impacts of invasive aquatics.

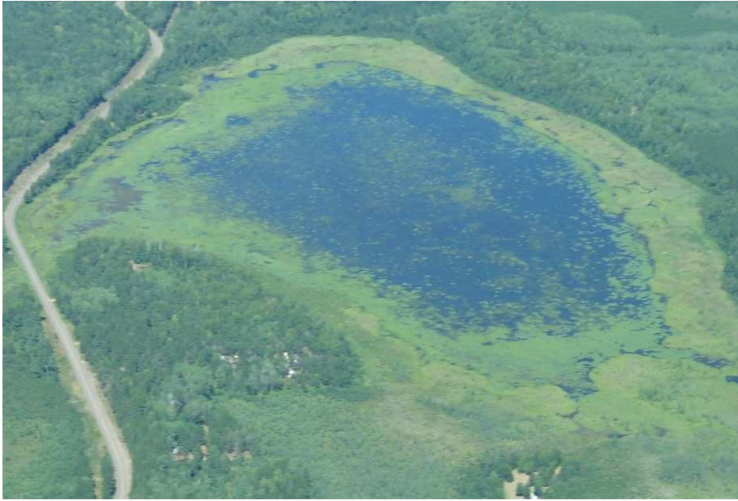
Figure 72. Mulligan Lake, Douglas County, 2007.

Mulligan Lake is a fairly significant rice lake that seems to have been less productive in most recent years than it was historically, based on anecdotal reports. Harvest is date-regulated at this site, and it is relatively heavily harvested when the crop permits. In good years, the lake is ringed with denser beds, and low density rice is scattered across the remainder of the surface. Because of the marshy nature of the lake, shoreline development is fairly limited, although nearly all of the shoreline is in private ownership. This lake is a high priority for beaver management.

Mulligan also was the site of an interesting footnote in the history of rice in Wisconsin. When a non-tribal member modified a small boat with a thrasher to mechanically harvest rice here, tribal members and others protested, eventually leading to a prohibition on mechanical harvesting on public waters in the state. Watch status, other than for beaver impacts, is medium-low.

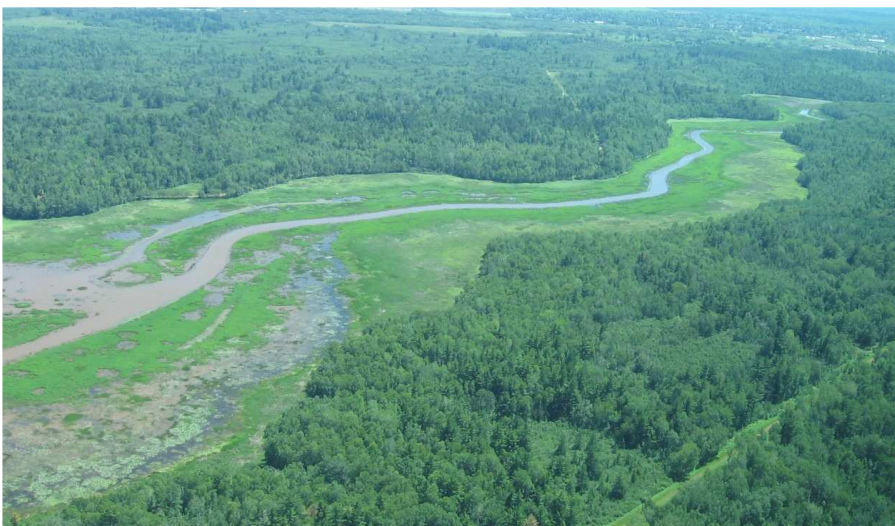
Figure 73. Pokegama Bay, Douglas County, 2007.

A fairly extensive rice bed exists where the Pokegama River widens to join the St. Louis River estuary. (Rice is not known to exist further upstream.) Perhaps because of its proximity to the city of Superior, this area is popular with duck hunters, and seems to be increasing in popularity with rice harvesters in recent years. This site is rather unique in that it

can be impacted by run-off from the clay plain, as well as the condition of the estuary. Watch status is medium because of limited annual abundance information.

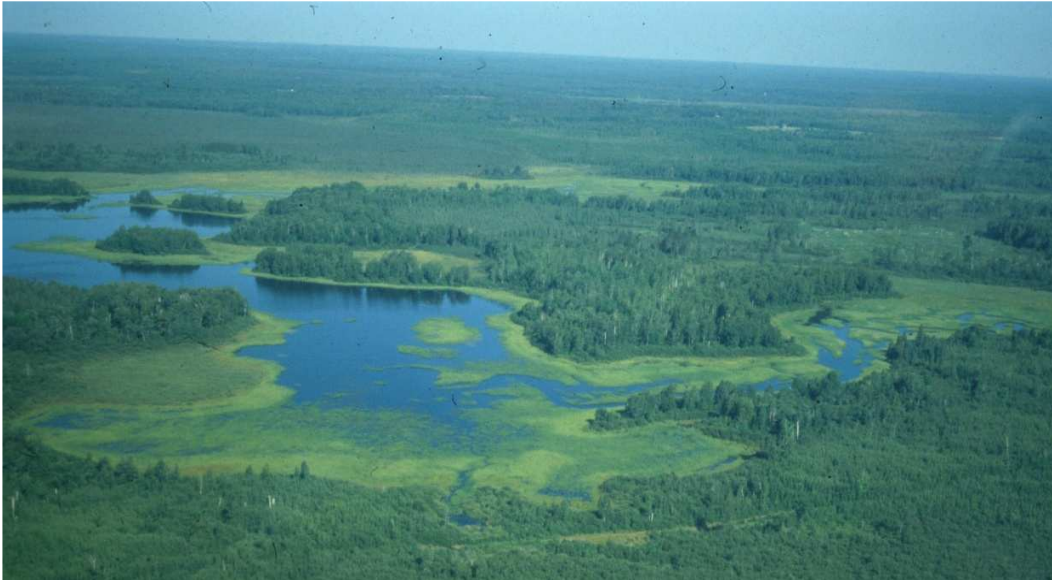
87. Radigan Flowage (WBIC 2687500).

Figure 74. Radigan Flowage, Douglas County, 1998.

The Radigan Flowage supports the most significant rice beds in Douglas County. (The photo above does not adequately display the beds on the western branch of the flowage.) In good years, a large portion of the flowage supports rice, and it is heavily harvested. This site was reportedly seeded decades ago by members of the Holmes family of the St. Croix Tribe. With most of the shoreline in ownership by the Town of Dairyland, the flowage is relatively protected from most direct negative human impacts. The biggest threat may be financial - ensuring that the dam at this site is preserved and maintained. In 2002 several agencies cooperated to complete needed repairs to the dam, but apparently additional work is needed on the water control structure at this time, and funding is limited. Watch status is medium-high because of the repair issues.

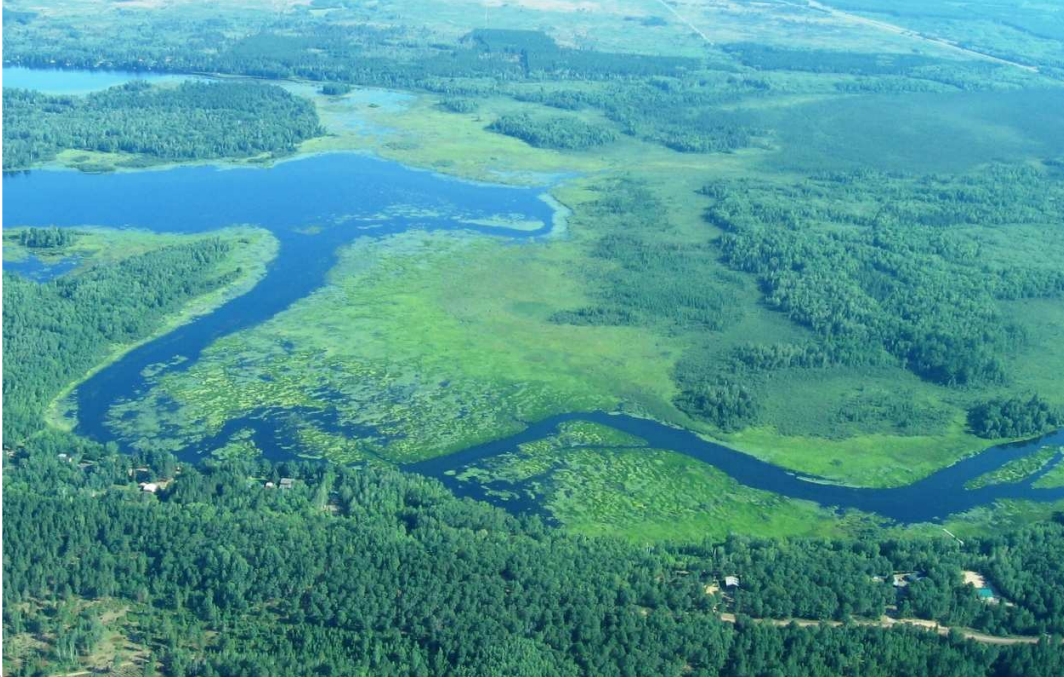
Figure 75. St. Croix Flowage, East end, Douglas County, 2006.

The St. Croix or Gordon Flowage has a very long history of supporting rice, but anecdotal information uniformly indicates that abundance is reduced from historic levels. The biggest existing bed is found on the east side of the flowage where the St. Croix River enters, though this rice is mixed with other vegetation in many spots. Smaller patches can be found in several other locations, including just east of the northern boat landing, and in the bays on the east and west sides of Bubar “Island” (actually a peninsula). Some seeding has been done by GLIFWC in recent years in cooperation with the lake association, especially in the bay east of Bubar, but heavy goose browsing has limited its take thus far. It may be that this site needs some water level management to restore rice, as it appears that levels may have been held too steady for many years, favoring perennial vegetation. Watch status is medium-high because restoration interest.

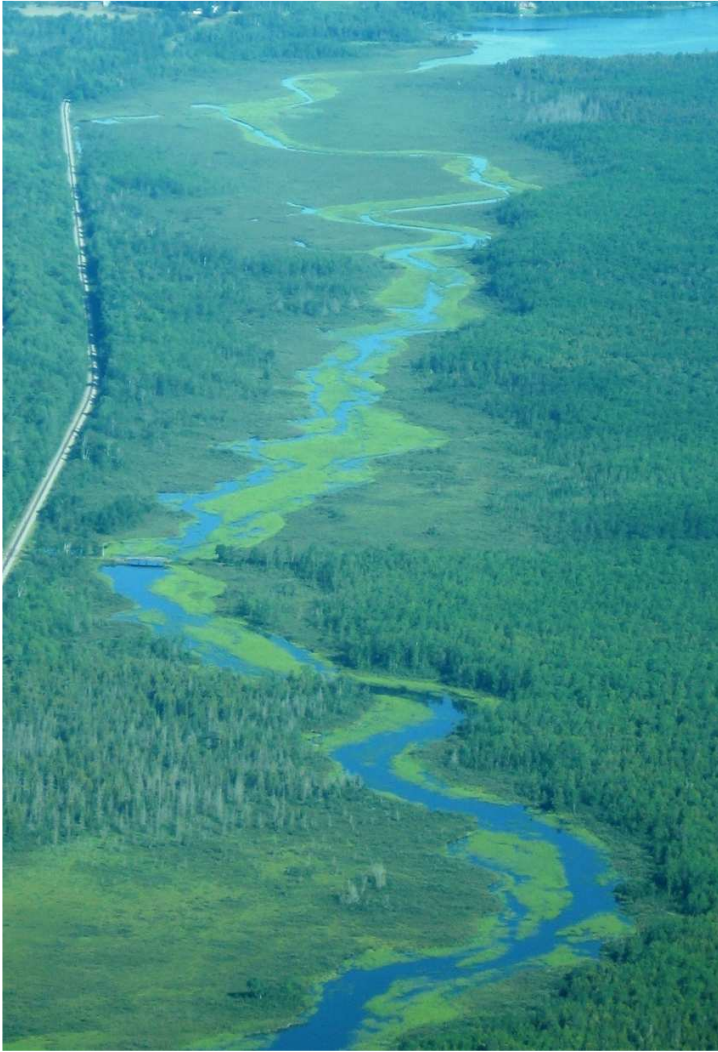
89. St. Croix River (WBIC 2601400).

Figure 76. St. Croix River at Cutaway Dam, Douglas County, 2006.

The St. Croix River has long supported rice, and the beds traditionally have been heavily harvested. Extensive beds exist from Upper St. Croix Lake to the area where Lower Ox Creek enters. This area is often referred to by harvesters as “Cut Away Dam”, although a bridge, not a dam, marks the location. (This bridge is visible in the photo above.) Beds are also present a few miles further downstream, where the river widens to form the St. Croix (or Gordon) Flowage. It is likely that small patches of rice exist below the St. Croix Flowage to the Douglas County line, but this has not been adequately surveyed. Watch status is low because of site familiarity.

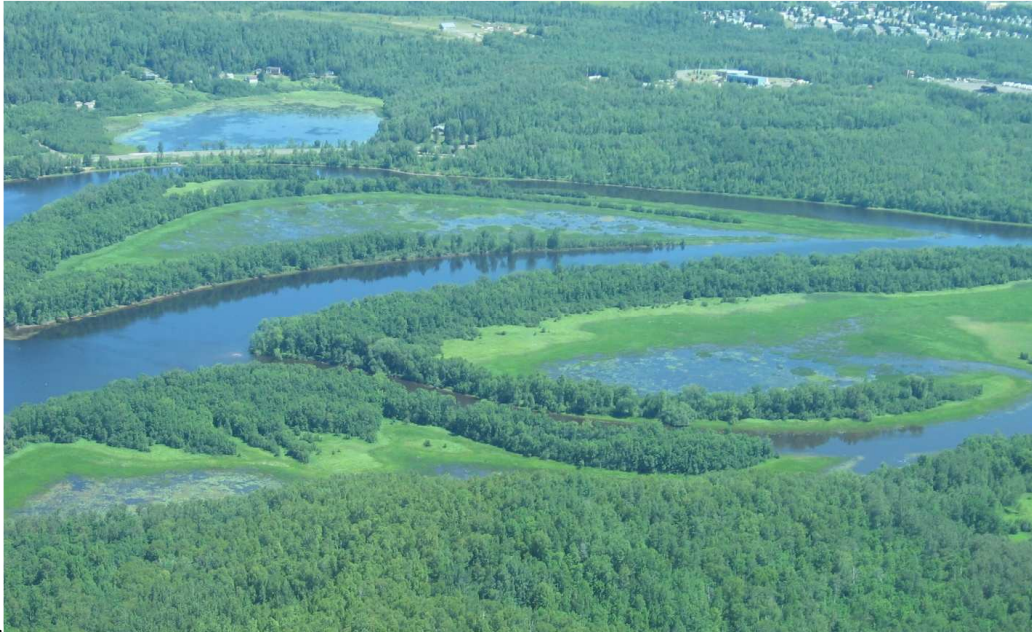
Figure 77. St. Louis River, Douglas County, 2007.

The full extent of rice in the St. Louis River remains to be determined. Historically, this area reportedly held very substantial beds, many of which are reported to have declined. However, some resurgence may have occurred in the last few years, perhaps as a result of relatively low water levels on Lake Superior. In addition to the beds in Pokegama Bay (discussed separately) rice also has been seen in some abundance in the upper slough area extending for several miles above the HWY 105 bridge, especially on the Minnesota side. (A portion of this area is shown in the photo above.) Some of the estuary is proposed for inclusion in the National Estuarine Research Reserve system, and in-depth mapping of the existing rice beds has already been proposed as an initial research effort should the Reserve be established. Watch status is medium-high because of this.

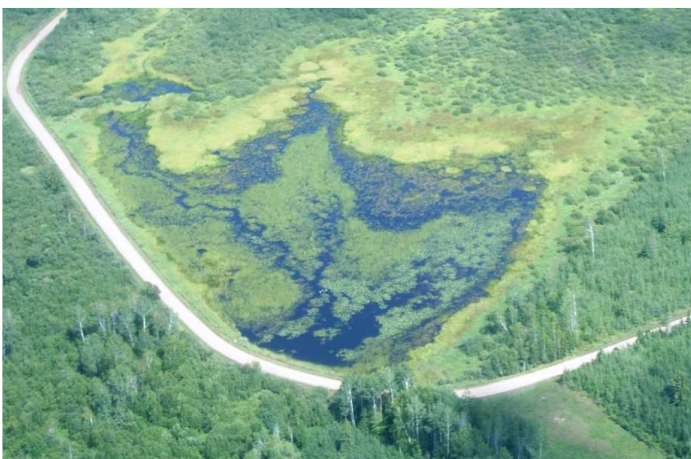
Figure 78. Stateline Flowage, Douglas County, 2009.

This small flowage was successfully seeded by the DNR, and now a relatively large portion of the flowage supports rice. DNR biologist Greg Kessler reports the site has been harvested, as well as being used by trumpeter swans and other

wildlife. Not surprisingly for a bed this size, heavy browsing by wildlife has also been observed. Watch status is medium because of limited annual abundance information.

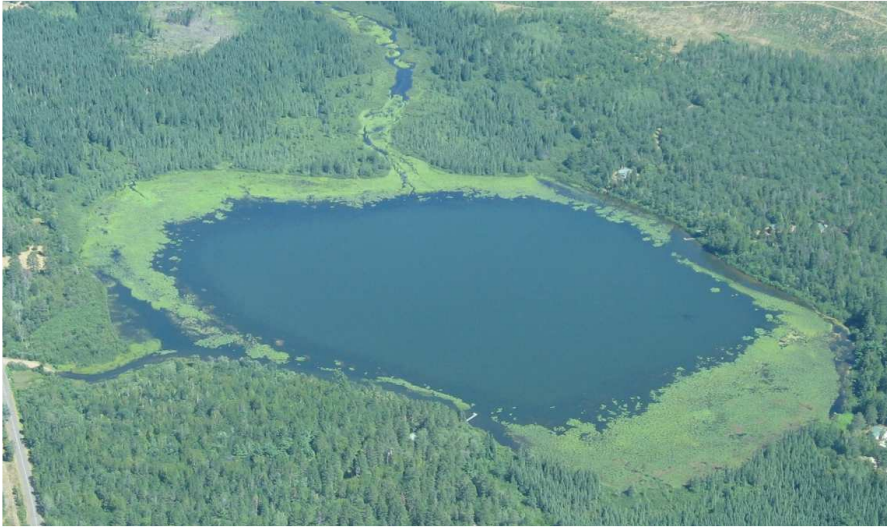
Figure 79. Upper Ox Lake, Douglas County, 2007.

Upper Ox Lake has long supported a rice bed on the northeast portion of the lake in the area around the inlet of Upper Ox Creek. (Rice also extends up the creek; the vegetation shown on the south side of lake consists of other species.) Upper Ox receives light but regular harvest. To date, shoreline development appears to have had little negative impact to rice at this site. Watch status is low because of site familiarity.

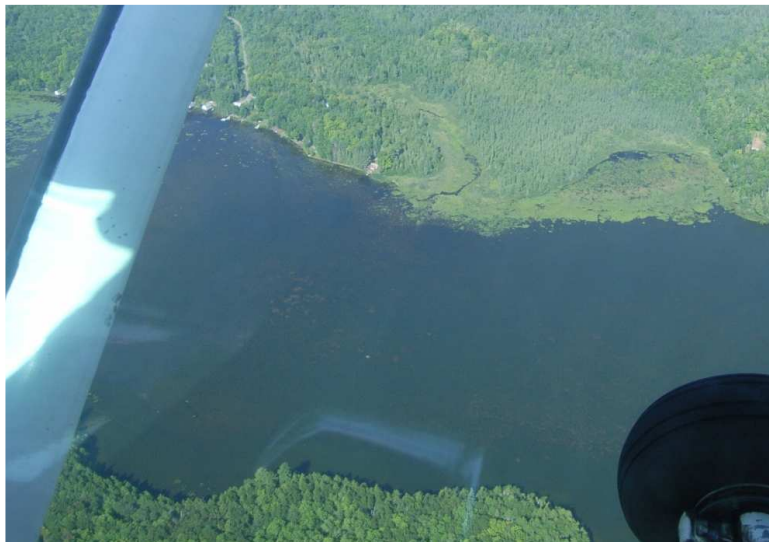
Figure 80. Fay Lake, Florence County, 2009.

Herbarium examples from Fay Lake exist from 1968, 1971 and 1998, but abundance was unknown. Surveys from 2008 and 2009 found only small amounts of rice (less than 2 acres of sparse rice), most near the Long Lake and Halsey Lake Outlets. Since this lake has not previously been surveyed, it is unclear how typical these years were with regards to abundance, but it is clear that much of the lake is unsuitable for rice. Watch status is medium-high because of limited annual abundance information.

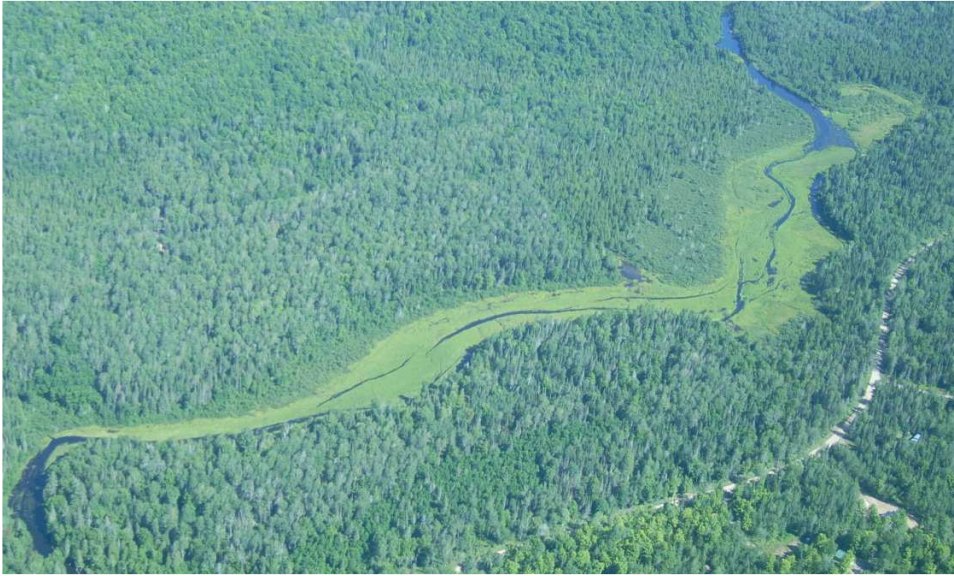
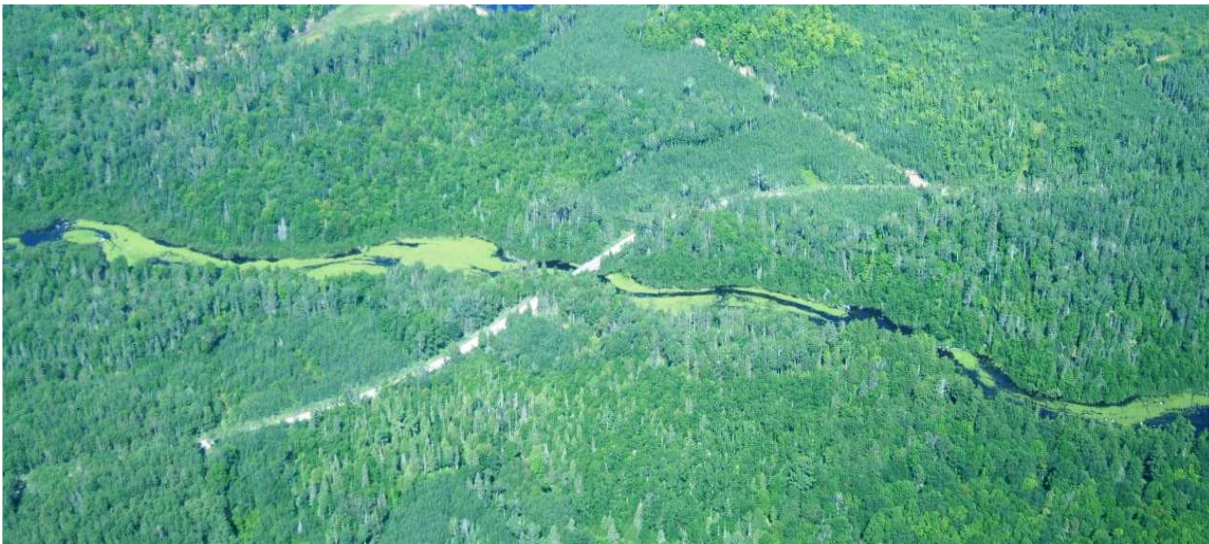
Figure 81. Armstrong Creek, SW of Revolver Lake, Forest County, 2008.

Figure 82. Armstrong Creek, 3 miles South of HWY 8, Forest County, 2008.

Large rice beds can be found on Armstrong Creek in at least 2 primary locations. One is the widening centered about a mile SW of Revolver Lake, with a length of approximately $\frac{3}{4}$ mile, and the other is further upstream, extending for roughly $\frac{3}{4}$ mile in both directions from the FS 2371 / Engeleking Road bridge crossing. Both sites are within the boundaries of the Chequamegon-Nicolet National Forest. Harvest is occasionally reported from this creek. Watch status is medium-high because of limited annual abundance information.

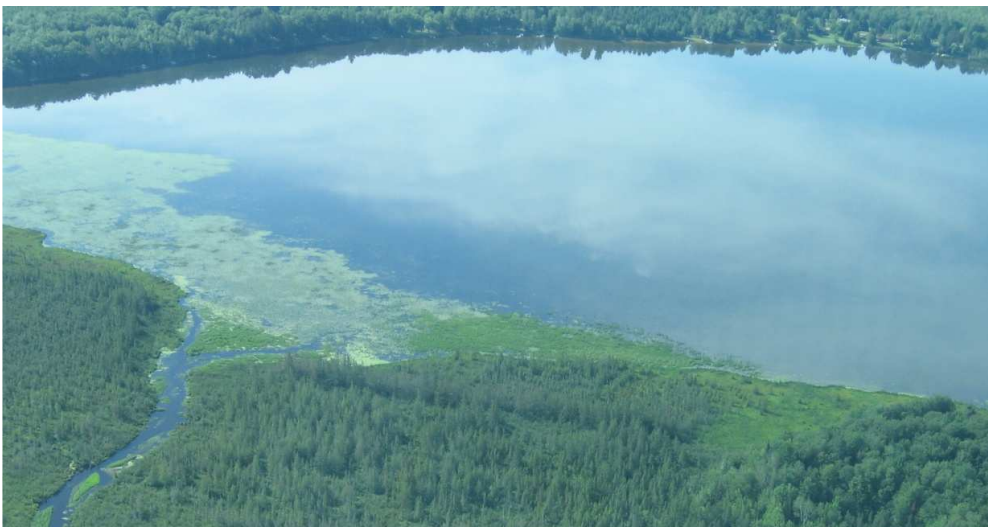
Figure 84. Bishop Lake, Forest County, 2006.

Bishop Lake is another site that reportedly has been much less productive in recent years than historically according to anecdotal information and older ricers. Presently the only appreciable amount of rice on Bishop is on the northeast part of the lake where Logan Creek enters. Recent seedings by the Sokaogon Chippewa Tribe has not expanded the bed. There has been concern that this bed is currently limited by depth, with the lake being held artificially high by beavers and/or an improperly set culvert on the outlet. This site is a good candidate for potential restoration. Watch status is medium-high because of restoration interest by the Tribe.

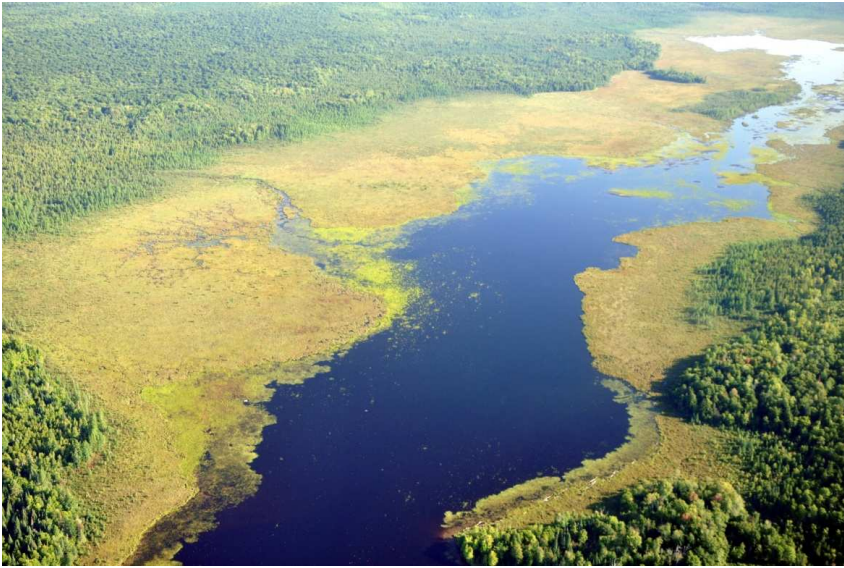
Figure 85. Hiles Millpond, Forest County, 2009. (Ron Eckstein photo.)

Hiles Millpond is the site of a successful seeding effort. Rice is scattered in a number of smaller beds in various locations along this long flowage. Although very beneficial to waterfowl, this site has not seen much harvesting pressure, in part due to the scattered nature of the beds. It has been suggested that it may be possible to substantially increase the amount of rice present at this site by lowering the depth slightly, an approach that should be explored more thoroughly. Watch status is medium because of the need to determine if the beds could be expanded.

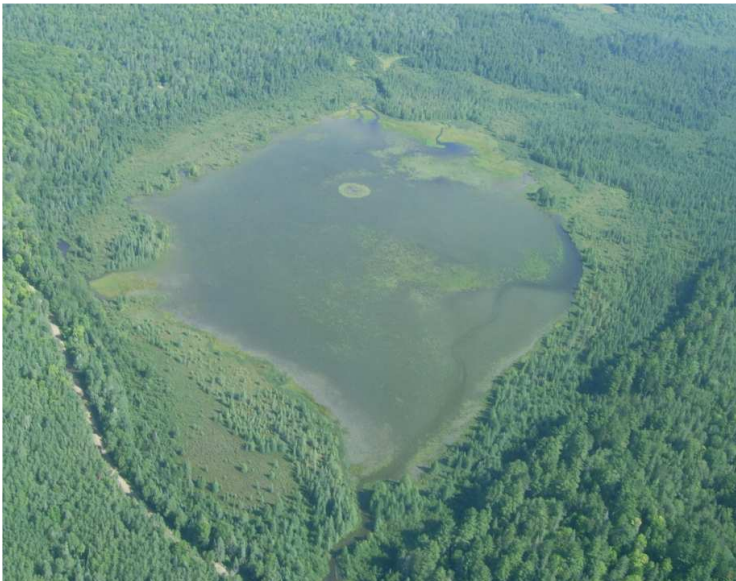
Figure 86. Kaine Lake, Forest County, 2009.

Kaine Lake is a small lake in the far northern part of the county surrounded by Forest Service Lands. Rice has been present here for a long time, but with a limited abundance. The best beds tend to be near the north end of the lake, or near the middle, but the density is usually low enough that they are more significant to waterfowl than human harvesters. This lake gives the impression of being able to support more rice than it typically produces. It is possible that beaver management or other efforts may be able to increase rice abundance on the site. Watch status is medium-low.

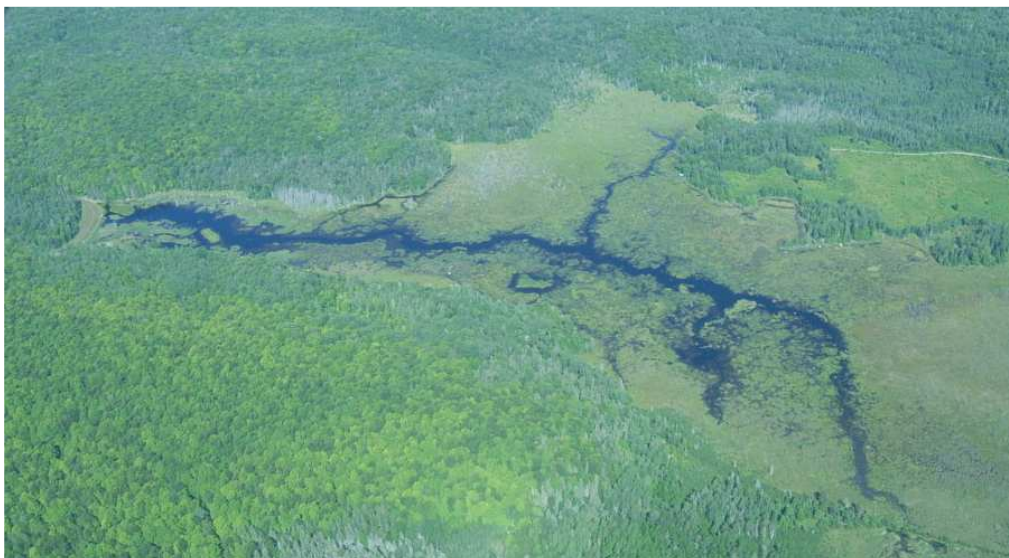
Figure 87. Knowles Creek Impoundment, Forest County, 2008.

on the Surface Water Viewer, about 1 west of McCaslin Tower Road, and 1.5 miles south of CTY C. Watch status is medium because of the limited annual abundance data.

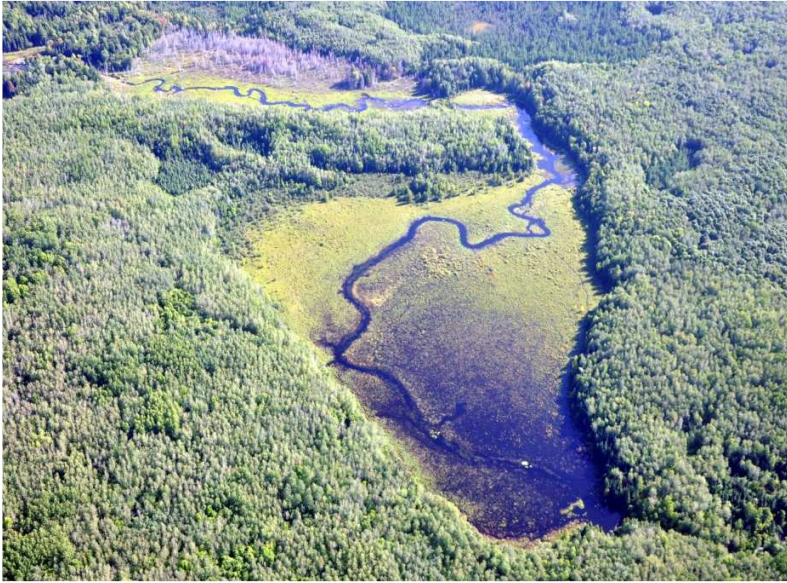
Figure 89. Otter Creek, Forest County, 2009. (Ron Eckstein Photo.)

GLIFWC just learned of this site in the winter of 2009. The beaver impoundment shown above is located on Otter Creek about a half mile north of Otter Lake (and 5 miles east of Wabeno). The area appears as a pinkish meadow on the 2005 air photo layer on the Surface Water Viewer. Watch status is medium-high because of the limited annual abundance data.

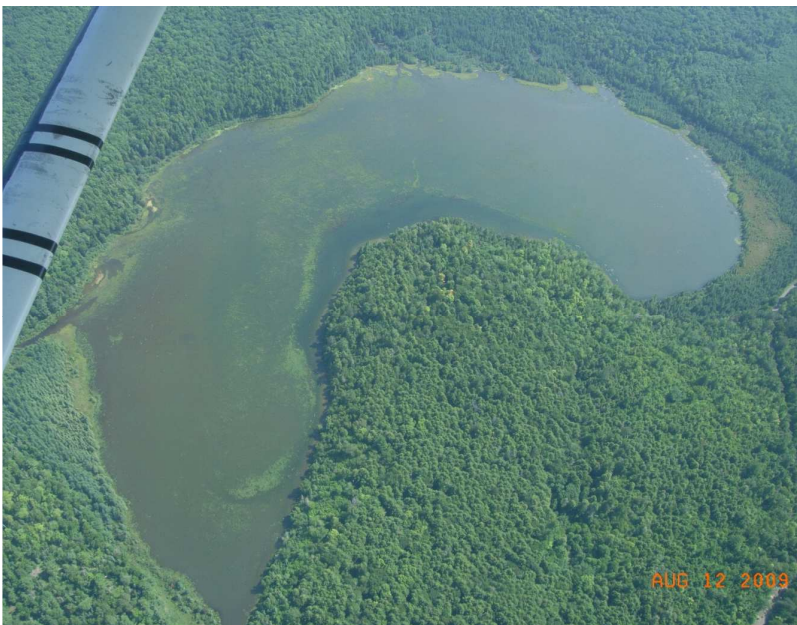
Figure 90. Pat Shay Lake, Forest County, 2009.

Pat Shay Lake is the site of the first cooperative seeding effort undertaken by GLIFWC, working in this case with the Forest Service. However, despite Forest Service records that this waterbody once supported rice, the seeding effort never established more than a small presence of rice on this lake. Although a fair portion of the lake sometimes supports rice, only a few acres ever reach more than a sparse density, and the beds are often hard to spot from the air. This site

has an extremely flocculent bottom, which may be limiting establishment. If an extended drought ever dries this site out and consolidates the bottom to some degree, the beds might merit additional seeding. Watch status is low because of site familiarity.

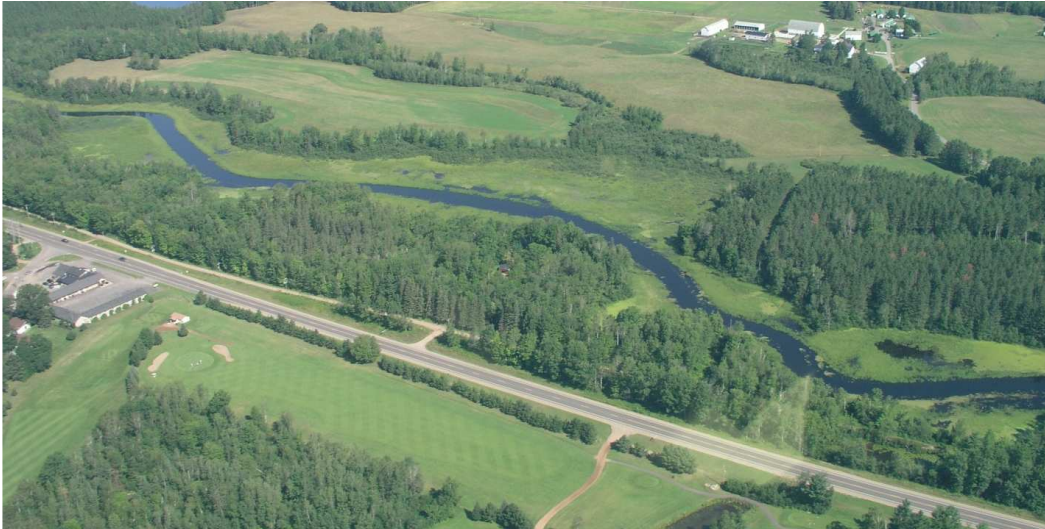
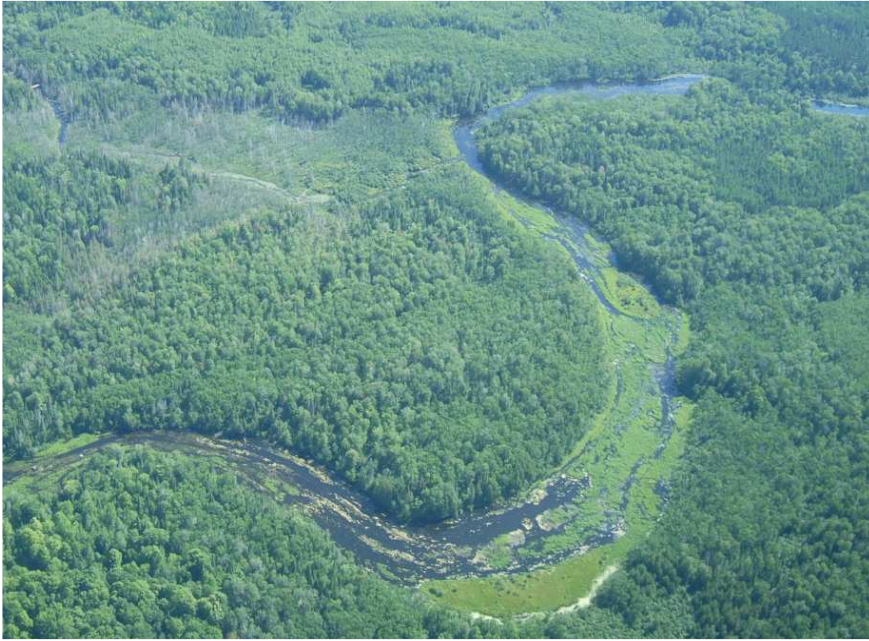
Figure 91. Rat River, North of HWY 8/32, Forest County, 2006.

The Rat River has rice beds in at least 3 locations, one long standing and two arising from seeding cooperatively by GLIFWC and the Forest Service. The oldest bed is located just west of Scattering Rice Lake, and extends for roughly 1.5 miles in the area where the river parallels HWY 8/32. One of the seeded beds starts just east of the Rat River Road Bridge, and extends for roughly a half mile, while the other is found a couple of river miles west of this site, just west of the Bear Creek Inlet. Harvest reported from the Rat River is thought to come primarily from the first bed, but it is possible some is coming from the other locations. Watch status is low because of site familiarity, but some additional annual abundance information would be useful for the two easternmost beds.

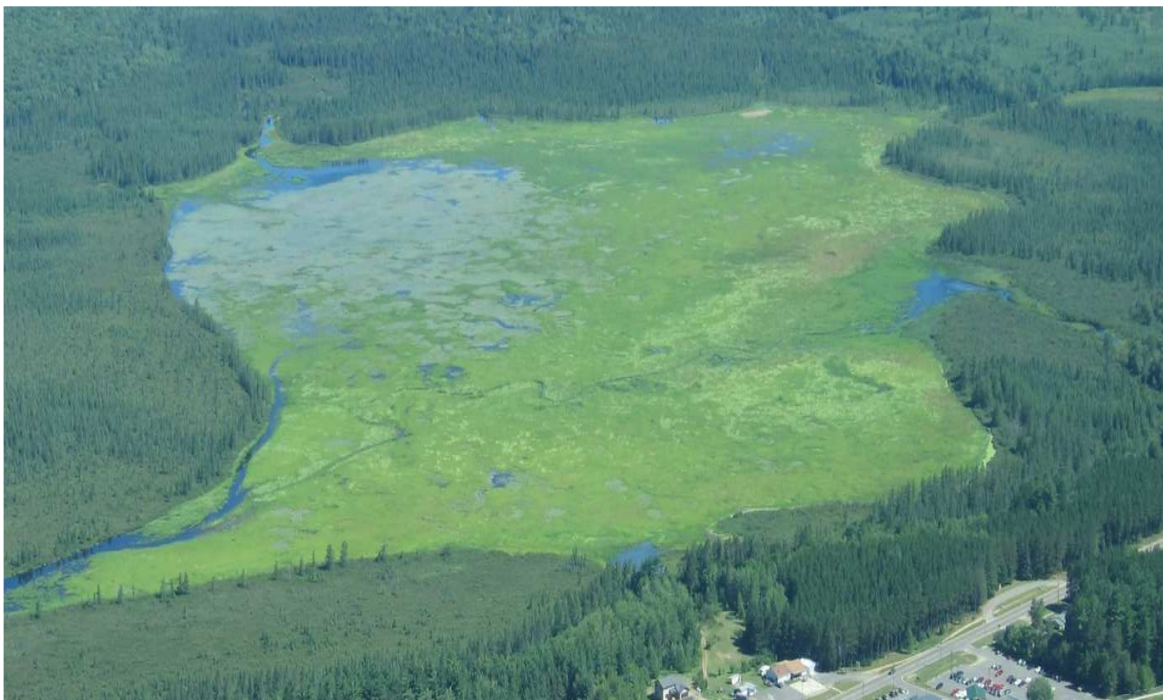
Figure 94. Rice Lake, Forest County, 2007.

This is the famous Rice Lake on the Mole Lake Reservation, and is likely responsible for the placement of the reservation. In years with a bumper crop, about 75% of the lake supports rice, although the northwest portion is currently dominated by other vegetation. The tribe has conducted numerous studies and restoration activities on this lake, which appear to be helping increase crop abundance. Most recently, efforts are underway to remove some of the competing vegetation in the northwest section of the lake where water lilies dominate. Watch status is low because of site familiarity.

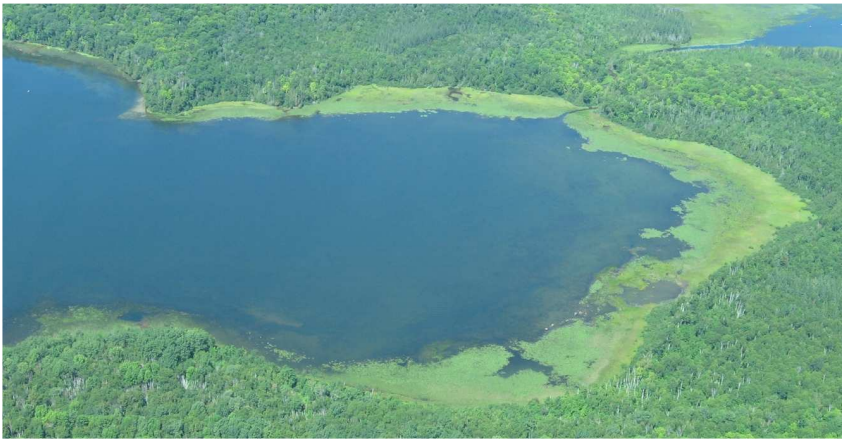
Figure 95. Riley Lake, Forest County, 2007.

Riley Lake, which is marked Indian Lake on some maps, is a relatively minor rice water. Nevertheless, this site is on the list of waters whose harvest is date-regulated. Beds appear to be limited to the north end of the lake, which has a short outlet into Wabikon Lake, which supports much larger rice beds. Watch status is low because of site familiarity.

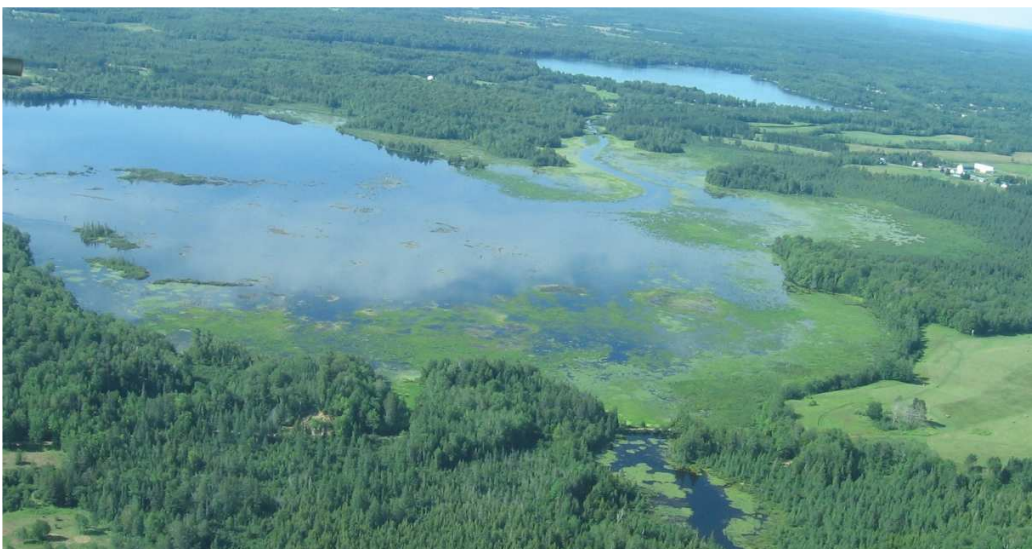
Figure 96. Scattered Rice Lake, Forest County, 2006.

Scattered Rice Lake is aptly named, for while the lake has a long presence of rice, most years the beds are fairly sparse and scattered. In unusually good years however, the north end of the lake supports fairly abundant and dense stands, especially near the Rat River inlet. It appears these good years may be triggered by relatively low water levels, and it may be possible to increase rice abundance on this site by lowering water levels slightly. Locals sometimes refer to this lake as the Laona Millpond. Watch status is low because of site familiarity.

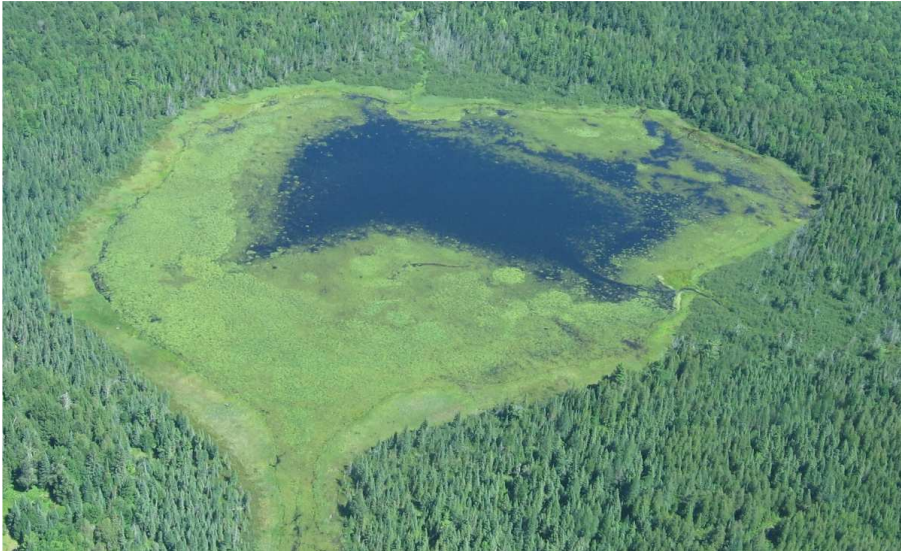
Figure 97. Scott Lake, Forest County, 2007.

Scott Lake is interesting in that the lake had not supported strong stands of rice for many years, but a couple of recent crops have been excellent. Some individuals wondered if this was the result of seeding. Although seeding by a private individual cannot be ruled out, no agency seeded this site, and it appears that this may have been a natural response to recent drought conditions, because a herbarium record collected in 1989 suggests the lake has had rice present for at least 2 decades. Watch status is medium-high because of the limited annual abundance data.
