**Wisconsin
Ceded
Territory
Manoomin
Inventory
Ver. 1.0**

**GLIFWC
Project
Report
2010-01
March, 2010**

**Peter David
Wildlife
Biologist**

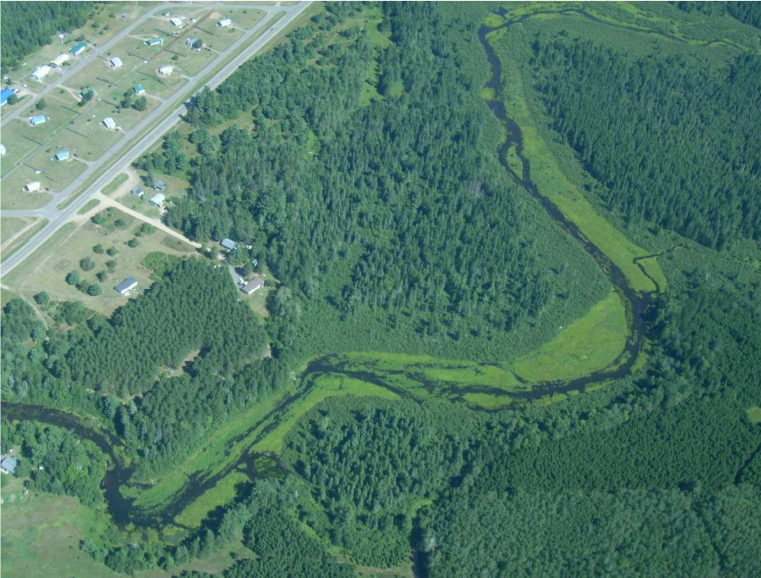
Figure 98. Swamp Creek above Rice Lake, Forest County, 2008.

Swamp Creek supports rice beds in the area just east of HWY 55 (shown in the photo) and also in the area south of Rice Lake. These latter beds appear to be expanding in recent years. Watch status is low because of site familiarity.

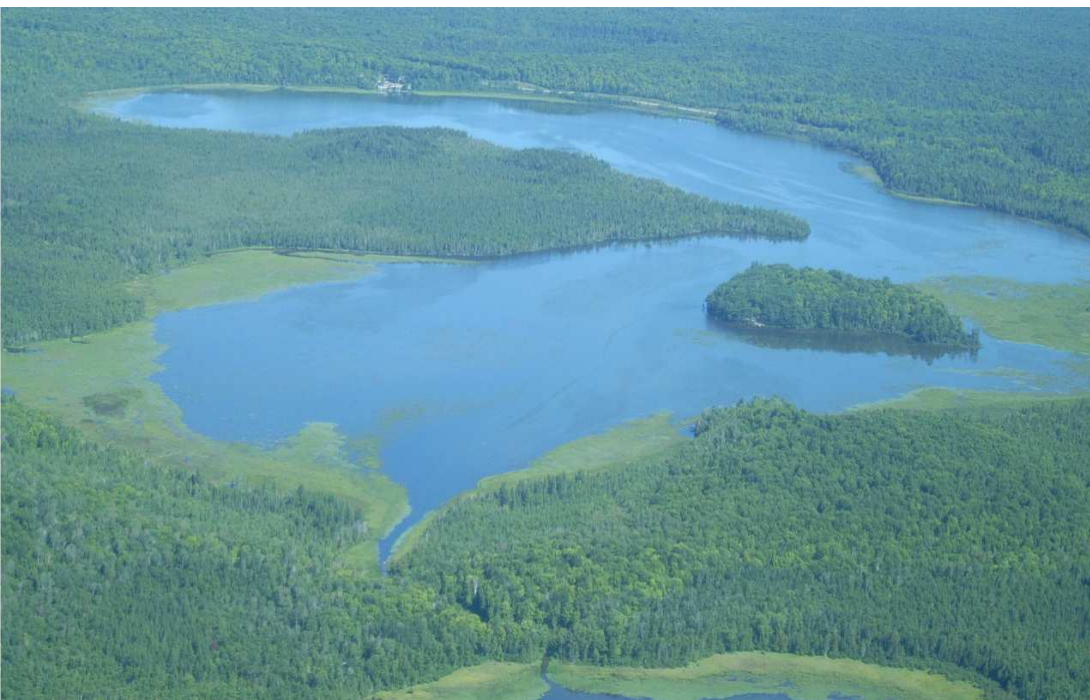
Figure 99. Wabikon Lake, Forest County, 2008.

Wabikon Lake is interesting. In recent years it has apparently recovered from a fairly long period of poor production to produce some very good stands. While some seeding was undertaken, most of the recovery appears attributable to natural causes. The largest beds occur on the south half of the lake, east of the island, and in a band of varying width along most of the southern shoreline. A narrow band also sometimes follows the northern shore of the lake, but this

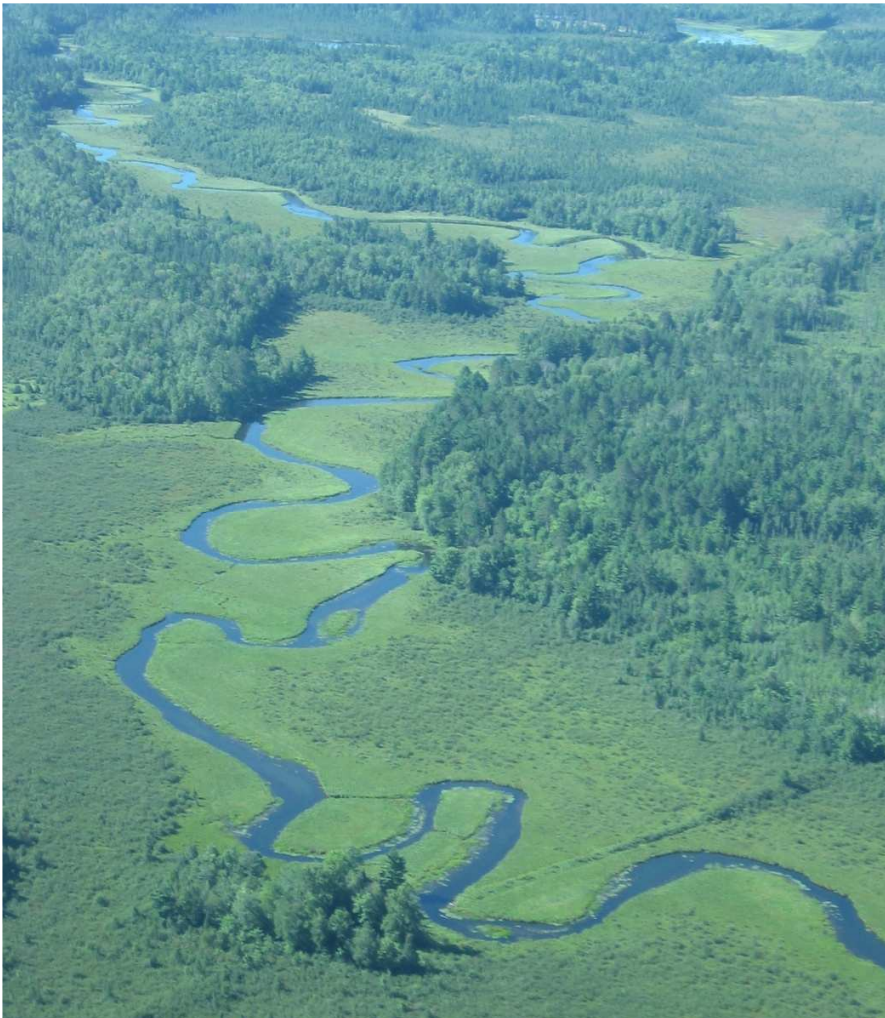
Figure 100. Bear River, Iron County, 2007.

The Bear River is an important rice bed on the Lac du Flambeau Reservation. This site is protected and managed by the tribe. It is undeveloped, and connects to the small Munnomin Lake. Although it is regularly harvested, it does not turn

up in harvest surveys because it is an on-reservation water. A small section of the rice on the river also extends into Vilas County. Watch status is low because of site familiarity.

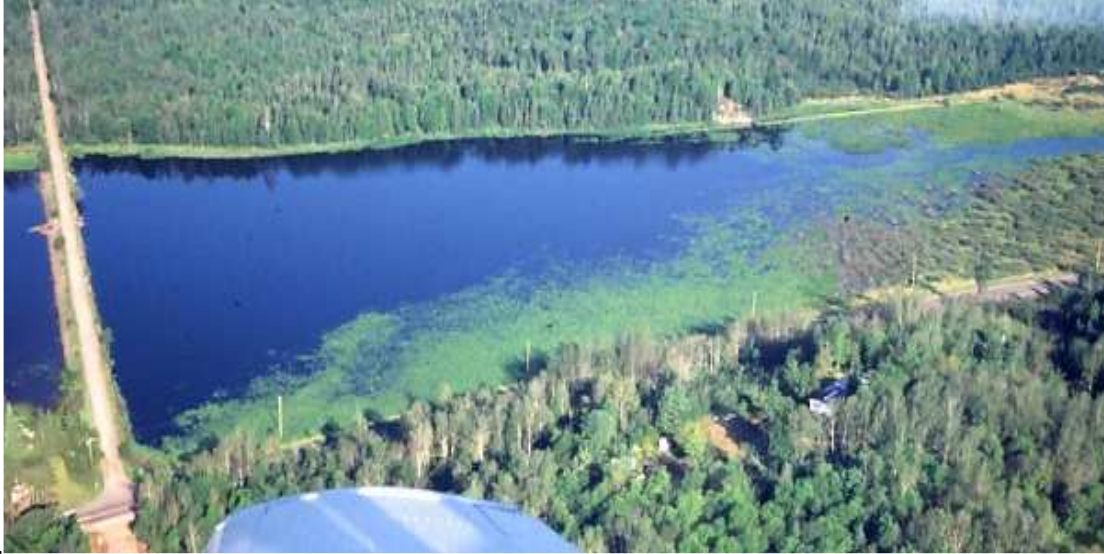
Figure 101. Gile Flowage, Iron County, 2001.

The only rice bed on the huge Gile Flowage exists on the small bay that is adjacent to HWY 51 at the far northeast reach of the flowage. It was seeded cooperatively by GLIFWC and the DNR. Most of the flowage experiences too much variation in water levels to support rice, but this bay became suitable when a separate water-control structure was installed under the road that separates this bay from the rest of the flowage (visible at the left side of the photo). This structure allows water to be held up in the bay when the rest of the flowage is drawn down. However, water levels cannot be kept lower than the rest of the flowage, and high water in the spring likely limits the productivity of this bed some years. When sparse beds are produced, they have sometimes been very heavily browsed by giant Canada geese. Since it is visible from a state highway, this bed may offer some greater-than-average public education opportunities. This site is late to ripen, but has been harvested in years with a sufficient crop. Watch status is low because of site familiarity.

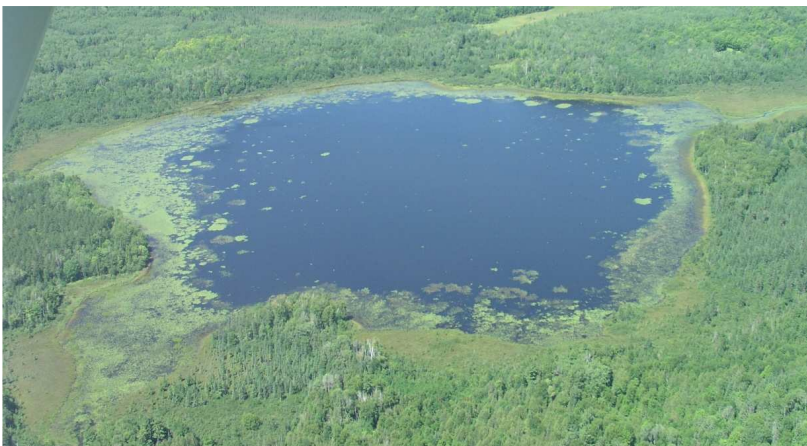
Figure 102. Hay Lake, Iron County, 2007.

Hay Lake is currently on the list of recognized rice waters, though it is listed in Price County. (The lake is located at the junction of Price, Iron and Ashland counties.) It will now be listed as an Iron County water. This site was seeded by the Forest Service, but rice presence in recent years has been minimal (less than 100 plants). Watch status is medium because it may be necessary to remove this water from the list of rice waters if it continues to decline.

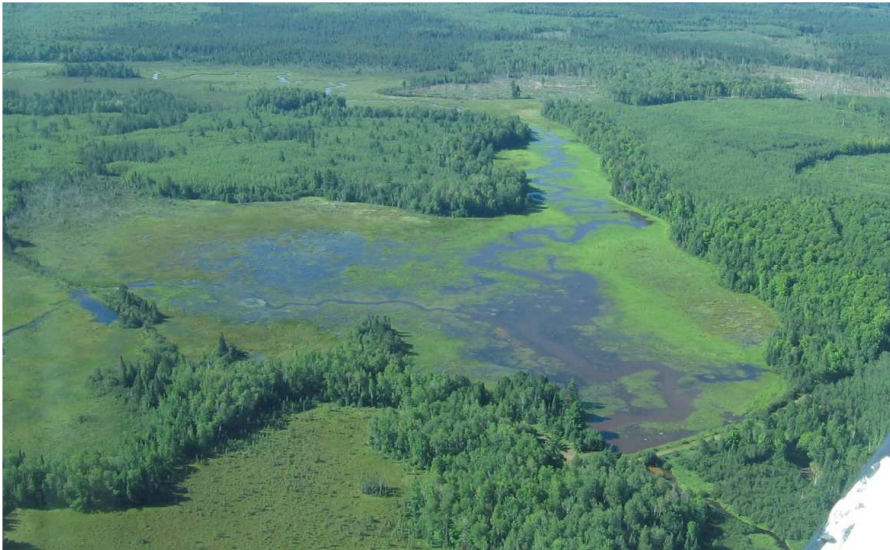
Figure 103. Little Bear Flowage, Iron County, 2007.

This flowage is located just north of the Lac du Flambeau Reservation on state land. This fairly new flowage cannot be found on the Surface Water Viewer, except in the 2005 air photo coverage. As such, the WBIC code used is for Little Bear Creek, which was dammed to create this flowage. Watch status is medium because the limited annual abundance data.

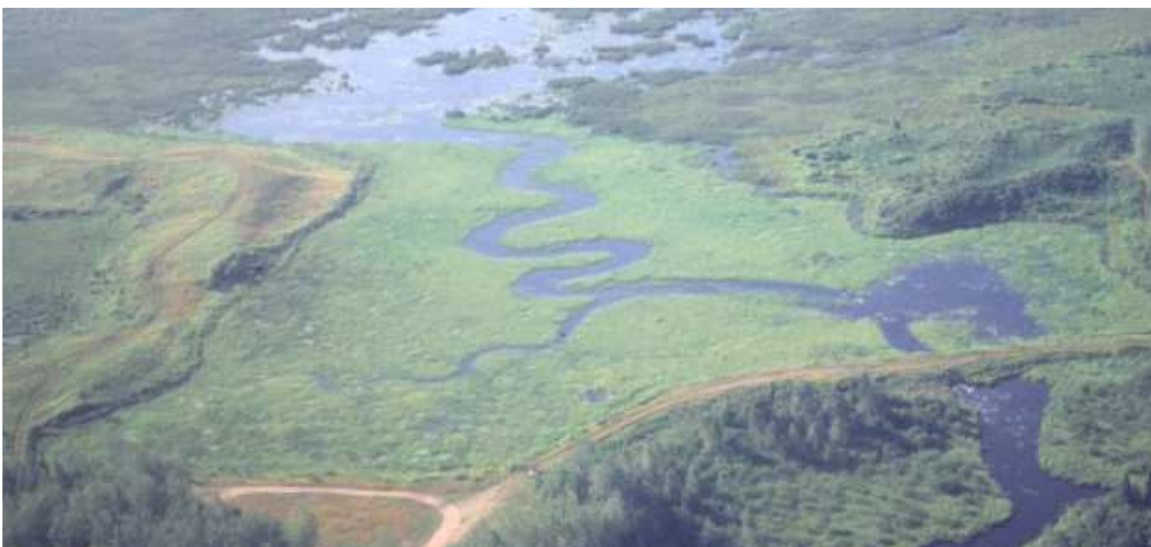
Figure 104. Little Turtle Flowage, Iron County, 2001.

The Little Turtle Flowage was seeded cooperatively by GLIFWC and the DNR with great success. This bed is now very well established, and appears to be going through the type of variation witnessed in natural beds. This site has regularly supported nesting trumpeter swans, and is harvested whenever the stand is good. However, the watch status is medium because of site familiarity because of some reports that the site may be showing some signs of decline..

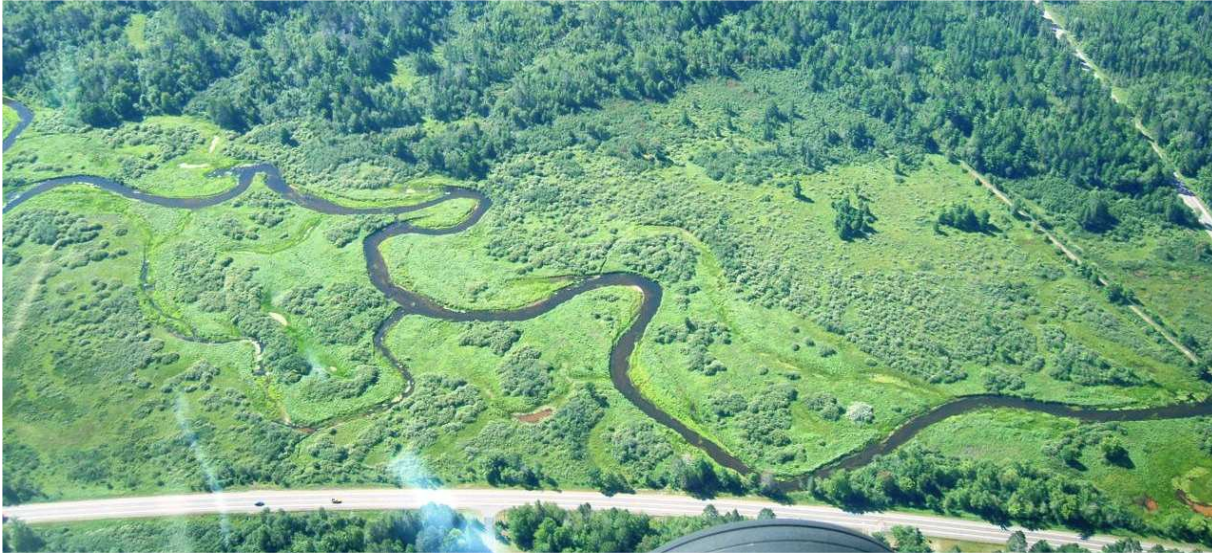
Figure 105. Manitowish River, South of HWY 51, Iron County.

The full extent of rice along different sections of the Manitowish River in Iron County still needs to be better documented, but rice is known to occur in some abundance in patches scattered throughout the section from the Vilas County line to the HWY 47 Bridge. It likely also occurs in patches of suitable habitat in the more remote sections downstream to the junction with the Flambeau River. (Also see Manitowish River, Vilas County.) The bands of rice on this river are often fairly narrow and do not show up well in air photos. Watch status is medium because there are suggestions that rice may be increasing on this river.

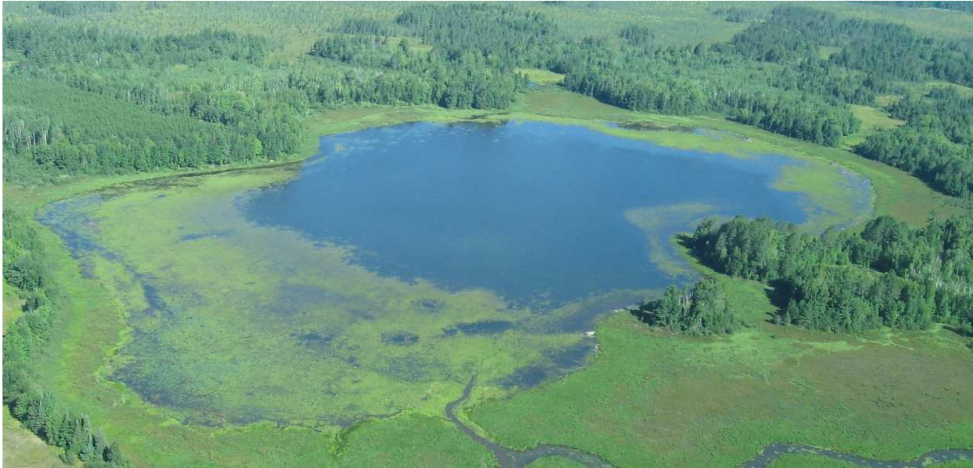
Figure 106. Mud Lake, Iron County, 2007.

Mud Lake was successfully seeded by the DNR. This bed seems to be expanding under the drought conditions experienced in the area the last few years. Although access is fairly limited on this undeveloped, state owned lake, the site has been harvested with some regularity, and is popular with duck hunters. The best rice is typically found on the south end of the lake near the outlet. Watch status is low because of site familiarity.

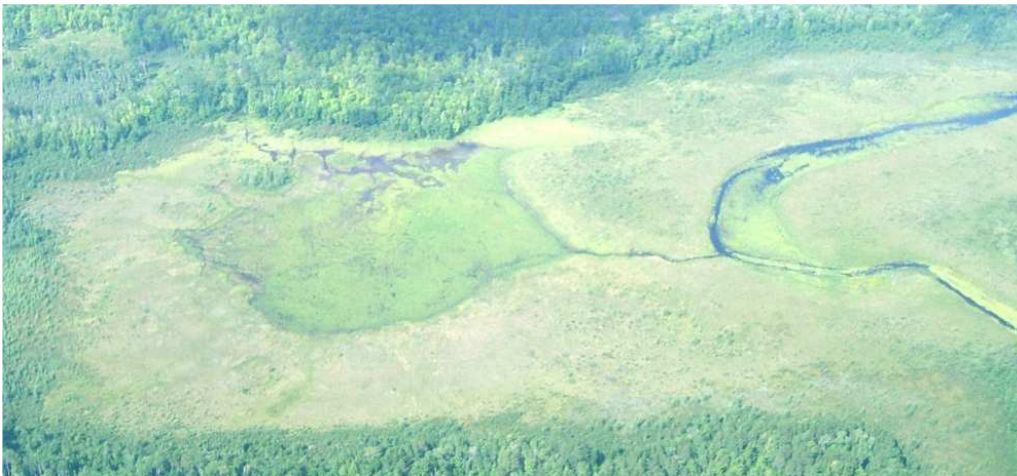
Figure 107. Munnomin Lake, Iron County, 2009.

As the name suggests, this lake has a long history of supporting wild rice. Located on the Lac du Flambeau Reservation, this small lake, which drains into the Bear River, is protected and managed by the tribe. Although harvested by tribal members, it does not show up in harvest surveys because it is an on-reservation water. Watch status is low because of site familiarity.

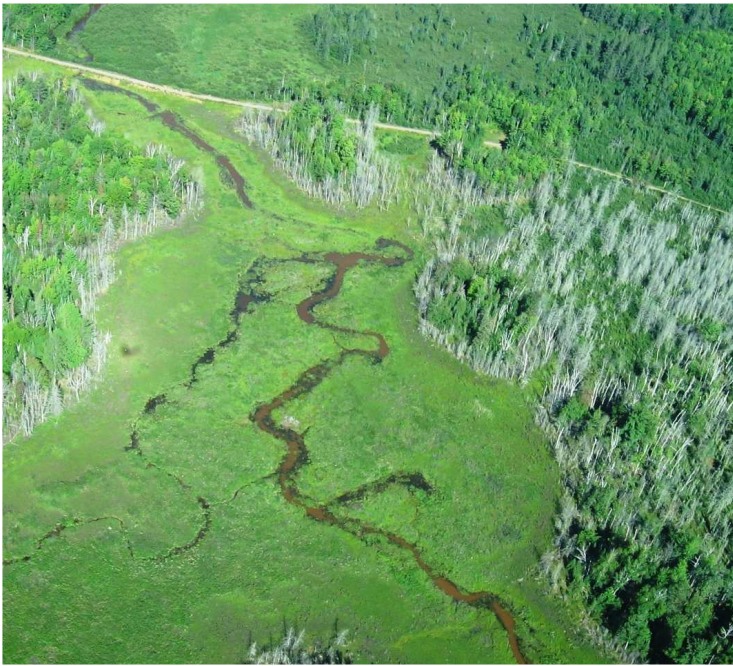
Figure 108. Sugarbush Flowage, Iron County, 2006.

Previous this was listed as unnamed flowage, and had the incorrect WBIC of 2315700. This flowage is on the Lac du Flambeau Indian Reservation, and it is managed and protected by the tribe. We suggest that this name, which the Tribe uses, be adopted by others. However, this fairly new flowage cannot be found on the Surface Water Viewer, except in the 2005 air photo coverage. As such, the WBIC code used is for Sugarbush Creek, which was dammed to create the flowage. Watch status is medium because the site recently experienced an extended drawdown for repairs.

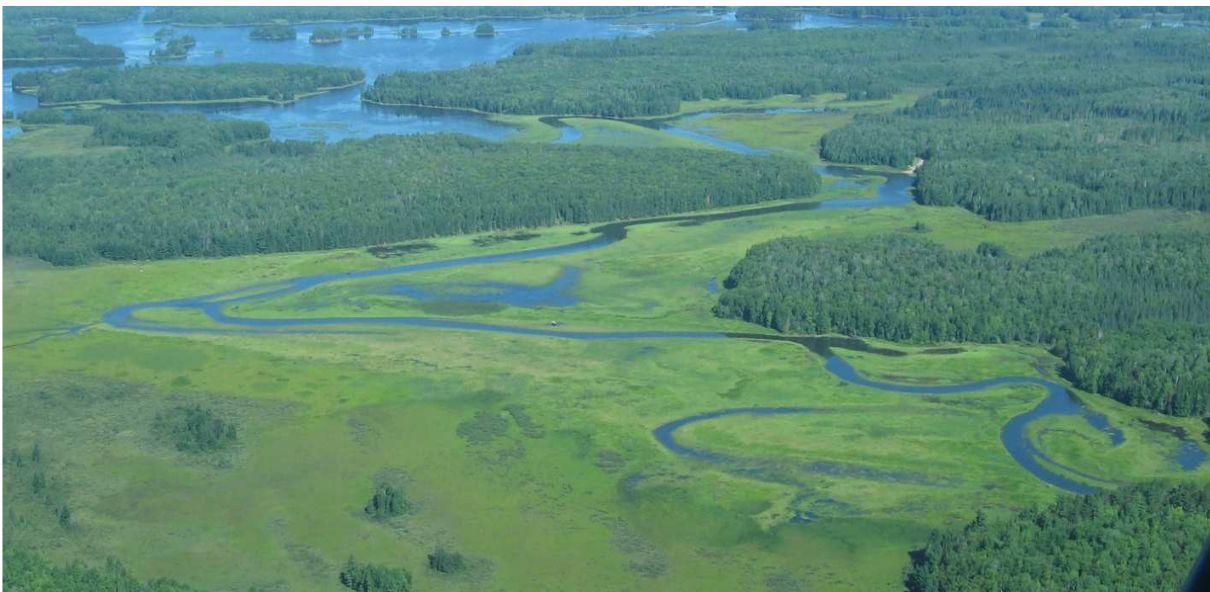
Figure109. Turtle Flambeau Flowage near Murrays Landing, Iron County, 2007.

Given the huge size of this flowage, the acreage of rice on it is quite small. It appears that the large fluctuations in water levels that occur as part of the management of this flowage limits rice growth to areas where rivers enter. The most

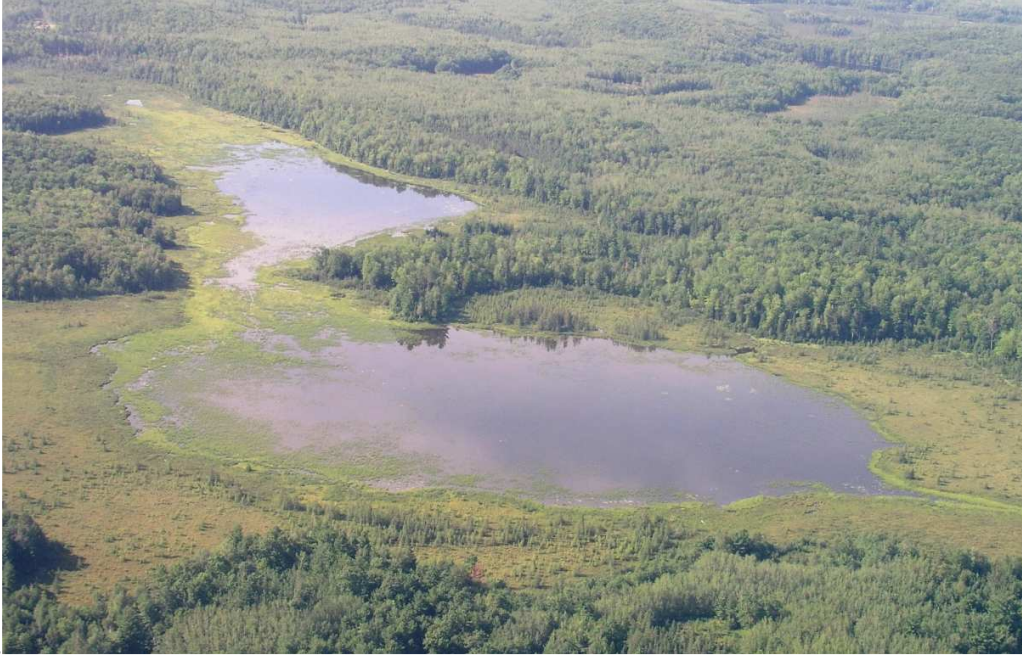
Figure 110. Miniwakan Lake, Langlade County, 2006.

Miniwakan is a small, undeveloped lake, consisting of south and north lobes. The best rice tends to be on the south lobe, and the east shore of the north lobe. Watch status is low due to site familiarity.

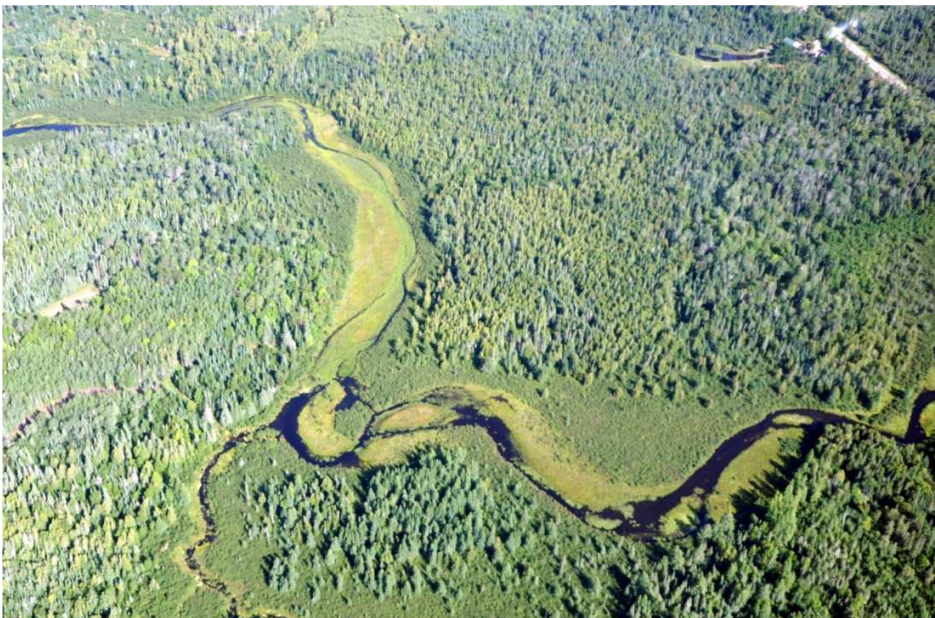
Figure 111. Pickerel Creek, below HWY 55, Langlade County, 2009. (Ron Eckstein Photo.)

Rice can be found at at least 2 locations on Pickerel Creek. One bed is just downstream from HWY 55 (first photo), the other just above the junction with the Wolf River. This latter site is commonly referred to as Goose Island, and this location is regularly harvested, and hunted over. Both are thought to be long existing beds. Watch status is low due to site familiarity, although better annual abundance information would be helpful for the upstream bed.

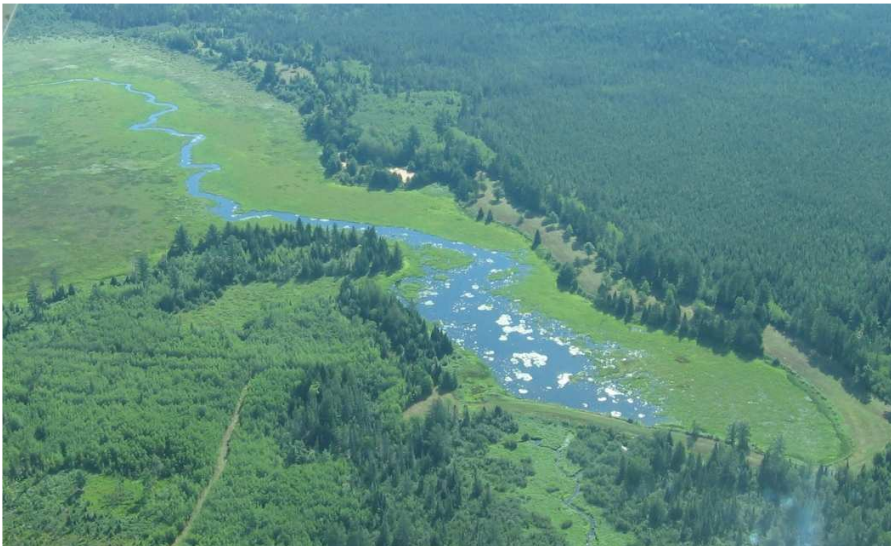
Figure 113. Spider Creek Flowage, Langlade County, 2006.

The Spider Creek Flowage is a state-managed property that was successfully seeded with rice. Beds are large enough to be harvestable, and are very attractive to wildlife. Direct threats to this site are minimal. Watch status is low due to site familiarity.

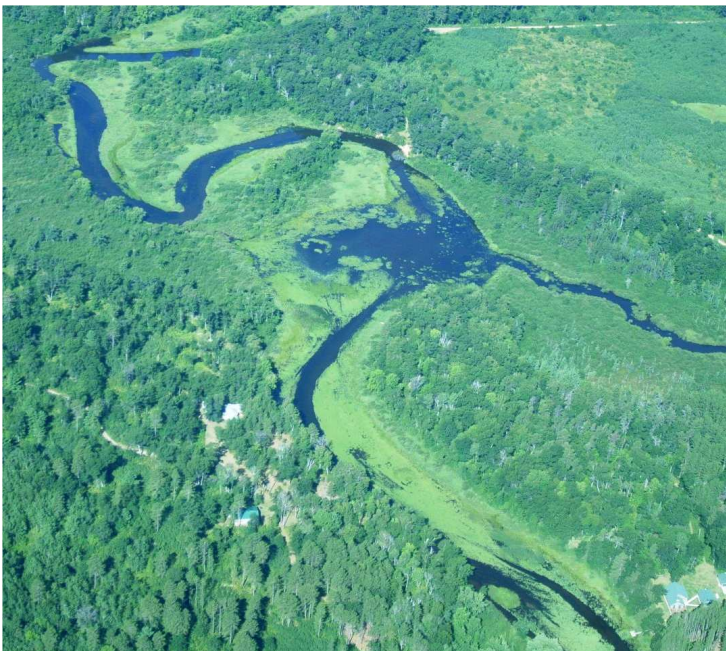
Figure 114. Wolf River at Turtle Lake, Langlade County, 2008.

Although locally referred to as Turtle Lake or Turtle High Banks, this bed is actually located on a wide spot on the Wolf River, about a mile SE of the town of Post Lake. This site is occasionally harvested. The WBIC code is for the river. Watch status is low due to site familiarity.

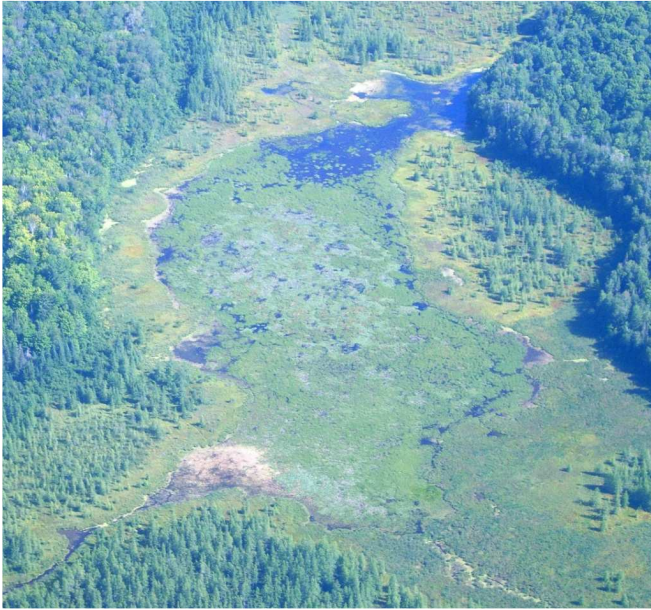
Figure 115. Unnamed (Daily) Pond, Langlade County, 2008.

Although this site is unnamed on the Surface Water Viewer, it is locally known as Daily Pond. It is found west of Rice Bed Road, just north of the Hunting River, into which it drains. Site is harvested regularly, and hunted as well. Rice can cover much of the site in a good year. Surrounding land is state-owned. Watch status is low due to site familiarity.

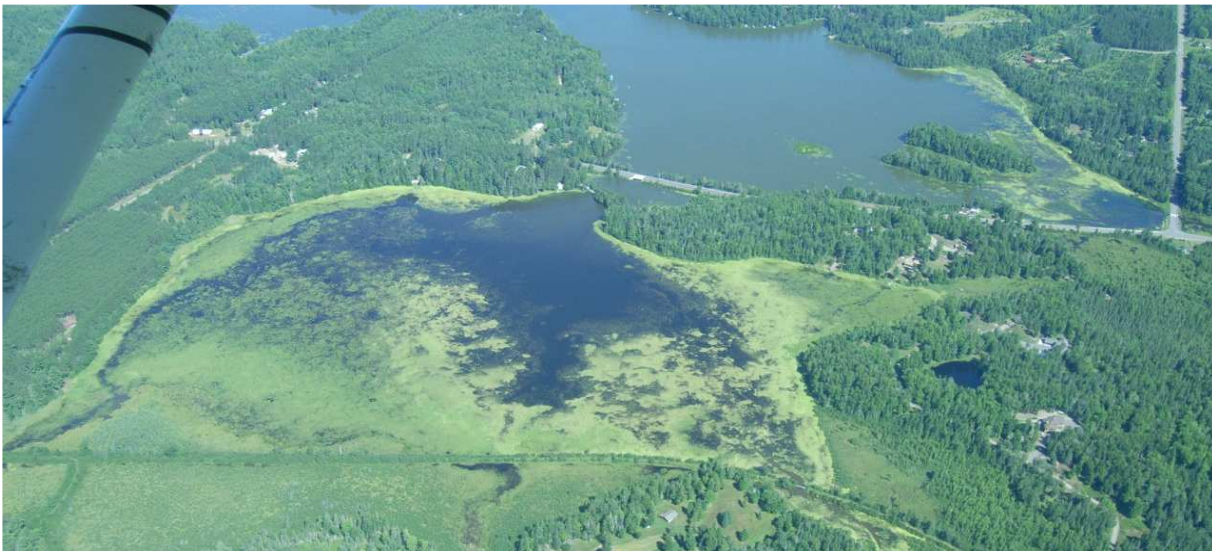
Figure 116. Alice Lake, Lincoln County, 2008.

Alice Lake (better known as Lake Alice) is a very large waterbody, but the rice is largely limited to the bay on the east end of the lake which is south of CTY D and the area near the far east end of the flowage where Big Pine Creek enters (both shown above). Small patches may exist in other locations. In some years this lake has been heavily harvested. Watch status is low due to site familiarity.

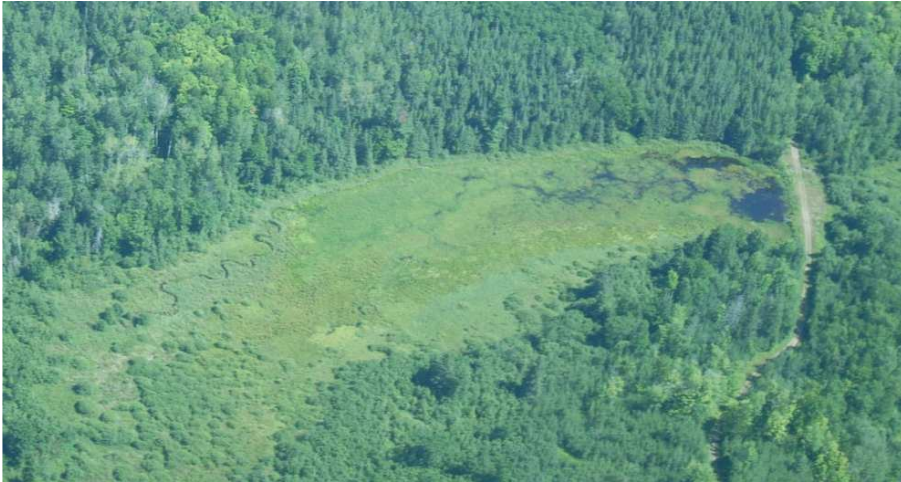
Figure 117. Camp 26 Flowage, Lincoln County, 2008.

This very small flowage is another location that was successfully seeded. All surrounding land is publicly owned. This seeding has been primarily beneficial to wildlife and waterfowl hunters. Watch status low.

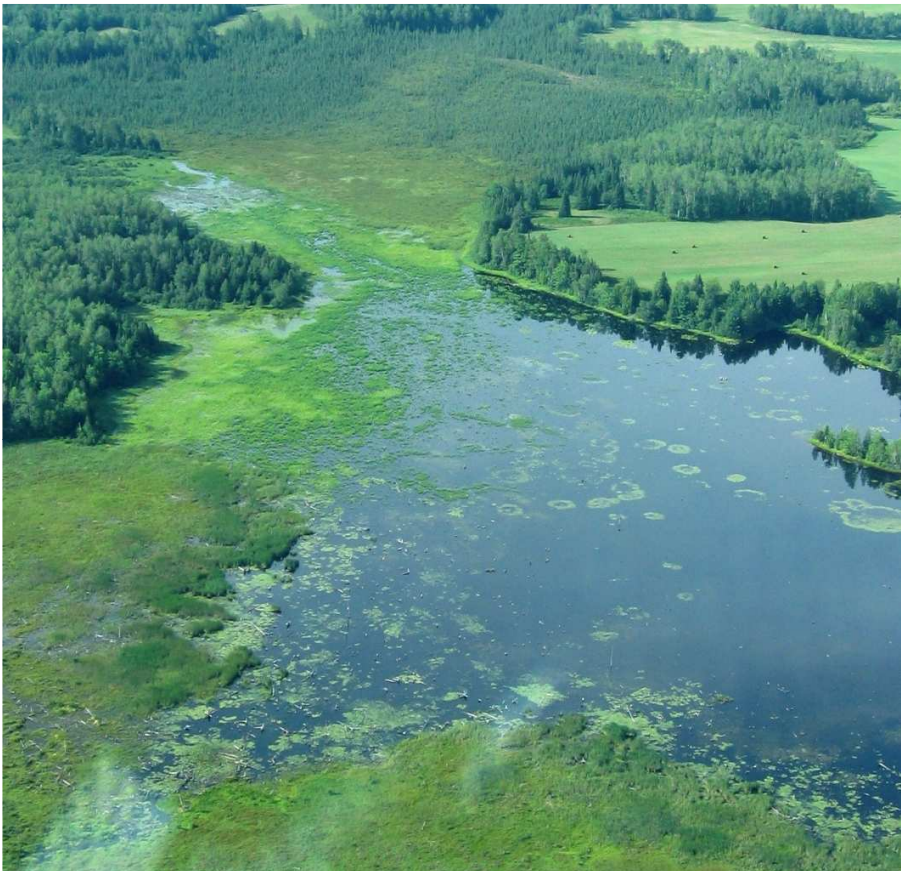
Figure 118. Harrison Flowage, Lincoln County, 2006.

Rice was seeded successfully on the Harrison Flowage by the DNR, and seems to be becoming well established. The primary bed is on the far southeastern portion of the flowage, shown in the photo above, but current efforts to more carefully control water levels, coupled with additional seeding, may lead to additional beds. A bay on the north shore that was recently planted is showing a very good initial take. Watch status is medium-high to monitor possible expansion of the beds.

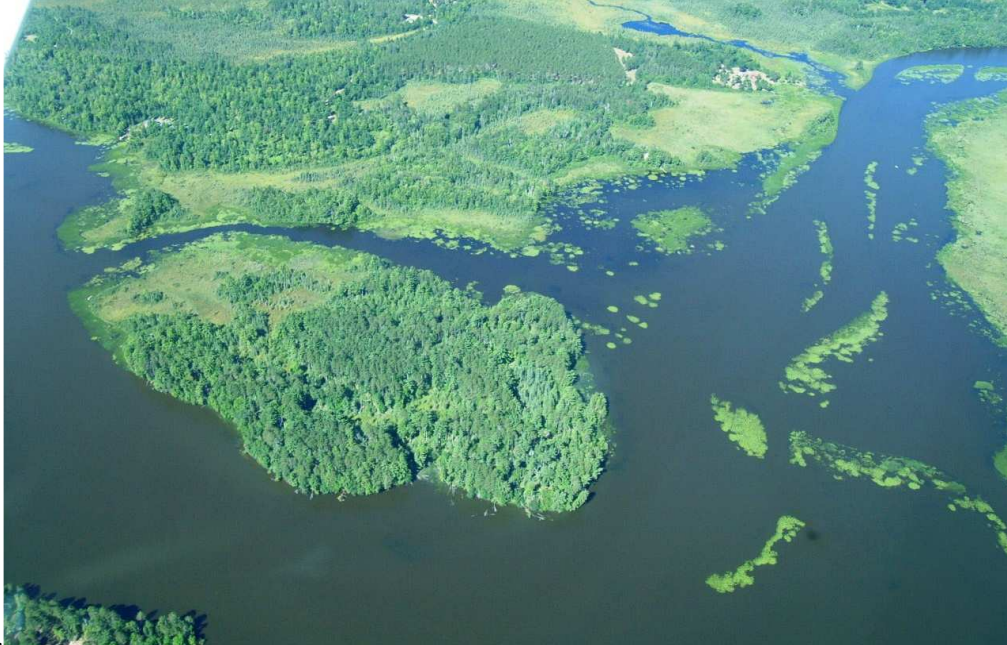
Figure 119. Jersey Flowage, Lincoln County, 2008.

This area once likely held abundant rice beds, most of which appear to have been lost. Recent seeding efforts by the DNR have re-established some small beds on this flowage, mostly in the area above the large island that is found here. Since most of these seedings are fairly recent, it will be interesting to see how they fare in the long run. Watch status is medium-high.

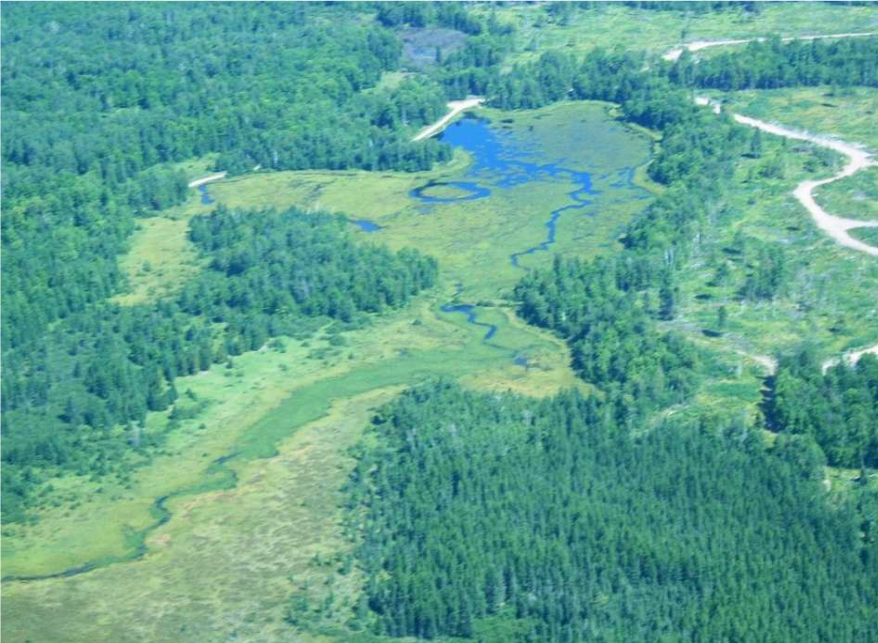
Figure 120. New Woods Wildlife Area Flowage, Lincoln County, 2008.

The New Woods Flowage is yet another example of a successful rice seeding on a state wildlife area. It is interesting perhaps that this site has done so well, given the dark water found on this flowage, which is typically not considered optimal for rice. Careful water level management seems to be part of the success of this seeding. Watch status is low due to familiarity with the site.

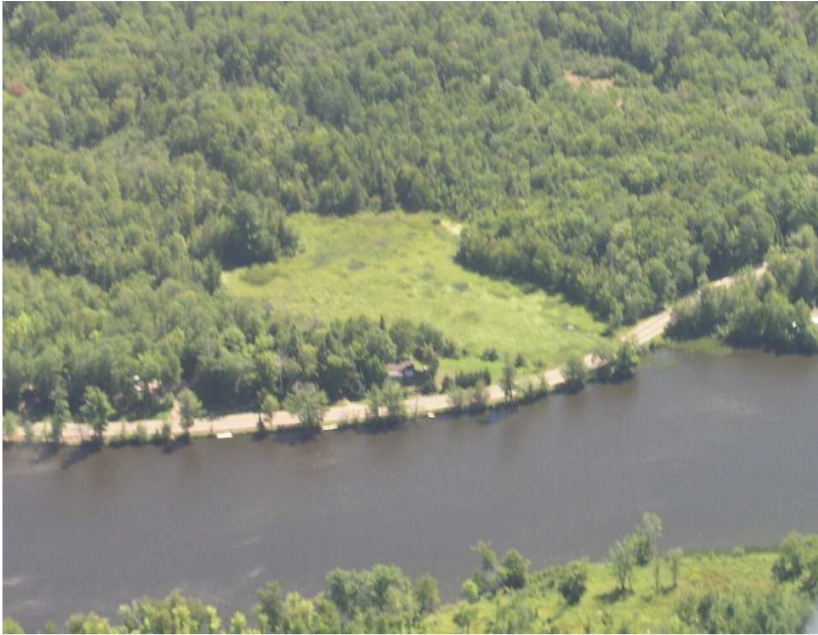
Figure 121. Unnamed Pond, Lincoln County, 2007.

Rice sometimes nearly covers the surface of this small, unnamed pond adjacent to the Wisconsin River (which is visible in the photo above). Pond is located on the east side of the river, just across HWY 107, about a half mile north of Eggert Drive. Watch status is low due to familiarity with the site.

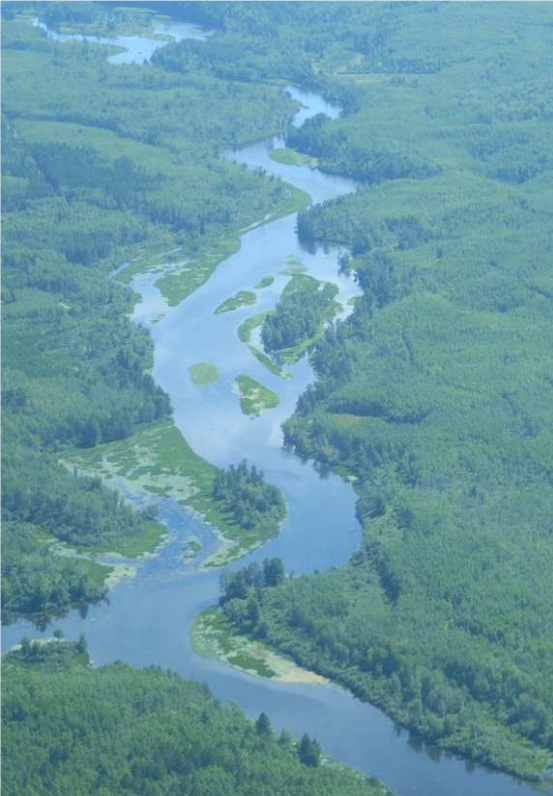
Figure 122. Wisconsin River North of Lake Alice, Lincoln County, 2008.

The section of the river above Alice Lake; these beds seems to be increasing in recent years after nearly disappearing.

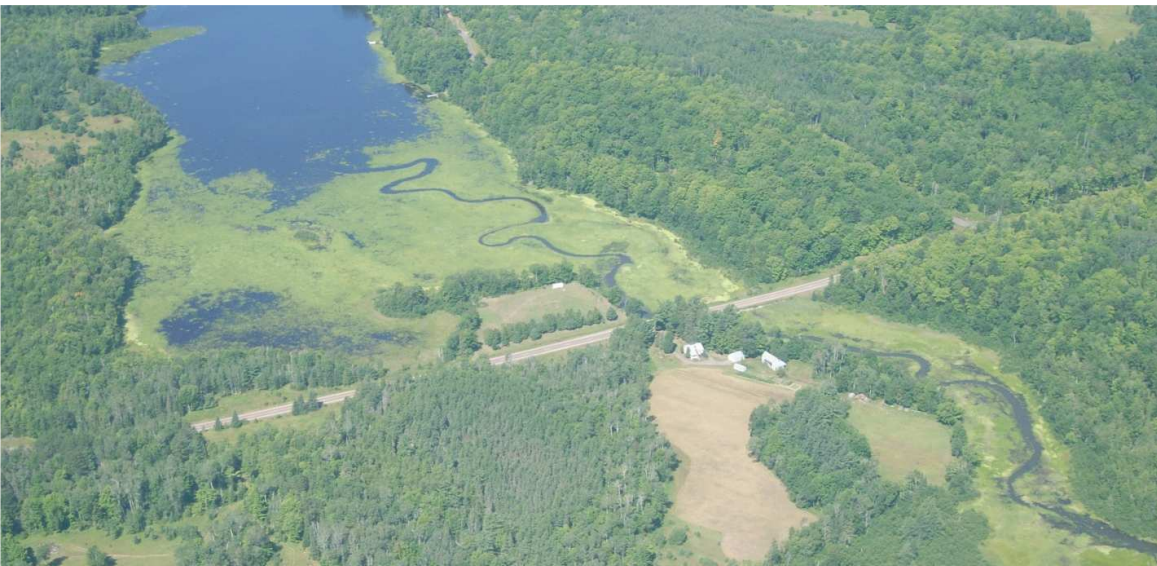
Figure 123. Unnamed Slough between the Wisconsin River and Little Pine Creek, Lincoln County, 2008.

The location where Little Pine Creek enters the Wisconsin River. On the Surface Water Viewer, this area is designated as "An Unnamed Slough" (WBIC 1503100).

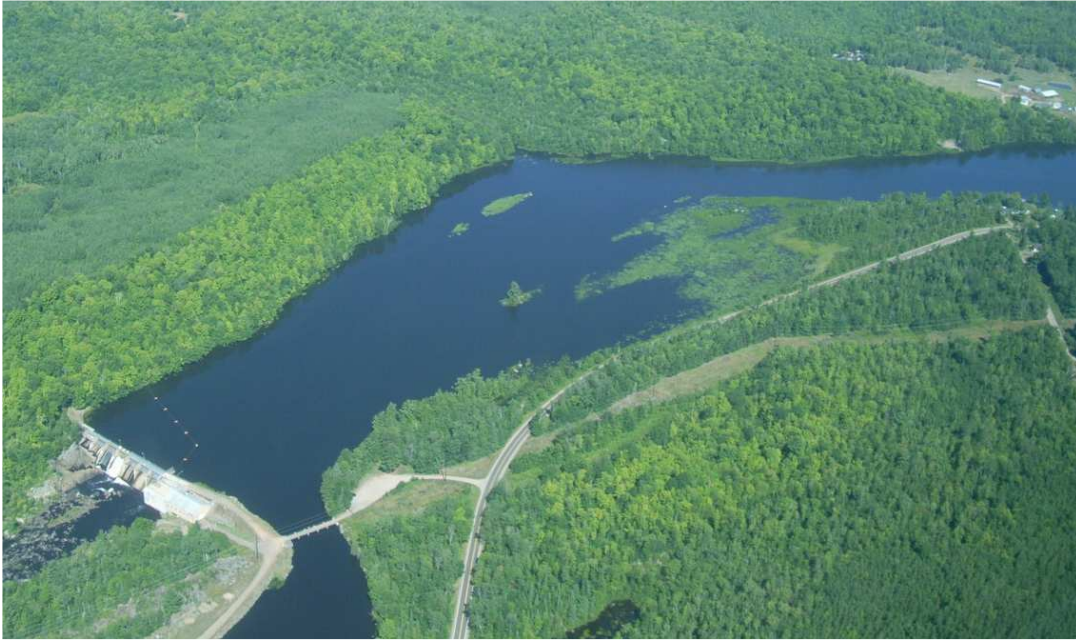
Figure 124. Grandfather Flowage, Lincoln County, 2008.

The portion of Grandfather Flowage south of the bridge that connects HWY 107 on the east side of the river with CTY E on the west (WBIC 1502400).

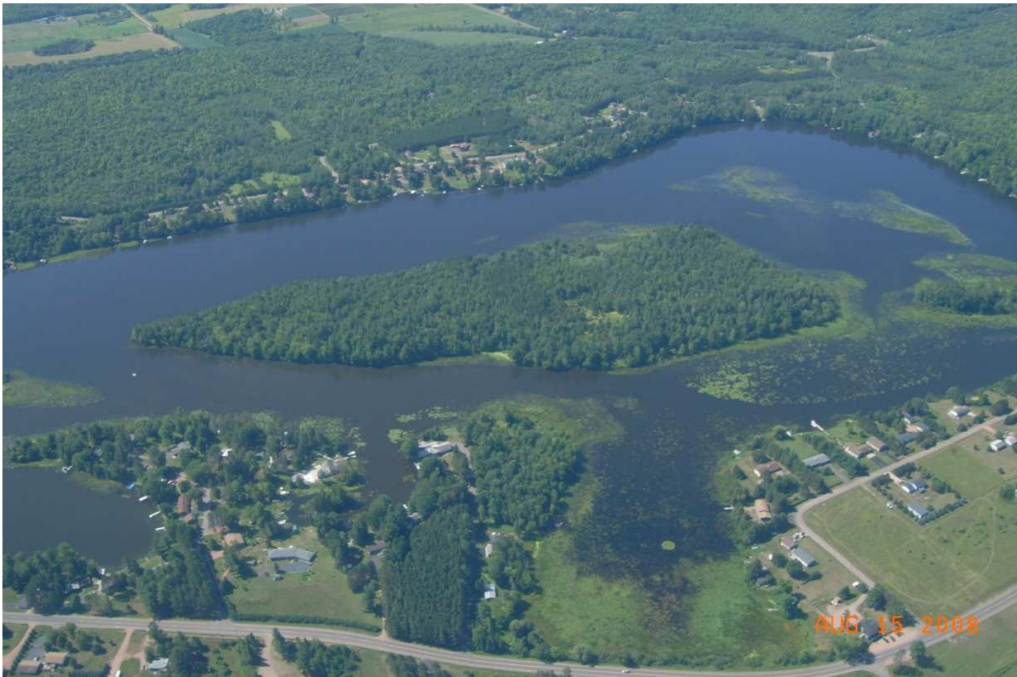
Figure125. Alexander Lake, North end, Lincoln County, 2008.

Several patches on Alexander Lake (WBIC 1494600).

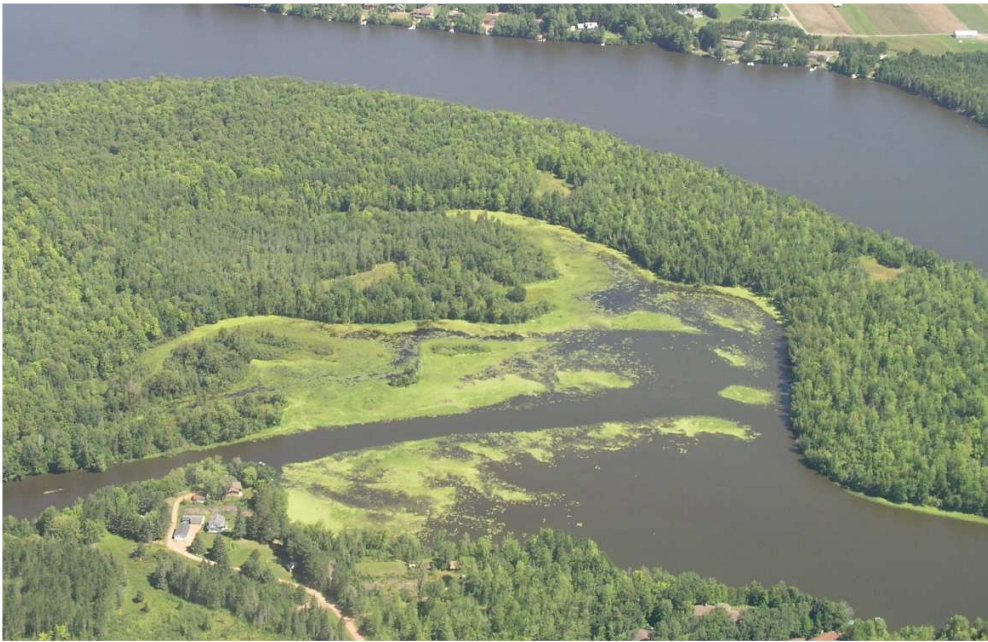
Figure 126. Mouth of the Copper River at Lake Alexander, Lincoln County, 2007.

The mouth of the Copper River where it meets Alexander Lake (WBIC 1494700).

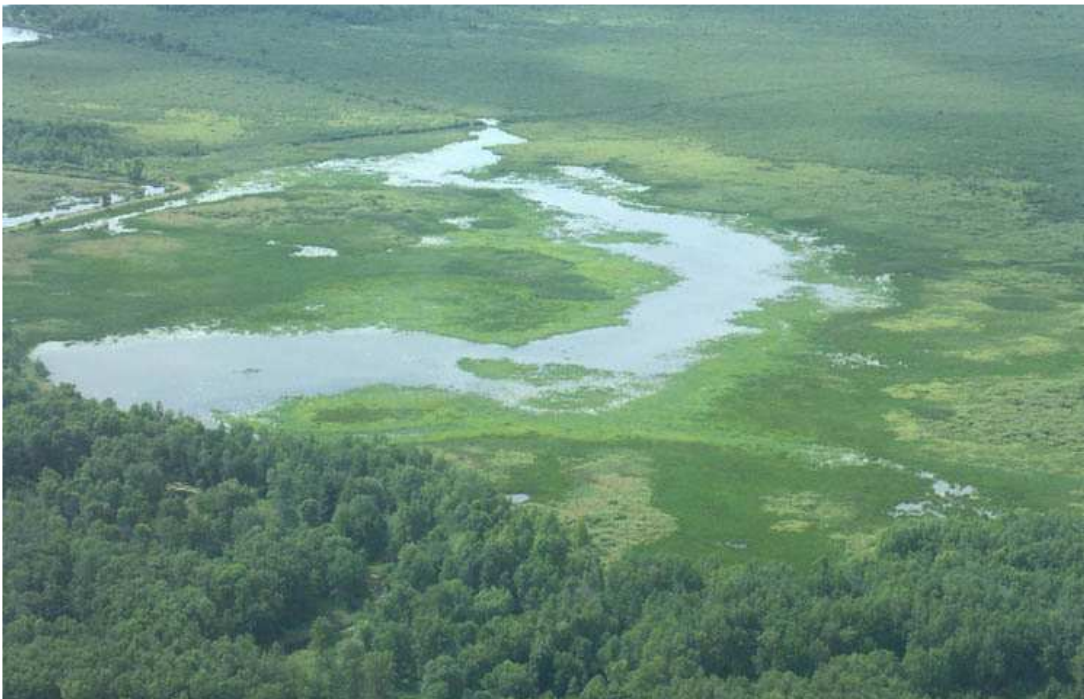
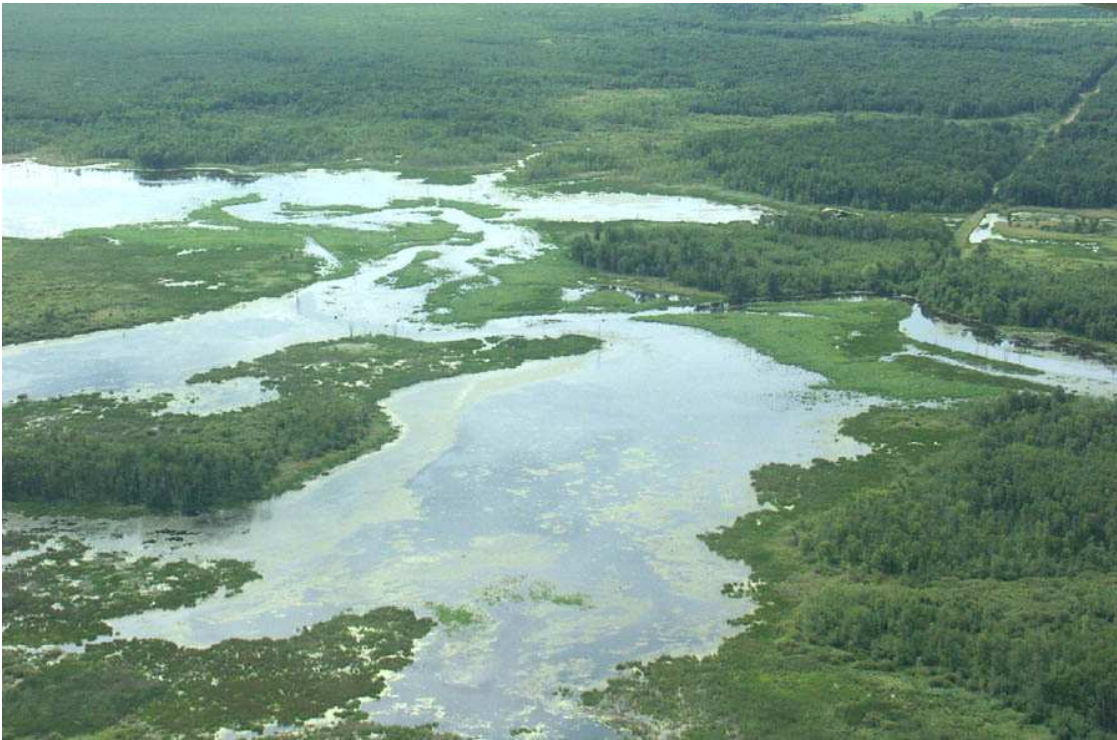
Figure 127. Main Flowage, McMillan Wildlife Area, Marathon County, 2009 (Jon Zellmer Photo.)

Figure 128. Reservoir Flowage, McMillan Wildlife Area, Marathon County, 2009 (Jon Zellmer Photo).

Jon Zellmer, DNR, reports fairly large and well established beds on the Main (WBIC 1422100) and Reservoir (WBIC 1422400) flowages at McMillan Wildlife Area as a result of seeding efforts.

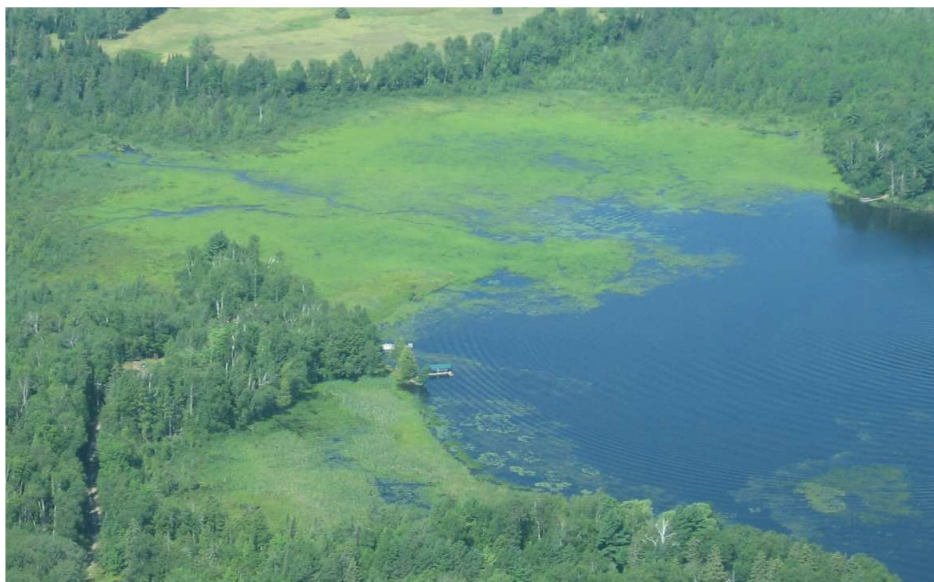
Figure 129. Big Lake, SW bay, Oneida County, 2006.

Big Lake supports a fairly substantial bed of rice, but it is limited to the bay on the far southwest corner of the lake. Although this stand is harvestable at least some years, it tends to get relatively little pressure, perhaps because the nearby Big Lake Thoroughfare generally offers a larger stand. Nevertheless, harvest on this lake is date-regulated. Watch status is low because of site familiarity.

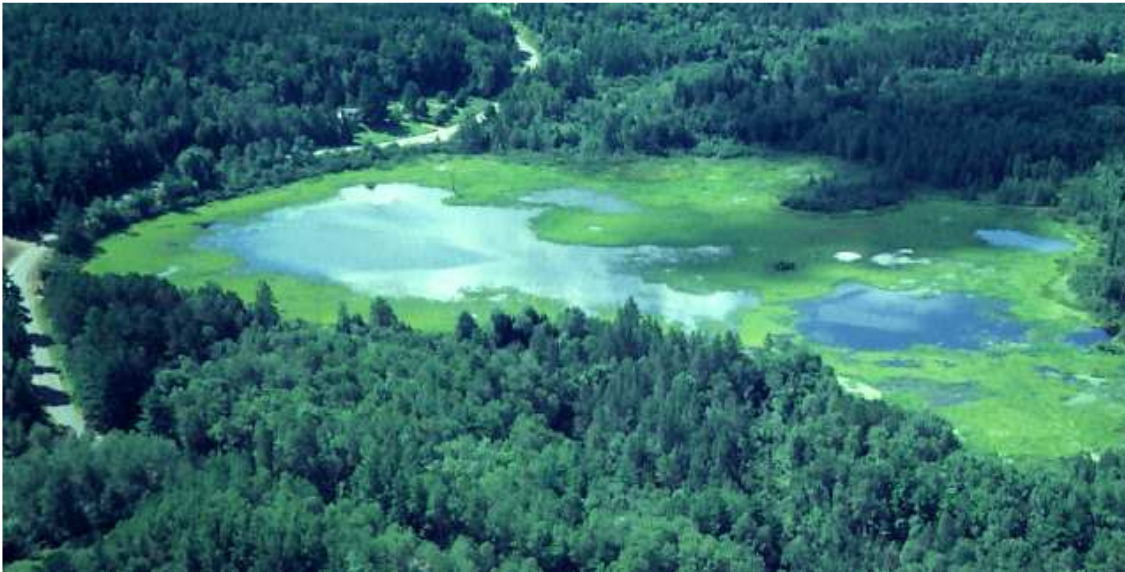
Figure 130. Cuenin Lake, Oneida County, 2002.

Small Cuenin Lake is located just a few miles south of the city of Rhinelander. In years with a good crop, rice can be found in a patchwork across the entire lake. Harvest is reported regularly. Watch status is low because of site familiarity.
