**Wisconsin
Ceded
Territory
Manoomin
Inventory
Ver. 1.0**

**GLIFWC
Project
Report
2010-01
March, 2010**

**Peter David
Wildlife
Biologist**

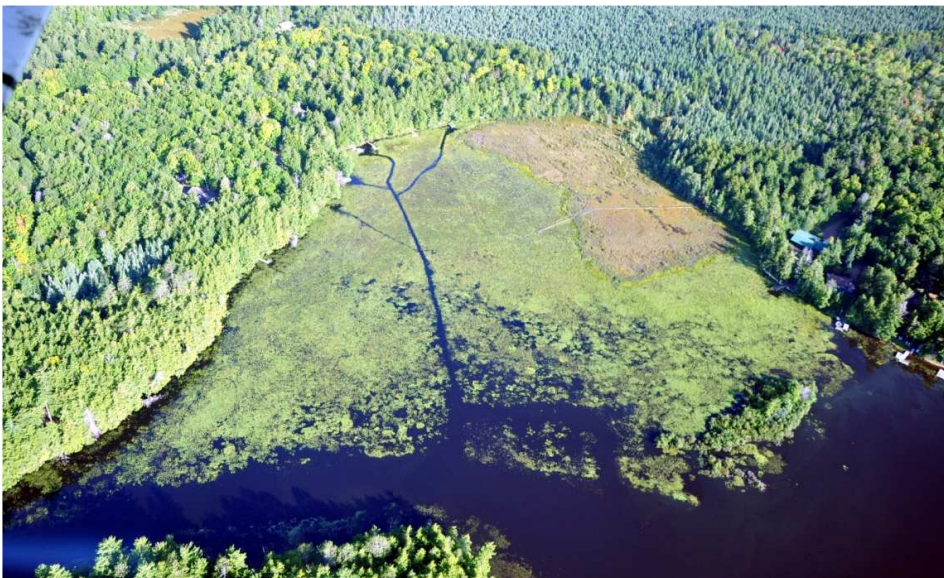
Figure 131. Deer Lake, Vilas County, 2009. (Ron Eckstein Photo.)

A bed of rice exists on this lake in the bay on the west side of the lake, where a small stream enters from the north (Ron Eckstein information). Watch status is medium-high because of the lack of annual abundance information.

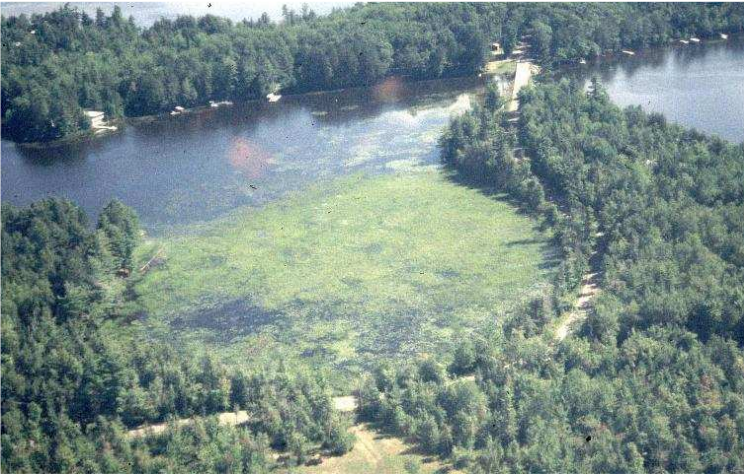
Figure 132. Dog Lake, Oneida County, 1996.

Dog Lake has a long history of supporting rice, but the bed is limited to the bay just northwest of the bridge which separates Dog and Big Lakes (visible near the top of the photo). The site rarely turns up in harvest surveys, perhaps because the much larger beds on the Big Lake Thoroughfare are just a short distance away. Watch status is low because of site familiarity.

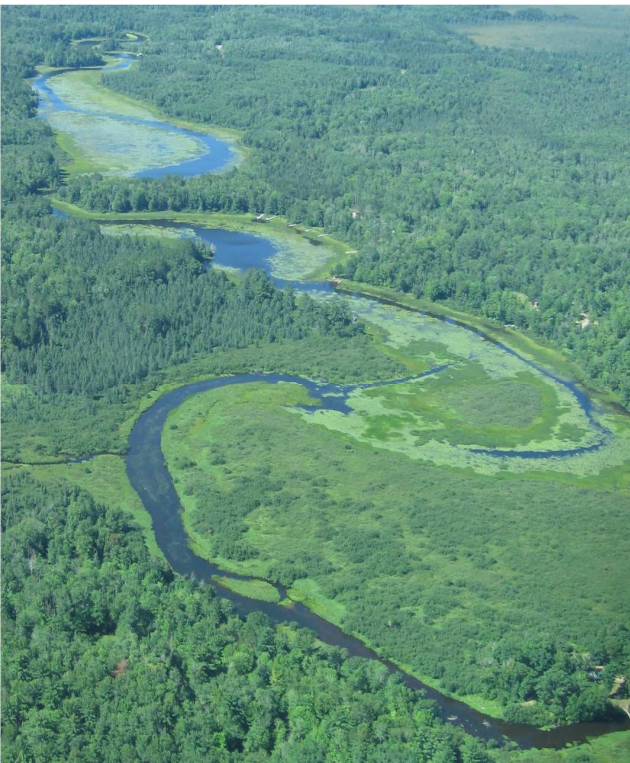
Figure 133. Fish Lake, Oneida County, 2007.

Fish Lake is actually a widening of the North Branch of the Pelican River. In recent years rice production seems to be poorer than occurred historically, but reasons for this are not clear (though beaver may be involved). Rice has a patchy distribution on this water body, and beds may move somewhat between years. Most of the aquatic vegetation in the photo above is species other than rice. Watch status is medium because of the possible indications of decline.

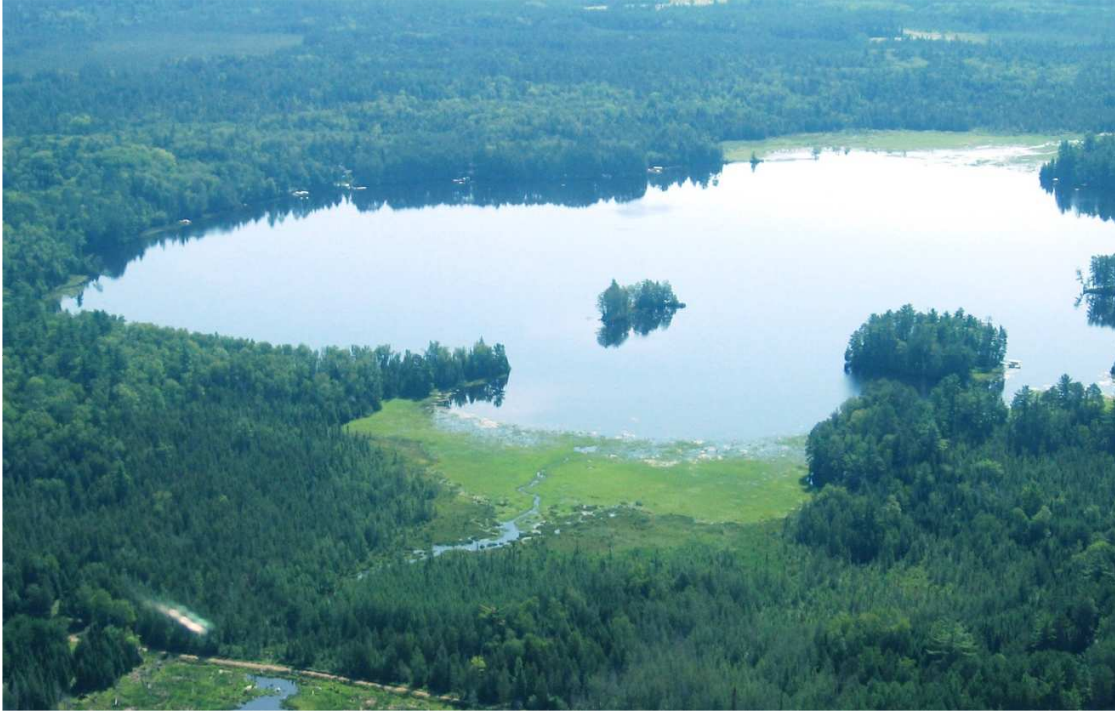
Figure 134. Fourmile Lake, Oneida County, 2006.

Fourmile Lake supports 3 distinct bays of rice. One is located on the west side of the lake where an unnamed creek enters (nearest bed in the photo above; creek WBIC is 1611600); the second is in the bay immediately south of this bay (not clearly evident in the photo above) and the third is on the east side of the lake where Fourmile Creek enters (top-right in the photo above). GLIFWC has only been aware of these beds since 2003, but likely they have been around for a much longer period of time. Watch status is low because of site familiarity.

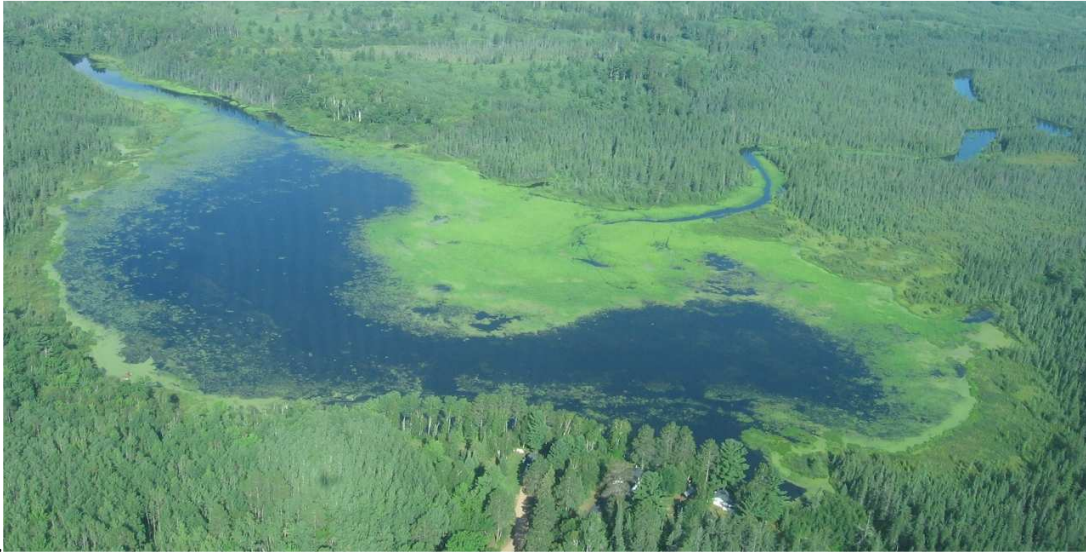
Figure 135. Gary Lake, Oneida County, 2006.

Gary Lake is located on Little Rice Creek in south-central Oneida County. The primary bed is located where the creek enters, but smaller amounts of rice can be found around most of the shoreline. Harvest on this lake is date-regulated, but has not generally been substantial, in part because public access is limited. For this reason, this site may be a candidate for removal from the date-regulated list. Watch status is low because of site familiarity.

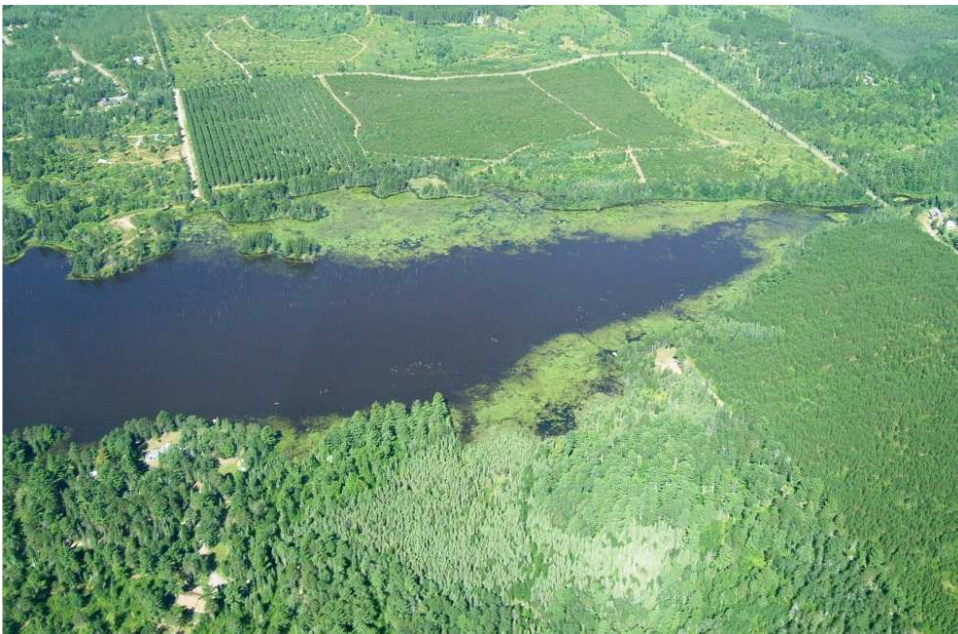
Figure 136. Killarney Lake, Oneida County, 2008.

A fairly substantial bed of rice can be found on the northern arm of Killarney Lake. It begins where Brown Creek enters, and extends down both shorelines for approximately three-quarters of a mile. The history of this bed is unclear, but it

has turned up in harvest surveys fairly regularly since 2005. Another smaller bed can be found on a bay on the southeast side of the lake. Watch status is medium because greater annual abundance information would be helpful.

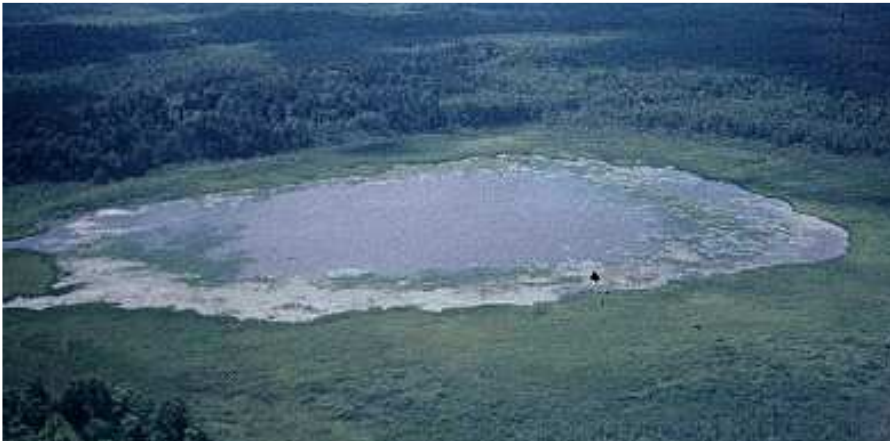
Figure 137. Little Rice Lake, Oneida County, 1994.

Although its name suggests a long historical presence of rice, this site has produced very little rice over the last 2 decades. (It is noteworthy that a photo from 1994 had to be used to display a relatively abundant stand.) Reasons for this are unclear, and the site has not been investigated to any extent because of its relative remoteness, but hydrological changes associated with nearby Rice and Thunder Lakes might be involved. Watch status is low because of site familiarity, but potential restoration opportunities need to be explored.

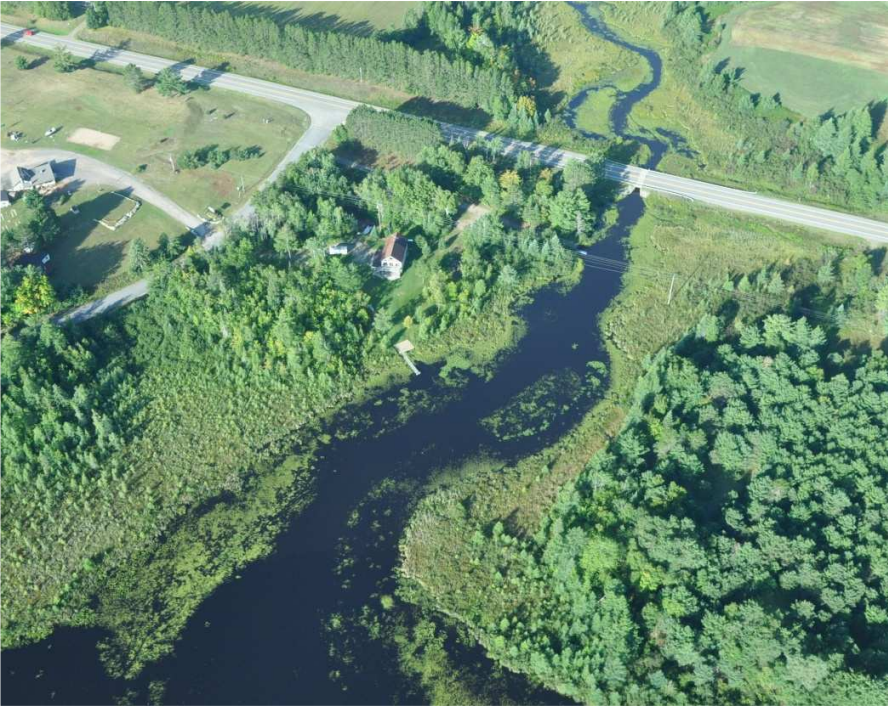
Figure 138. Mud Lake at HWY 45, Oneida County, 2009. (Ron Eckstein Photo).

Ron Eckstein, DNR, reports the presence of a small bed of rice on the very west end of Mud Lake (Crystal Lake on some maps) where Crystal Creek enters. GLIFWC is not familiar with this location, but did not verify it given the reliability of the source. However, we gave it a watch status of medium-high due to the lack of annual abundance data.

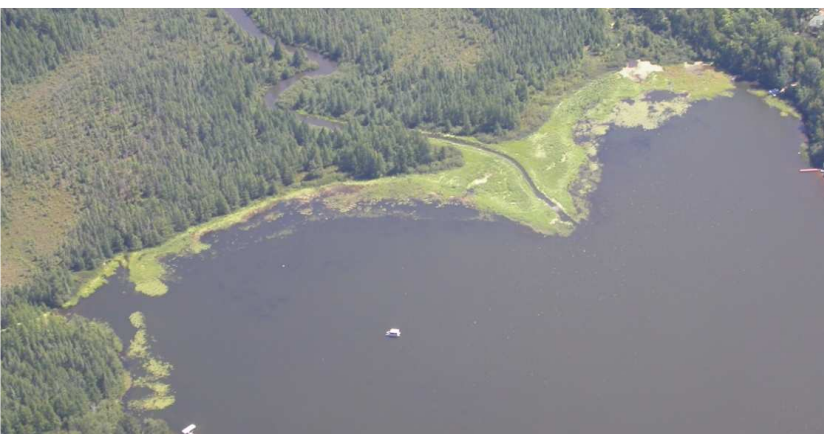
Figure139. Oneida Lake, Oneida County, 2005.

Several acres of rice can be found on Oneida Lake where Rice Creek enters the northeast bay of this lake. Though not large, this bed has been present for a long time. Watch status is low because of site familiarity.

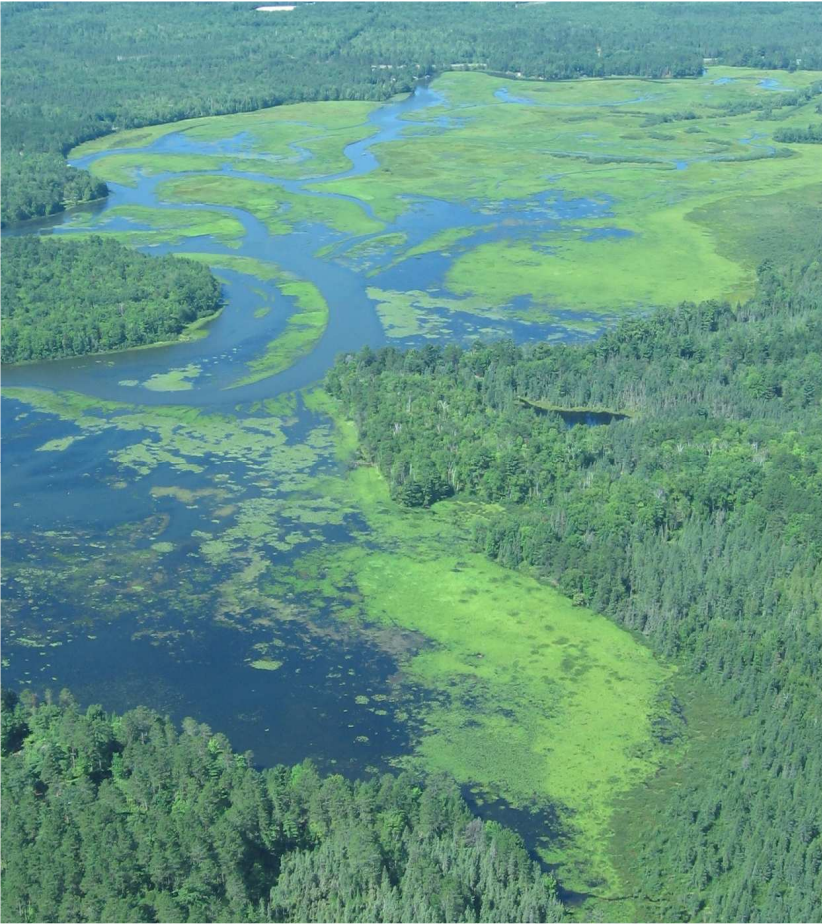
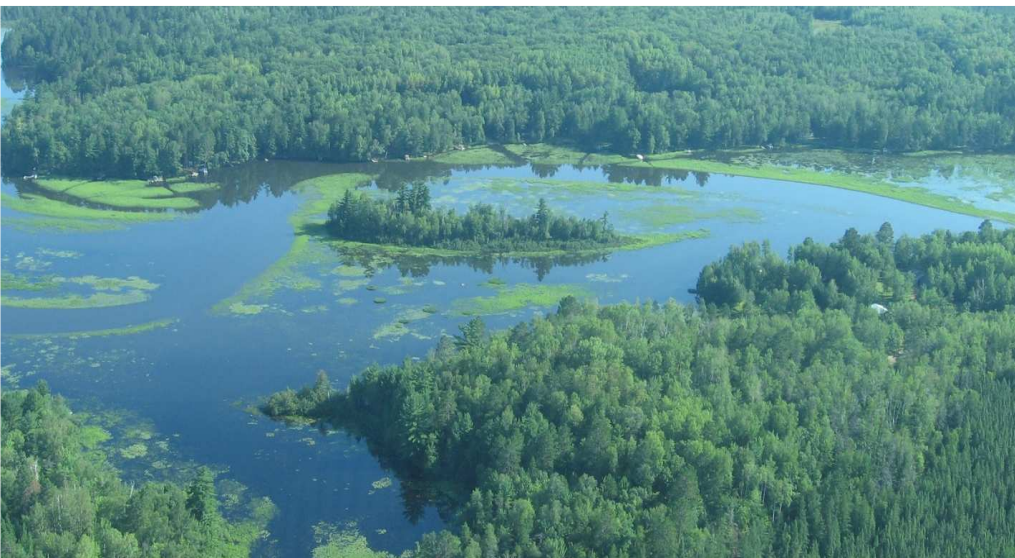
Figure 140. Rhinelander Flowage, Upper Region, Oneida County, 2007.

Figure 4. Rhinelander Flowage, Mid Region, Oneida County, 2006.

The Rhinelander Flowage holds one of the largest rice beds in the State. This bed is large enough that it is not adequately captured in the 2 images above, but rice has a presence from the head waters to the area east of Wildwood Lake. The current operation of the dam on this system has been very compatible with rice production. We have not

documented rice in any other sections of the Wisconsin River in Oneida County, though it is possible smaller beds occur. Watch status is low because of site familiarity.

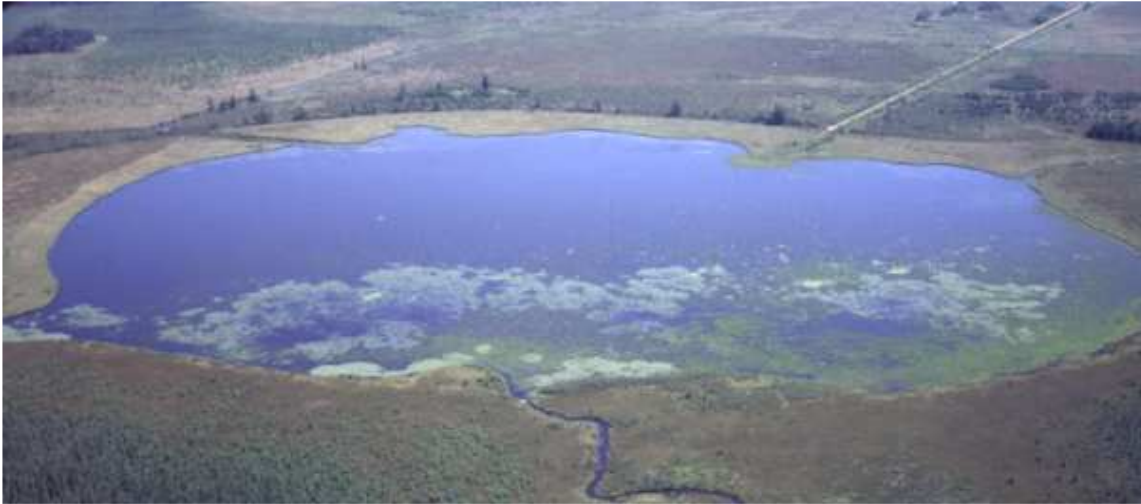
Figure142. Rice Lake, Oneida County, 2004.

Rice Lake, located on the Thunder Lake Wildlife Area, has been a bit of a puzzle. While the name reflects the long history of rice on this water, abundance has been poor over the last 2 decades. The most likely cause may be hydrological modifications in this system (which encompasses Thunder and Little Rice Lakes) perhaps coupled with an extended period of above average precipitation for the much of this period. Over the last 3 year, precipitation has been below average, however, and the lake has yet to show positive response. Unlike some nearby lakes which have experienced rice decline, such as Spur (Oneida County) and Atkins (Forest County), Rice Lake does not appear to have become dominated by other vegetation. Watch status is low because of site familiarity, but restoration opportunities need to be explored.

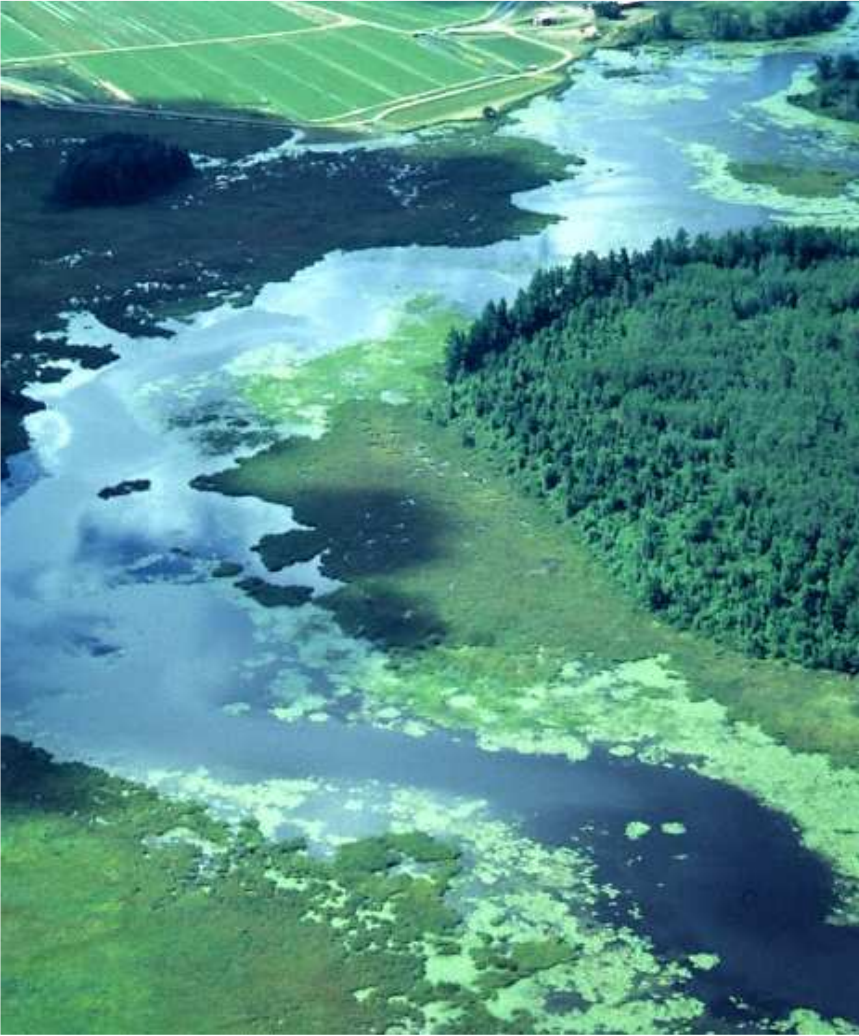
Figure 143. Rocky Run Flowage, Oneida County, 2002.

The Rocky Run Flowage is yet another Oneida County site that seems to be in decline in recent years, again for unknown reasons. There is a large cranberry operation adjacent to this flowage, but at this time there is no evidence that it is having a negative impact on the rice, and the owner has expressed an interest in rice restoration at the site. Competition from other aquatic vegetation appears significant. Watch status is high because of the apparent decline and the opportunity for restoration.

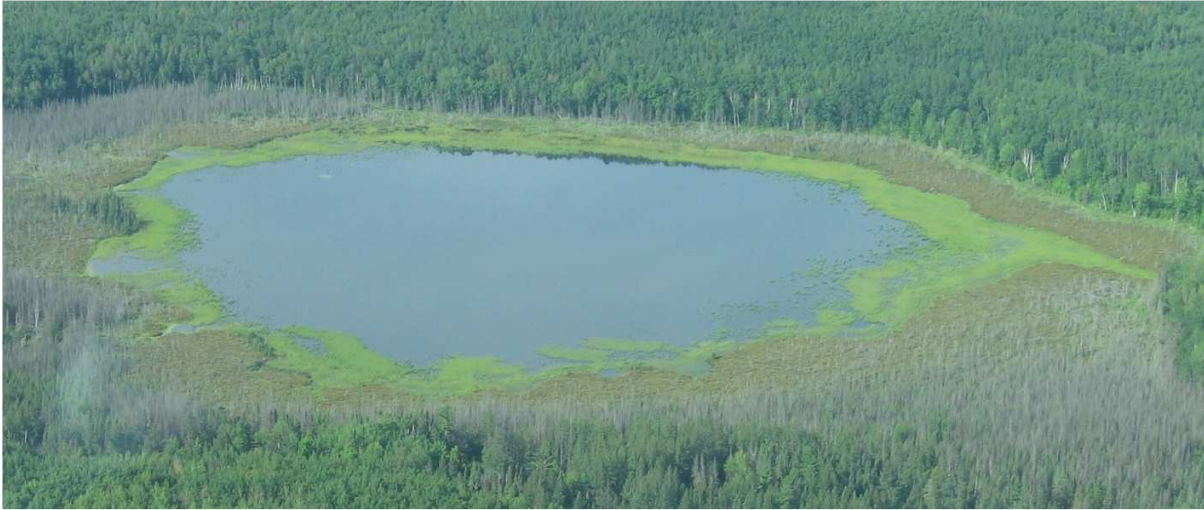
Figure144. Roe Lake, Oneida County, 2006.

Roe Lake is another site that was successfully seeded cooperatively by DNR and GLIFWC. Rice has done very well at this site, with the help of APHIS beaver control. Local individuals also occasionally try to sand bag this lake to increase its depth, so regular monitoring of water level is important to maintain this success. Although this bed was first seeded in just 2003, it is already showing up in harvest surveys. Watch status, other than for beaver impact, is low because of site familiarity.

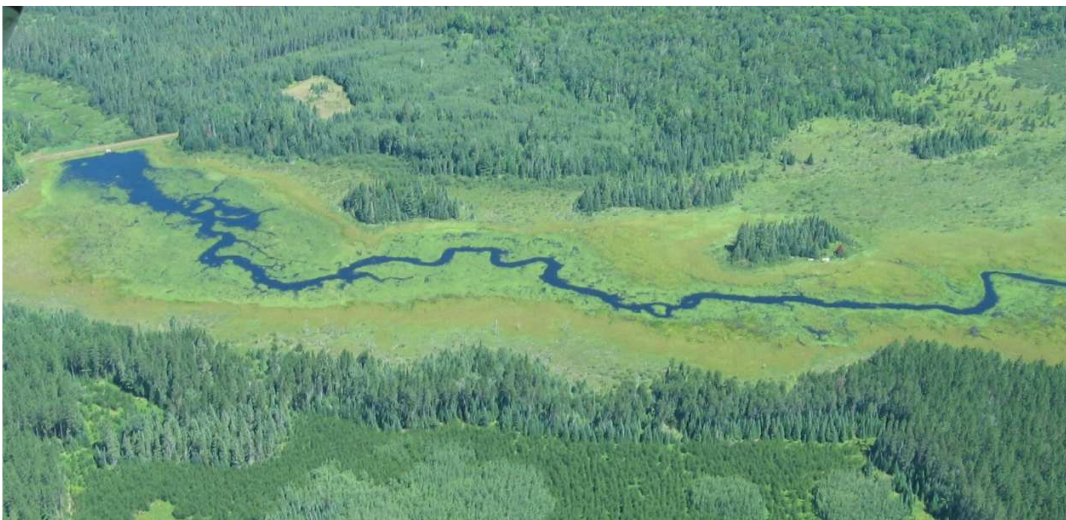
Figure 145. Scott Creek Impoundment, Oneida County, 2007.

The Scott Creek Impoundment is on Forest Service Lands, and was successfully seeded by GLIFWC and the Forest Service. Annual rice production has been quite variable, but persistent. Note that this WBIC code is for the Scott Creek, not the impoundment, which has not been added to the Surface Water Viewer map. However, the impoundment is visible in the 2005 air photos on the Surface Viewer, just east of HWY 32, and extending to approximately the Forest County line. Rice is not known to exist on the Creek in Oneida County outside of the impoundment. Watch status is medium because of the significant annual variability in abundance.

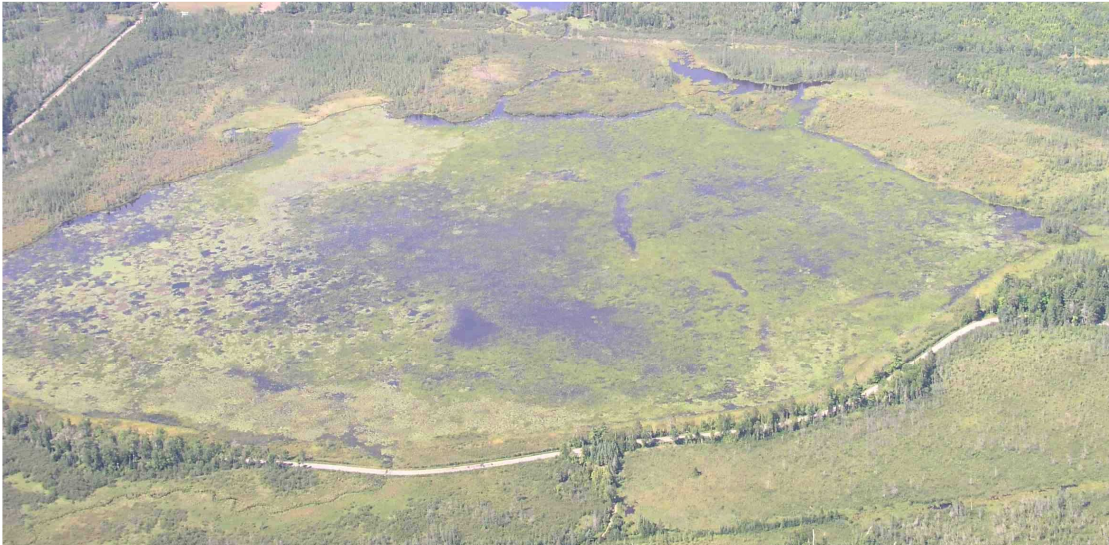
Figure 146. Spur Lake, Oneida County, 2003.

Spur Lake was once a premier rice water in the area, heavily utilized by harvesters. This is a true “rice lake”, capable of supporting rice over nearly its entire surface. However, like a number of other area lakes, rice production on Spur has been very poor in recent years, and other vegetation has come to dominate the lake. Reasons for this are not well known, but a reduction in flow out of the lake (due to beaver and/or vegetation growth) has been suggested as a possible cause. Watch status is high because of the need for restoration efforts.

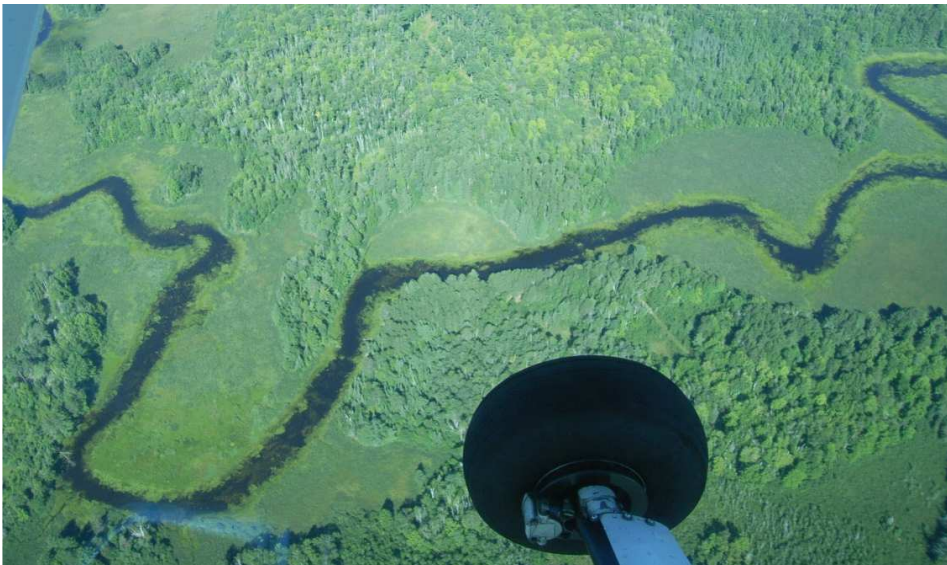
Figure 147. Squaw Creek, Oneida County, 2008.

Squaw Creek supports rice in scattered patches over a section several miles long that is centered approximately at the junctions of Oneida, Vilas, and Price counties. Although most of this section is found in the other counties, roughly a half mile of the creek bisects the northwest corner of Oneida County. Watch status is low because of site familiarity.

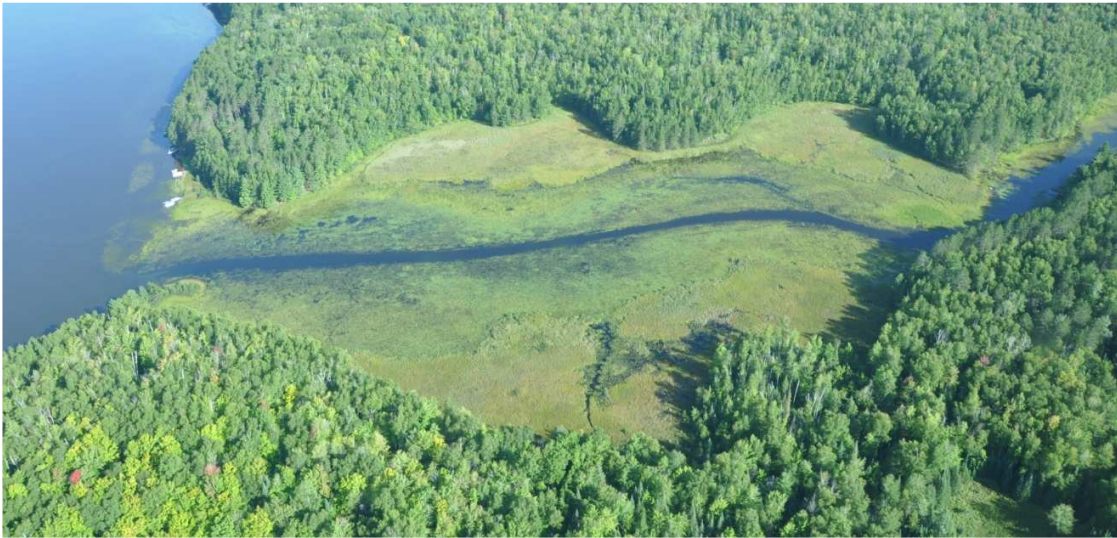
Figure 148. Sugar Camp Creek at Stone Lake, Oneida County, 2009. (Ron Eckstein Photo)

DNR wildlife manager Ron Eckstein reports the presence of a rice bed on Sugar Camp Creek just east of Stone Lake, extending for roughly a quarter mile. GLIFWC is not familiar with this site, and did not verify it given the reliability of the source, but did give it a medium-high watch status due to the lack of annual abundance information.

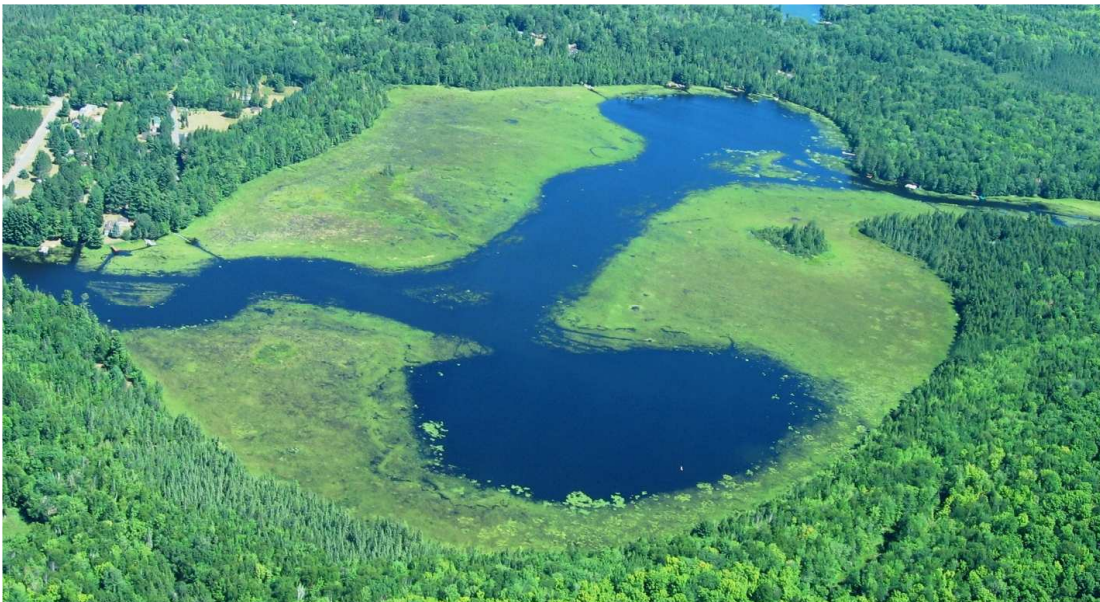
Figure 149. Big Lake Thoroughfare, West, Oneida County, 2007.

While this report generally uses the place names identified in the Surface Water Viewer, an exception is made here. Local usage generally considers The Thoroughfare (or the Big Lake Thoroughfare) to be the section of water that originates at Whitefish Lake to the east and ends at Big Lake to the west. The Surface Water Viewer applies this name only from Whitefish Lake to the point where the Eagle River enters. I encourage the Viewer apply this name to the entire section.

The Thoroughfare is an important water, whose harvest is date-regulated. It has occasionally been severely infected with brown spot disease, reducing seed production, but this has not harmed the long-term productivity of the bed. Rice is found throughout the system in good years. Watch status is low because of site familiarity.

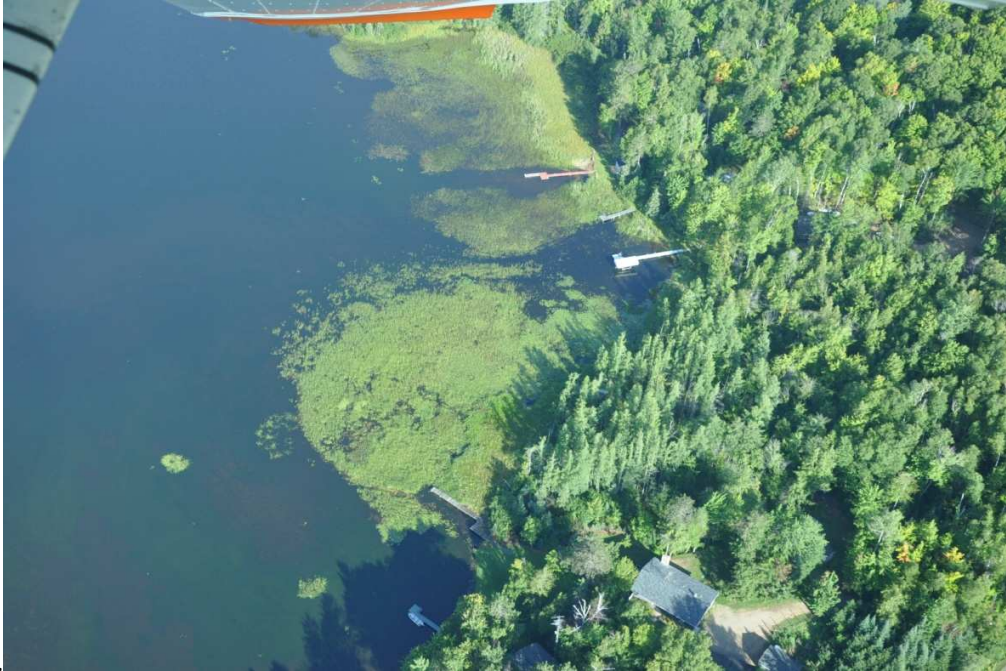
Figure 151. Thunder Lake, Oneida County, 2009. (Ron Eckstein Photo).

Thunder Lake once supported substantial rice beds, but these are nearly gone. This lake has gone through an interesting and complex history of water level manipulation that has negatively impacted the rice. Small stands still exist, however, and were confirmed in ground surveys in both 2008 and 2009. These are located primarily in the southeast section of the lake, with patches going about as far north as the area east of the island. While the abundance here is far less than historically occurred, this is still consider a rice water, and it remains a location for possible restoration efforts. Watch status is medium-high because of the continued need to explore restoration opportunities at this site.

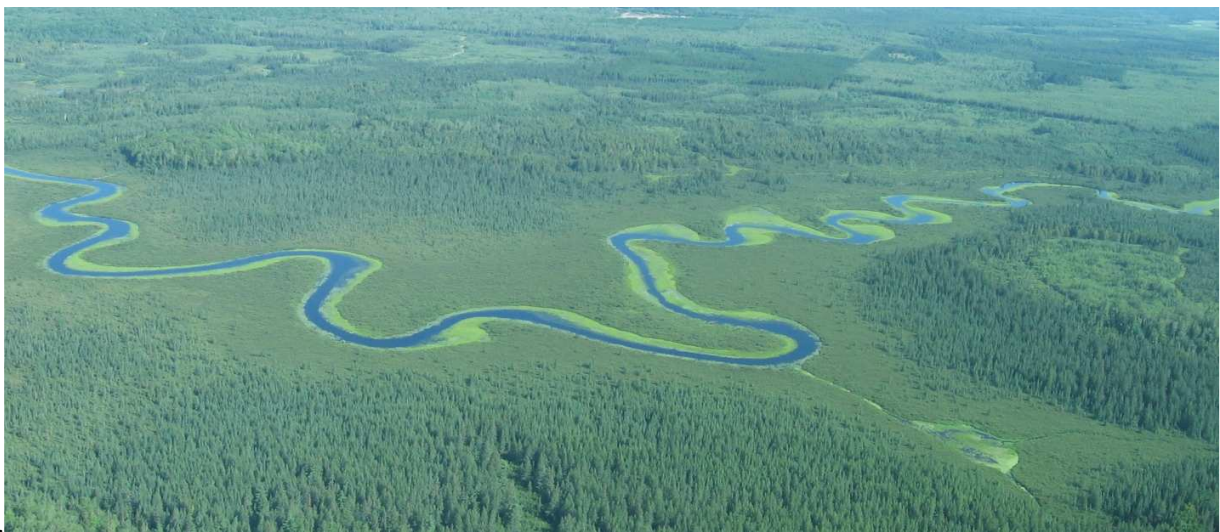
Figure 152. Wolf River, East of the Forest County Line, Oneida County, 2006.

Although a relatively small portion of the Wolf River passes through Oneida County, this portion is quite rich in rice beds. Beds begin where the river enters from Forest County, and cover about half the river distance to the wide area west of Lake Lucille. Although regularly harvested, these beds would be picked more if access was easier. Watch status is low because of site familiarity.

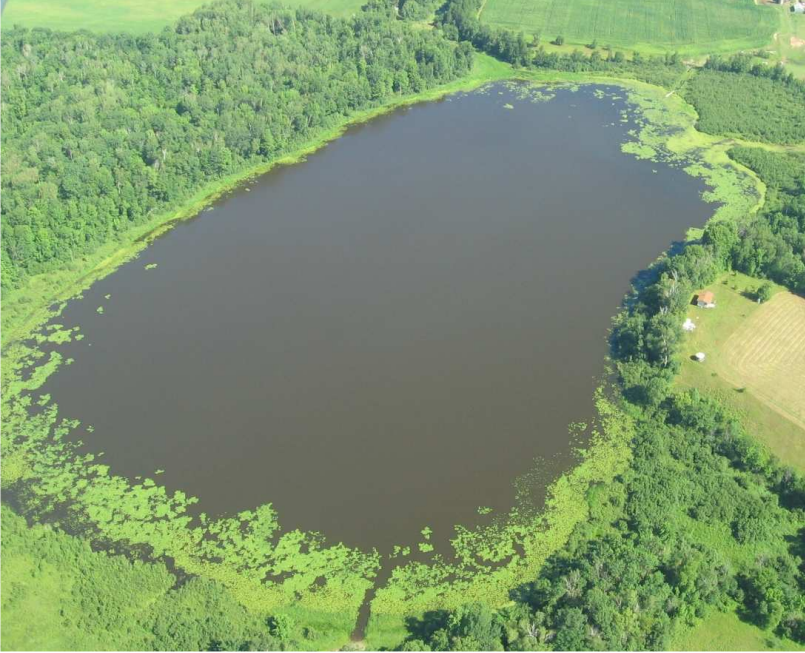
Figure154. Andrus Lake, Polk County, 2008.

Andrus Lake is also marked on some maps as Little Round Lake. Relatively small rice beds can be found on the north and south ends of this lake, with the larger being located on the north end near the Sucker Creek inlet and outlet.

Enforcement actions have been taken against one local landowner on this lake who undertook some illegal activities which had a negative impact on the rice and other aquatics. Watch status is medium high because annual abundance data is lacking.

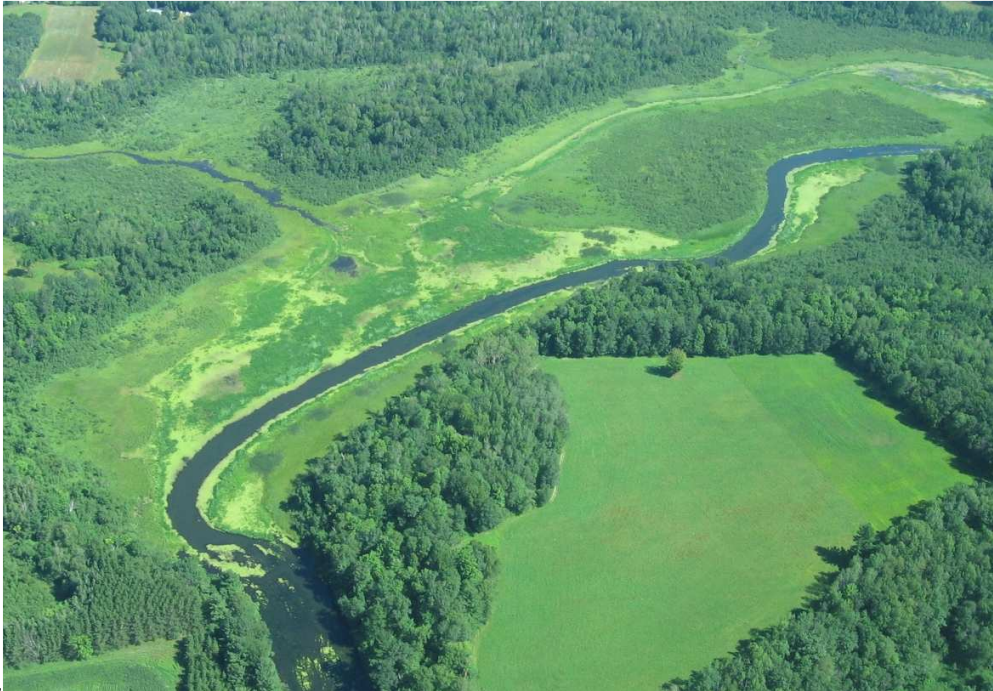
Figure 155. Apple River, West of CTY H, Polk County, 2008.

The Apple River is known to support rice in several locations, and likely more remain to be discovered. Primary areas include the area just below White Ash Lake, at the junction with Fox Creek, and in the widening just west of CTY H, 3 miles north of HWY 8 (shown above). Another bed is present just north of HWY 8, at a site known as the Shiloh Flowage, but a failing dam at this site is slated to be removed, and the rice will likely be lost when this occurs. Rice is likely to exist in any section of this river with suitable habitat. Watch status on most of the river is medium, primarily to better document rice presence over additional sections of the river, and high on the Shiloh Flowage due to likely loss.

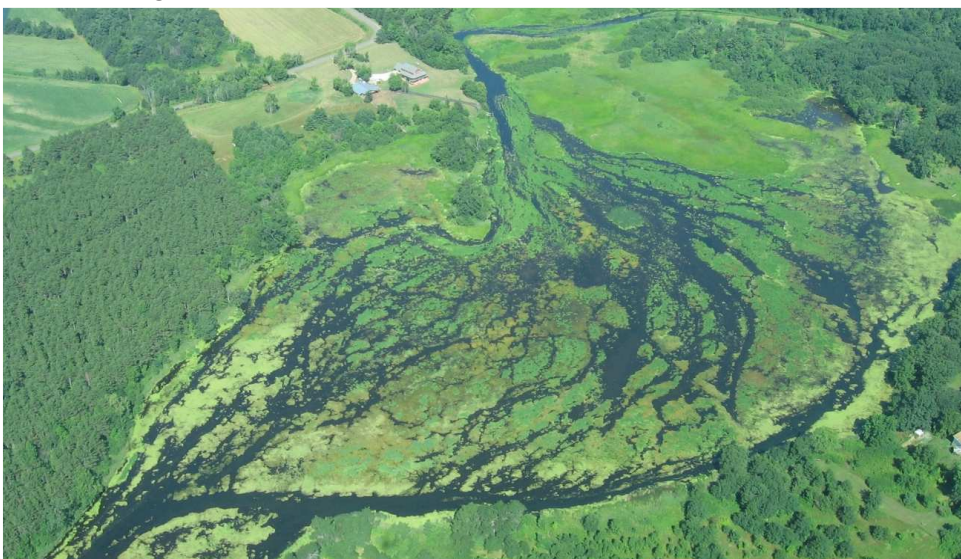
Figure 156. Apple River Flowage, Polk County, 2008.

Rice is present on the very north end of the Apple River Flowage where the Apple River enters. This is a fairly large bed, and is likely important to wildlife, but is not easily accessed by ricers and so has not had a presence in harvest surveys. Small patches of rice may occur in other parts of the flowage, but they have not been documented to date. Watch status is medium high because annual abundance data is lacking.

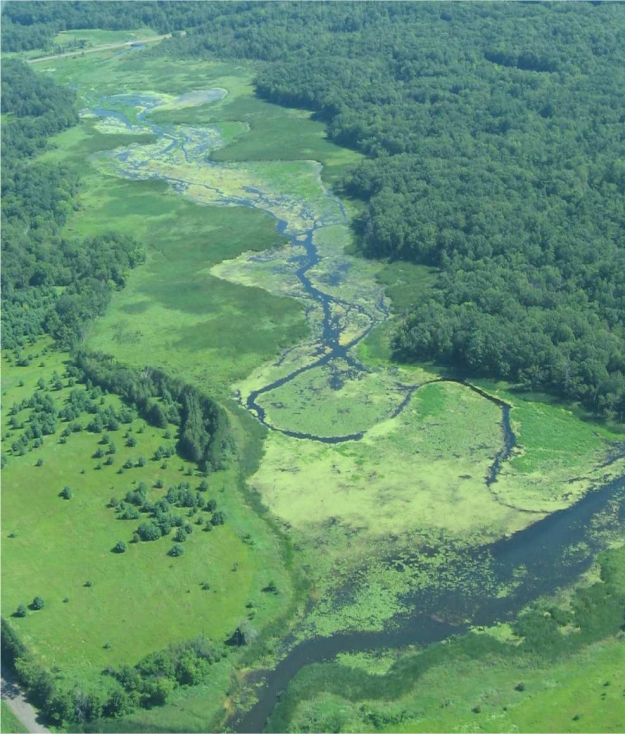
Figure157. Balsam Branch, Polk County, 2008.

Balsam Branch has long supported rice beds, and harvest on the site is date-regulated. While this stream runs from Balsam Lake to Wapogasset Lake and likely supports small rice beds in other sections, the only well documented presence is in the approximately mile-long section south of HWY 8 (shown above). There is also rice on Wapogasset Lake where Balsam Branch enters. Note that the very bright green in the photo above is not rice, but duckweed; the photo depicts a year with only fair abundance. Watch status is low because of site familiarity.

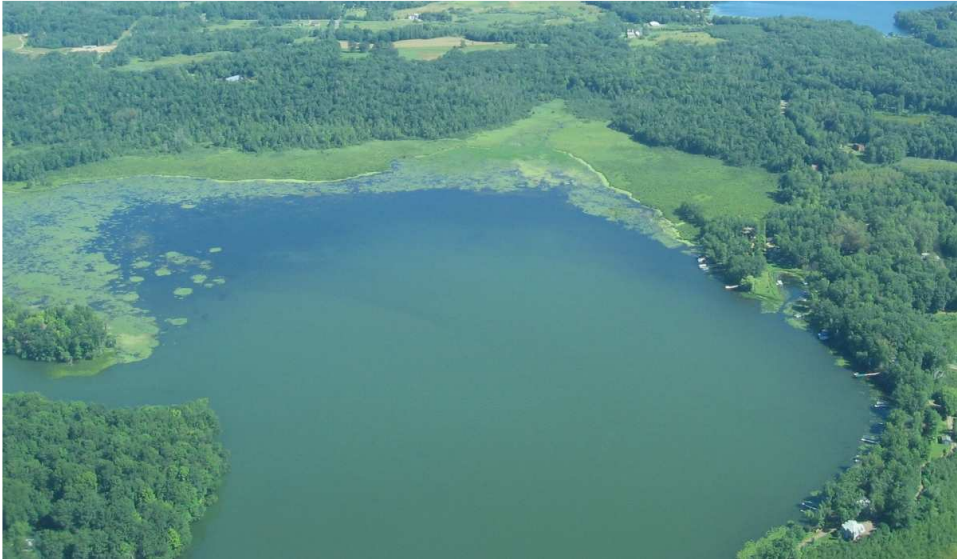
Figure158. Balsam Lake at Harder Creek ("The Stumps"), Polk County, 2008.

Balsam Lake is another site where the historical record suggests rice was once more abundant, but where remnant patches continue to exist. Ground crews confirmed the presence of patches in at least 2 locations: near the Harder Creek inlet (an area locally known as "The Stumps"; shown above) and near the Rice Creek inlet on the far northwest bay. Additional confirmation can be found in the Balsam Lake Sensitive Area Report, which can be linked from the Surface Water Viewer. Watch status is medium-low because of site familiarity.

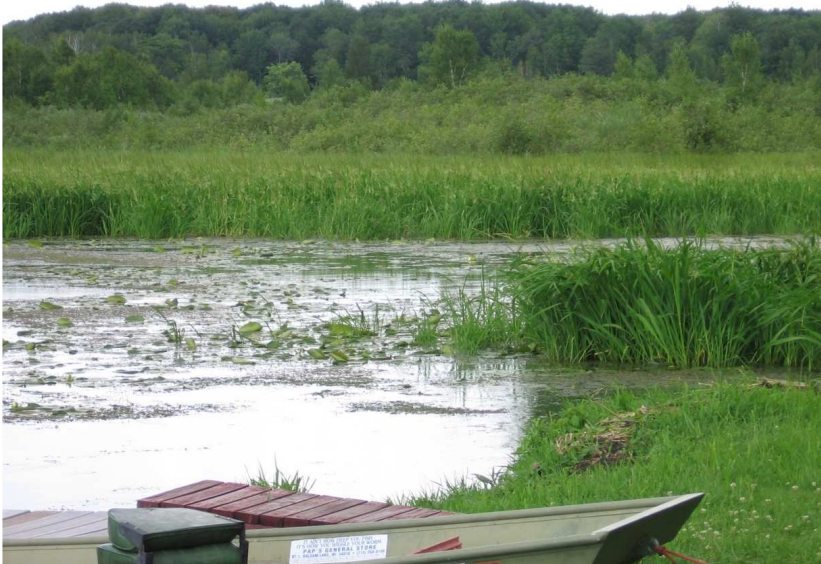
Figure 159. Big Blake Lake, North end, Polk County, 2008.

A small but robust stand of wild rice is located on the north end of Big Blake Lake, in the area where Lost Creek enters. A DNR Sensitive Area Report for the lake also reports rice being present on the southeast end, near the junction with Little Blake Lake, but we were not able to confirm that presence in recent surveys. The remainder of the lake is heavily

developed, and tends to drop off fairly quickly, and so would not be expected to support rice. Watch status is medium until additional annual abundance information is collected.

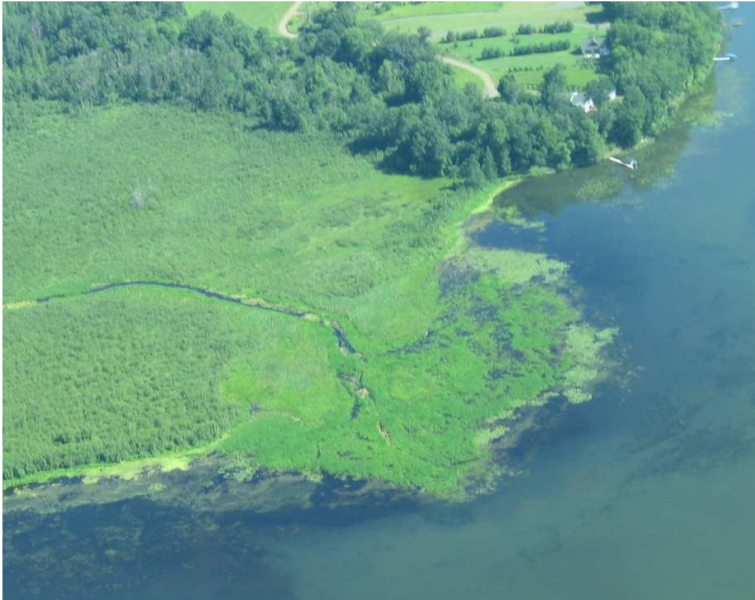
Figure 160. Big Round Lake at the mouth of the Straight River, Polk County, 2008.

Although small amounts of rice have been reported from areas along the west shore and near the outlet on the south end of the lake (see DNR Sensitive Area Report), the most significant rice bed on Big Round exists at the Straight River inlet, and extends up the river itself. This area (DNR Sensitive Area I) is shown in the photo. Harvest on this water is date-regulated, reflecting the long presence of this bed. This lake is of great interest to the St. Croix Tribe, whose reservation includes a parcel on this lake and who have been cooperatively managing this water. Watch status is medium-low due to site familiarity.

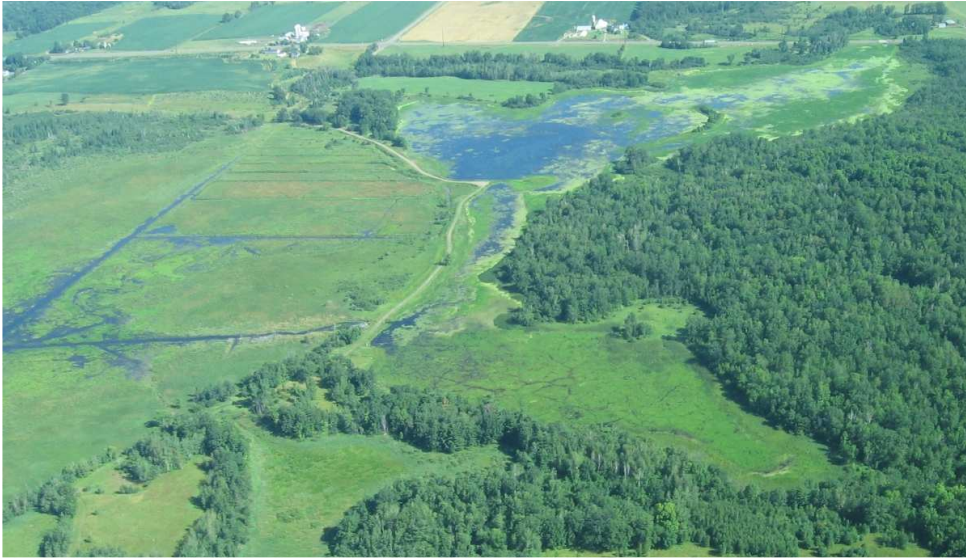
Figure162. Joel Flowage, Polk County, 2009.

The Joel Flowage is another cooperative seeding success story. The beds on this wildlife area have been very attractive to wildlife, and are increasingly being human harvested. Currently, the greatest amount of rice can be found on the flowage with the WBIC given above. However, there is now a second flowage (partially visible to the left in the photo above) where rice is also becoming established. This flowage is quite new, and is not yet recognized in the Surface Water Viewer, and does not even show up in the 2005 air photos available on the viewer. Watch status is medium due the apparent expansion of the existing beds.

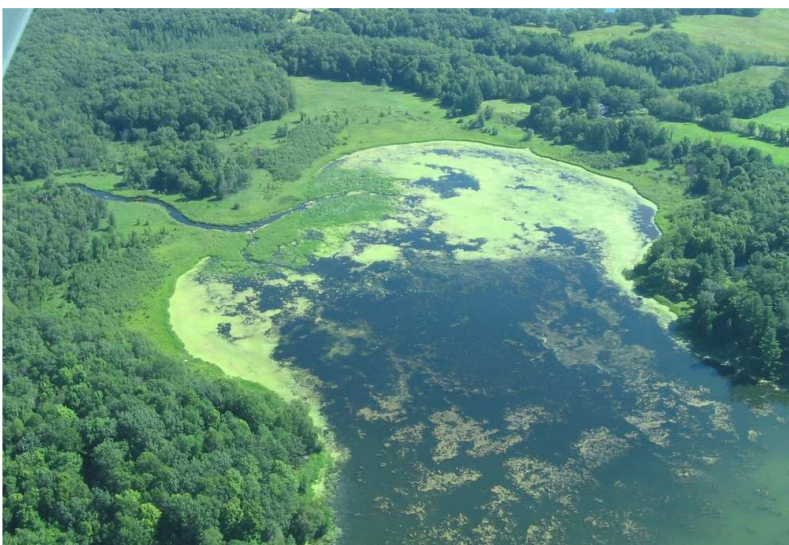
Figure 163. Little Blake Lake, North end, Polk County, 2008.

A delta of rice can be found at the north end of Little Blake Lake where the Straight Lake enters. GLIFWC surveys this lake infrequently, so it is not known how well the 2008 photo represents other years. A DNR Sensitive Area Report for the lake also indicates that rice is present on the southwest end of the lake near its junction with Big Blake Lake, but no rice was found in this area in 2008 or 2009. Watch status in medium-high because annual abundance information is lacking.

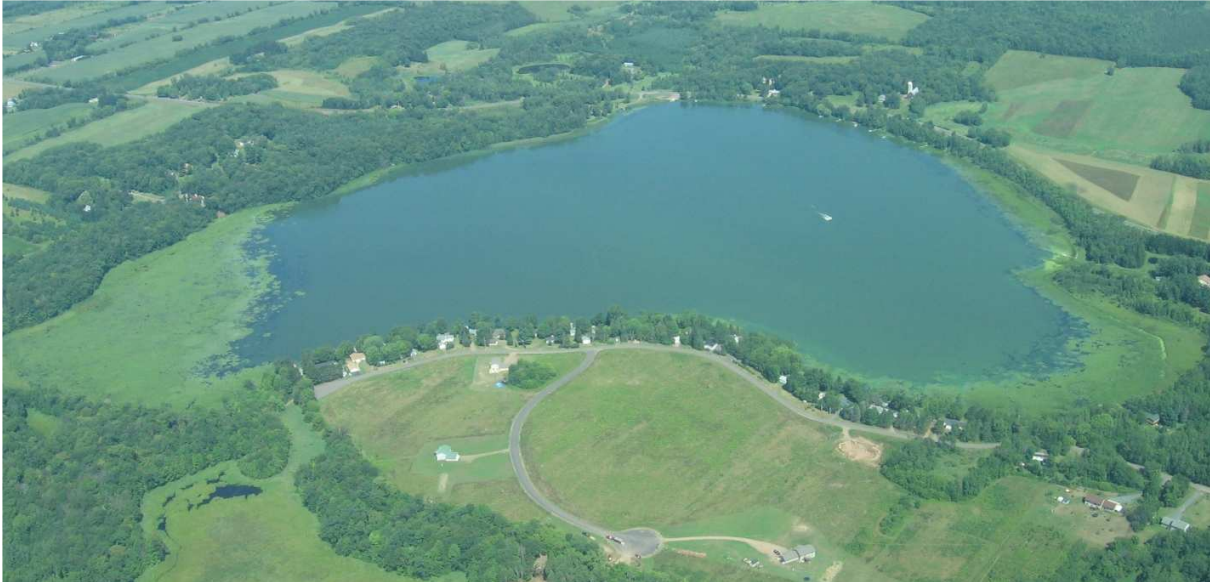
Figure164. Little Buttenut Lake, Polk County, 2006.

The photo of Little Butternut Lake shown above is not from a year with a particularly good rice crop, but the rice areas can be seen in along the northeast, southeast, and especially southwest bays. Harvest on this water is date-regulated, but has been fairly minor most years. Crop abundance also has not been particularly noteworthy in the last 10-15 years. Watch status is medium-low because of site familiarity.
