**Wisconsin
Ceded
Territory
Manoomin
Inventory
Ver. 1.0**

**GLIFWC
Project
Report
2010-01
March, 2010**

**Peter David
Wildlife
Biologist**

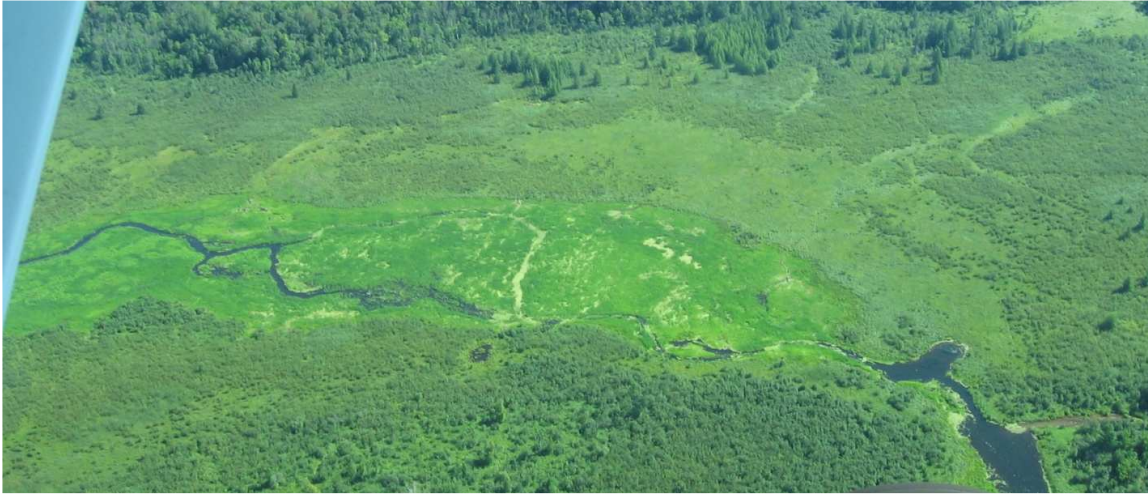
Figure 165. Rice Bed Creek, Polk County, 2008.

The only significant rice bed on Rice Bed Creek is on the wide spot shown above, which occurs in Rice Beds Creek State Wildlife Area. This bed begins about three-quarters of a mile above the junction of Rice Bed Creek and the Apple River. This site seems to be more heavily harvested than harvest surveys would suggest; I suspect this is because the relatively small number of people harvesting here don't care to disclose its location. Watch status is low because of site familiarity.

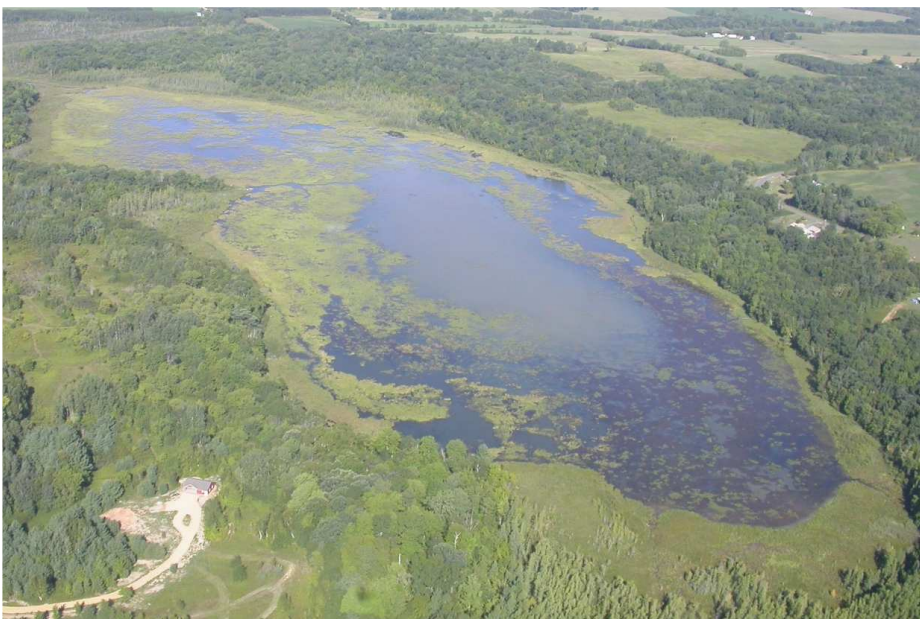
Figure 166. Rice Lake, Polk County, 2005.

This lake is capable of supporting rice over a significant portion of its surface; the photo above depicts only an average year. Theoretically, the harvest on this lake is date-regulated; however, there is no public access, and so this provision has essentially been disregarded. (It is my understanding that a private landing that once existed here has been closed; currently access must be gained through private land, or possibly by the outlet stream.) This has also limited the amount of harvest reported for this water. Watch status is medium-low because of site familiarity.

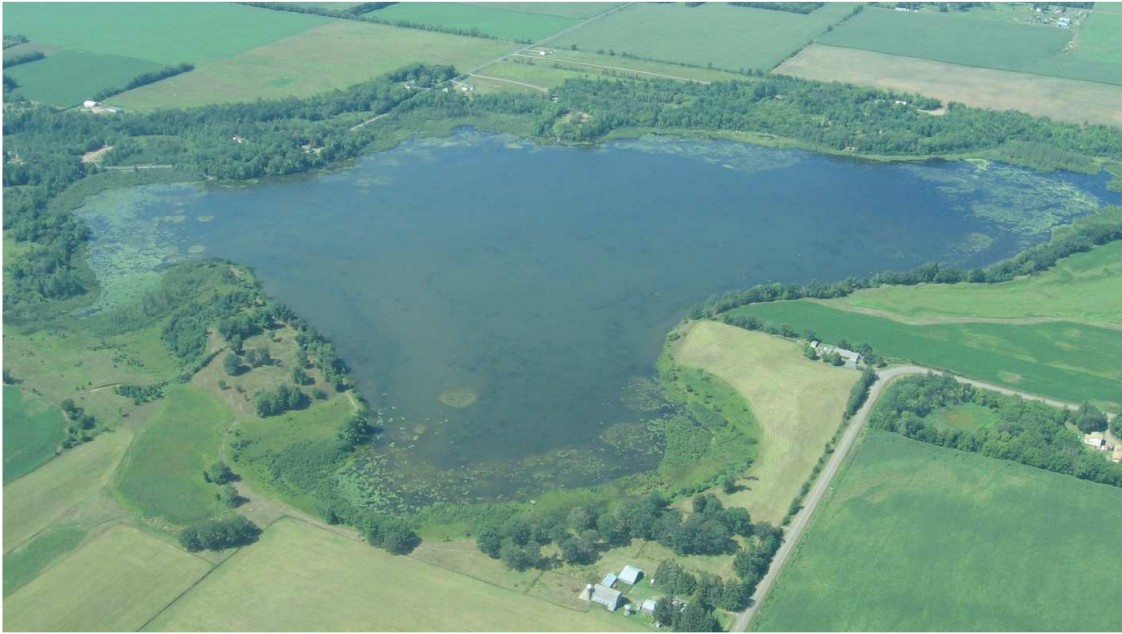
Figure 167. Rice Lake, Polk County, 2006.

Rice Lake could be the poster-child of rice loss in Wisconsin. This lake is also known locally as Glenton Lake (the name used in the list of date-regulated waters) or as Rice Lake at Milltown. Although historically an important rice water, the rice beds have been nearly destroyed from a variety of negative impacts, including sewage run-off. Currently, only tiny remnants of rice remain in scattered locations. A good history of this lake can be found in the document “Restoring Rice Lake at Milltown, Wisconsin”, DNR Technical Bulletin No. 186.

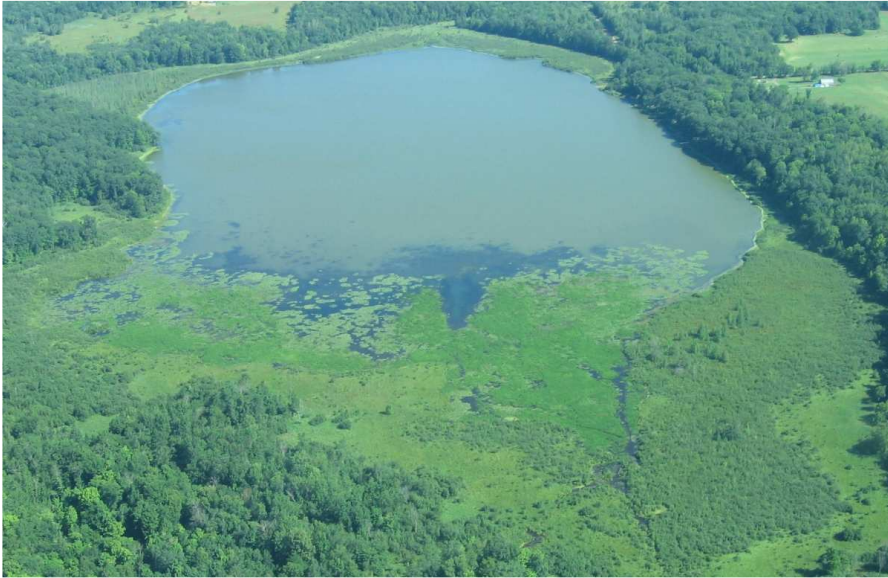
Figure 168. Somers Lake, Polk County, 2008.

GLIFWC only became aware of the rice on Somers Lake when it began appearing in harvest surveys in recent years. Much of the southern end of the lake, where Somers Creek enters, supports rice. This lake is relatively undeveloped, but much of the remainder of the lake is too deep to support beds, so recent air photos are thought to be reflective of typical distribution. Watch status is medium-low because of site familiarity.

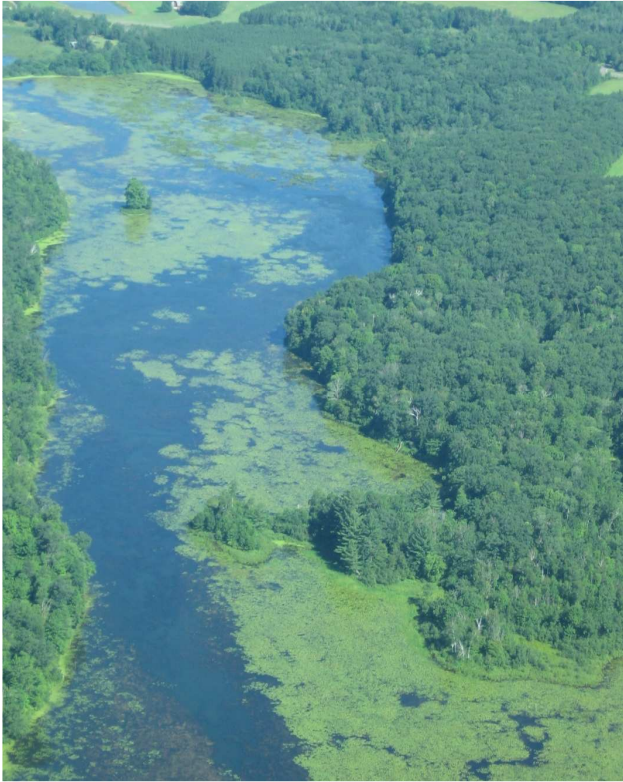
Figure 169. Straight River above Shilling Dam, Polk County, 2008.

Rice was found growing in several small patches on the Straight River between the Shilling Dam and HWY 48. These were located along the north shore, one near the south end of this section, the other just south of the narrow gap that occurs about half way between the dam and the highway. Rice also can be found above and below Big Round Lake. Watch status is medium because of limited annual abundance information, and the likelihood that beds exist in other locations.

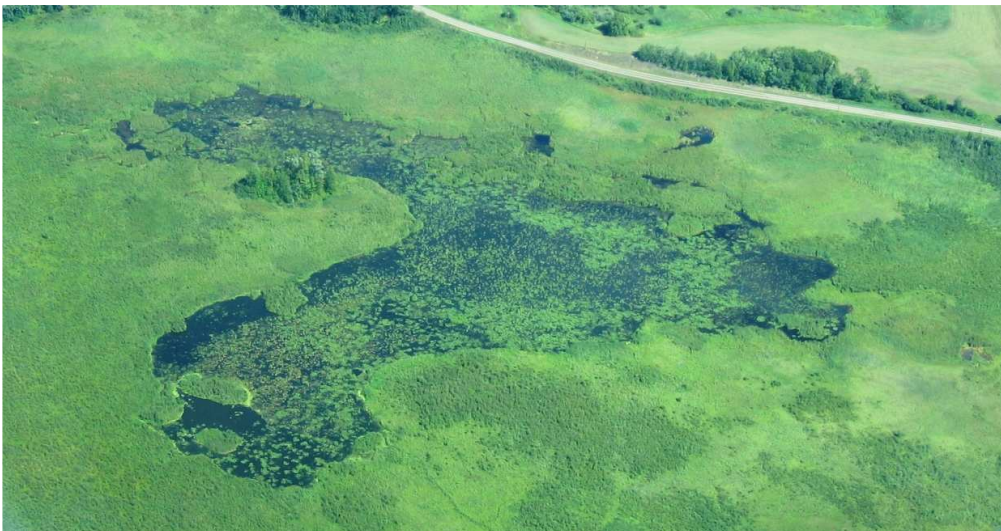
Figure170. Unnamed (Rice) Lake, near Frederick, Polk County, 2007.

This site shows up as Rice Lake on some maps, and is listed as Rice Lake (Frederick) in GLIFWC files, but is unnamed on the Surface Water Viewer. This small body of water can be covered with rice in a boom year, and have very little other

years. It has frequently supported families of trumpeter swans. Because it is a small bed on private land, it is not thought to be important to harvesters, but it would also be difficult to differentiate harvest reported for this site from harvest reported for the other Rice Lakes in Polk County. Watch status is low because of site familiarity.

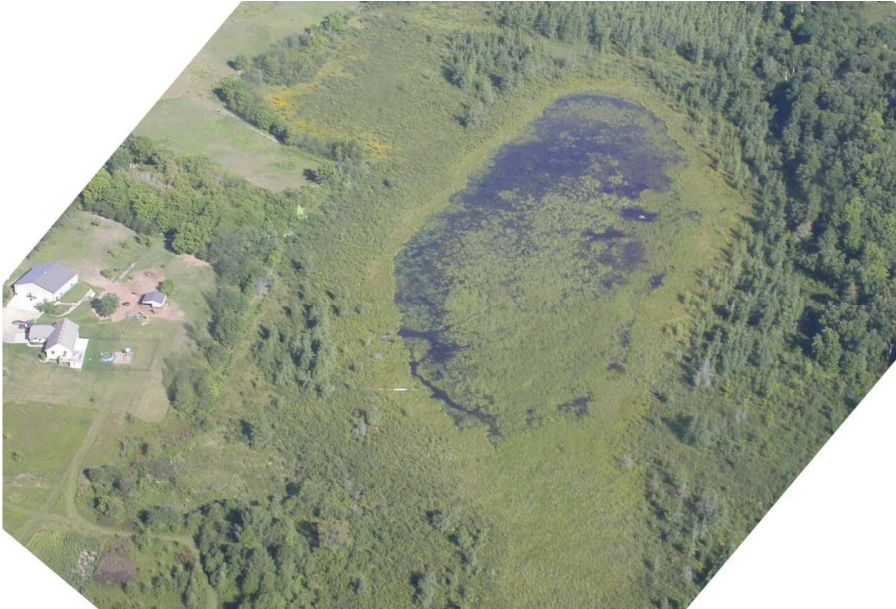
Figure 171. Unnamed Pond near Paulson, Polk County, 2005.

GLIFWC became aware of this site several years ago when it was reported by DNR employee Mary Greisbach. This small, private pond is located northeast of a bend in Church Road. It appears to be capable of supporting rice over a significant portion of its surface in some years, and is interesting because it seems to be lacking an appreciable outlet. Watch status is medium low.

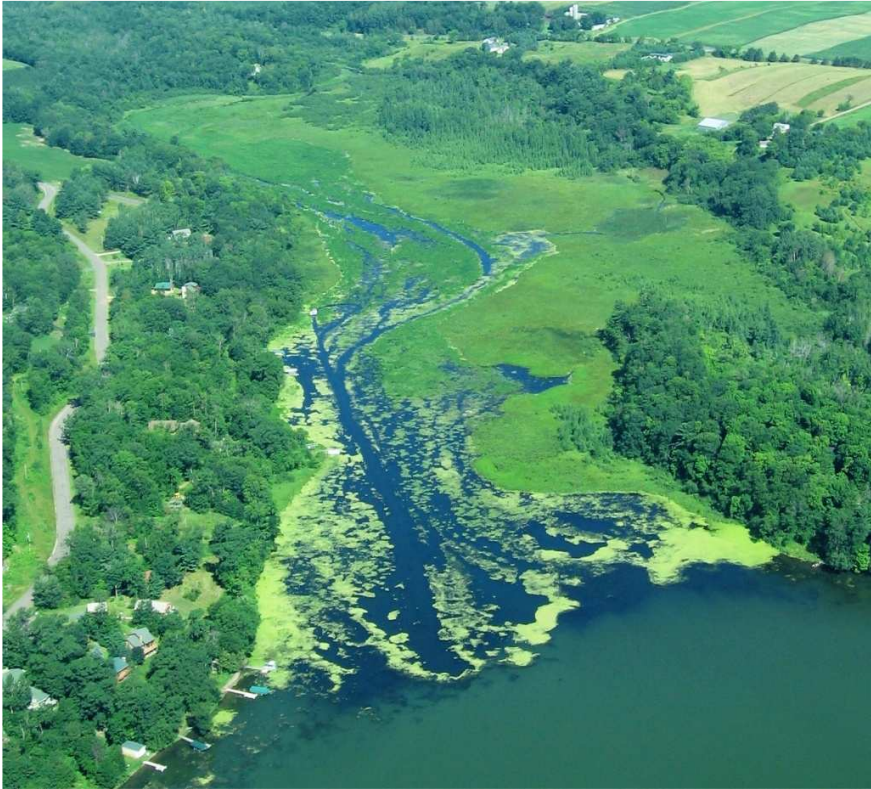
Figure 172. Wapogasset Lake, North end, Polk County, 2008.

A substantial bed of rice can be found on Wapogasset Lake, on the northwest bay where Balsam Branch enters. This bed regularly receives some negative impact from boaters who appear to enlarge certain channels through the bed, but the damage thus far has not had significant long-term effects. Harvest has been reported for this bed only occasionally. Rice is not known to exist in other areas on this large lake. Watch status is medium because of limited annual abundance information.

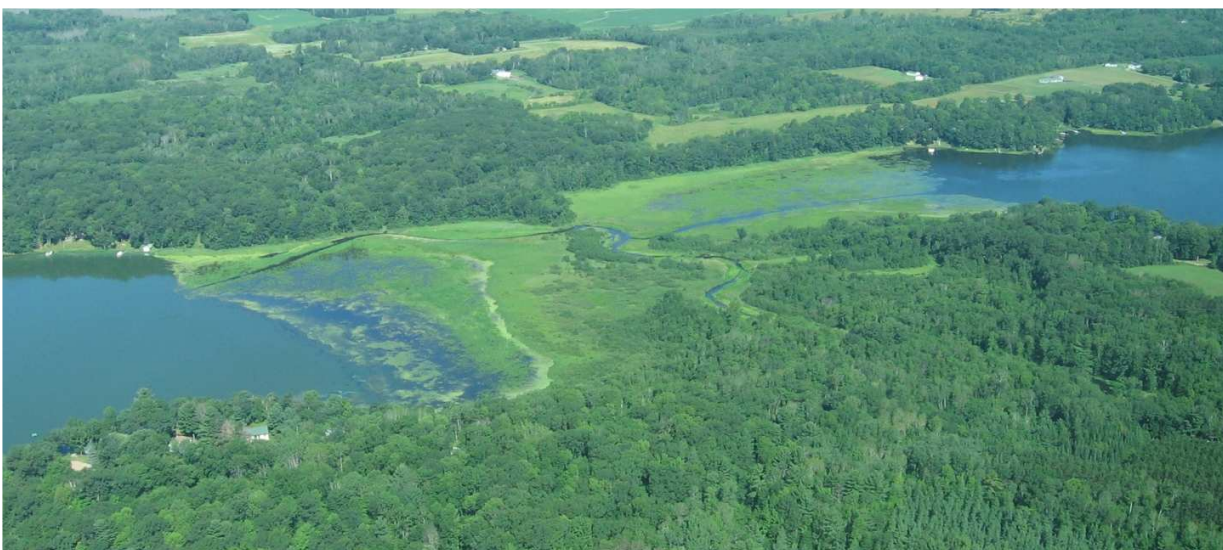
Figure 173. White Ash and North White Ash Lakes, Polk County, 2008.

This is another location where there is some confusion regarding naming. The photo above shows a narrows between 2 lakes; the 2 lakes are sometimes collectively referred to as White Ash Lake, sometimes as White Ash and North White Ash. The Surface Water Viewer uses the latter approach and assigns each lobe a WBIC code. Rice occurs on each lobe, as seen in the photo above. There is also rice at the outlet on White Ash Lake, on the Apple River, but only a minimal presence on other parts of the lake(s). The rice on these lakes is very robust, and may represent one of the northernmost stands of the southern species in the state. A mechanical weed harvester operates on these lakes; its operation may need to be monitored to ensure minimal impacts to the rice.

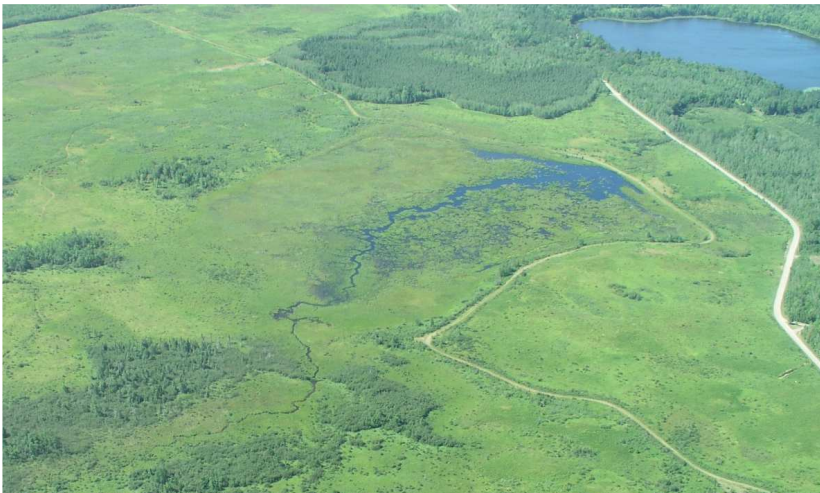
Figure174. Beaver Creek Flowage, Price County, 2007.

This site was previously listed as the Skunk Creek Flowage, based on misinformation about the name of the small creek which creates this waterbody. Located on the Kimberly-Clark Wildlife Area, this site was seeded by the DNR with GLIFWC cooperation. This bed now appears to be well established, enhancing the area significantly for wildlife. Watch status is medium because annual abundance data is limited.

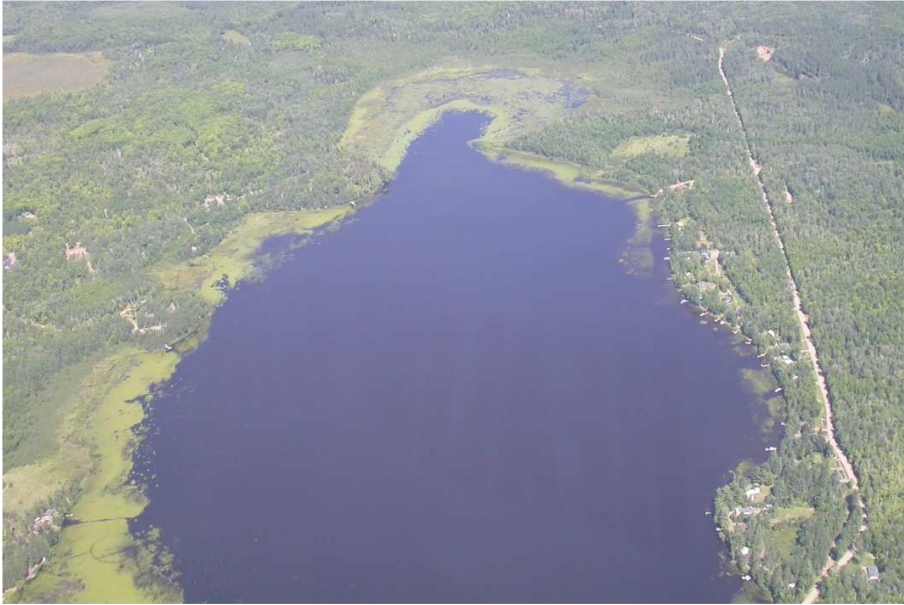
Figure175. Blockhouse Lake, Price County, 2005.

Blockhouse Lake is another site that is rather puzzling. This lake once supported fairly significant beds, occurring primarily in the north bay and in several stands along the west shore. In the last 20 years, however, rice production has been very poor to non-existent. Reasons for this decline are not clear, but may have to do with how lake levels are regulated on the outlet dam. Another possible concern that has been raised is that the timing of the decline seemed to be associated with the installation of a winter aerator; rice seed needs a period of low oxygen conditions to break dormancy, and perhaps the aerator is preventing that from occurring. This is another site which should be identified as a high priority for restoration efforts. Despite the lack of a recent rice presence, this water body should continue to be considered a rice water at this time, but with a medium-high watch status.

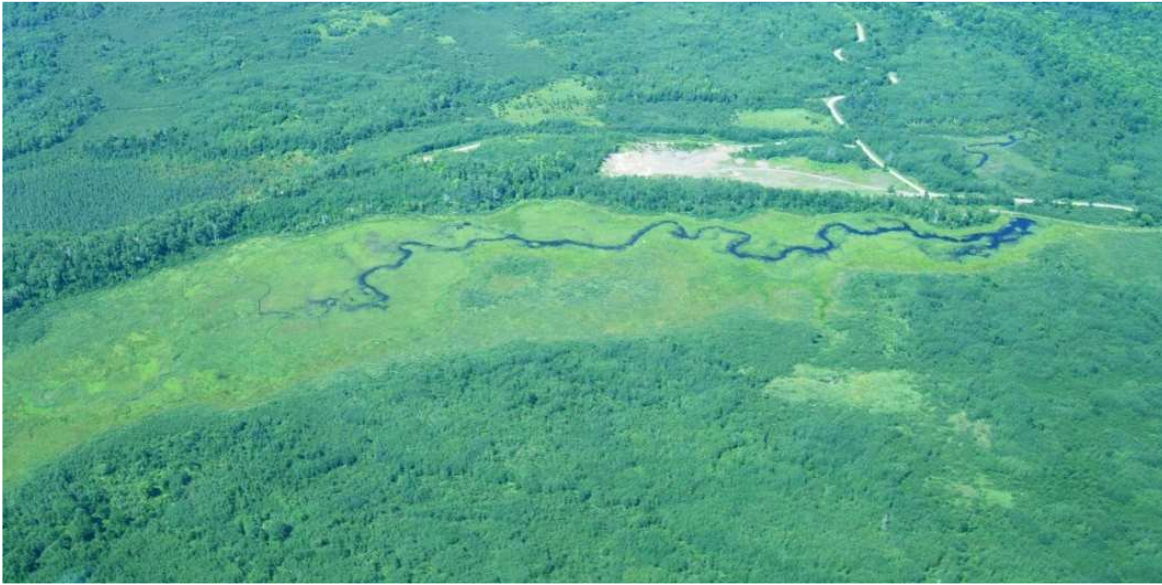
Figure177. Lower Steve Creek Flowage, Price County, 2008.

This flowage, located just a mile north of the Taylor County line, is surrounded by Price County Forest property. Seeding at this location has been very successful, with the flowage at its capacity for rice. Harvesters are utilizing this site more in recent years, but occasionally seed production seems to be negatively impacted by disease outbreaks, especially Brown Spot. Watch status is low because of site familiarity.

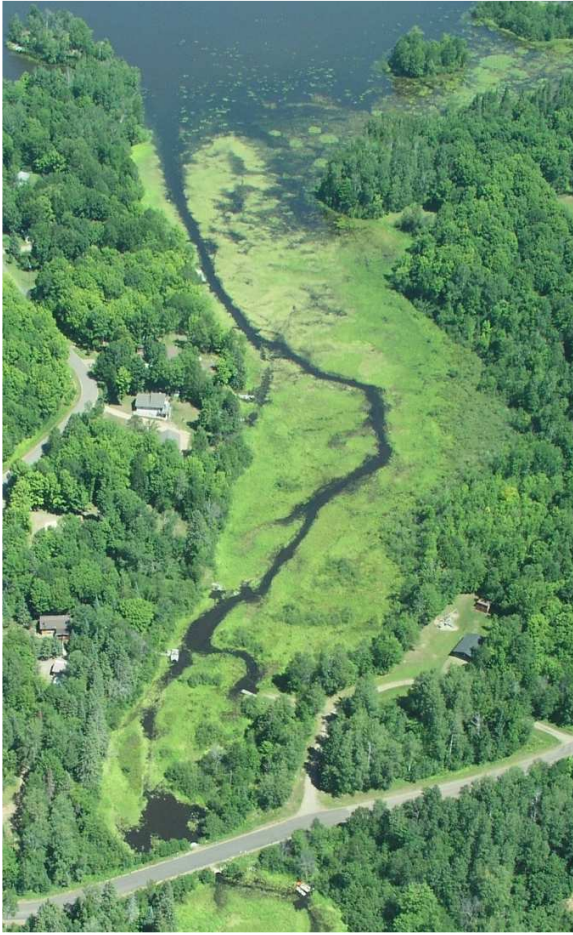
Figure 178. Musser Lake at Musser Creek Inlet, Price County, 2008.

The rice beds on Musser Lake appear to be limited to the areas near the inlets of Musser Creek (shown above) and Popple Creek (not shown). While some of the areas on the east end of the lake appear to have fairly suitable habitat, rice has not been reported there. Like many other State lakes, this one has had problems with invasive aquatic species, and will be important to try to ensure that control efforts do not negatively impact rice beds. Watch status is low because of site familiarity.

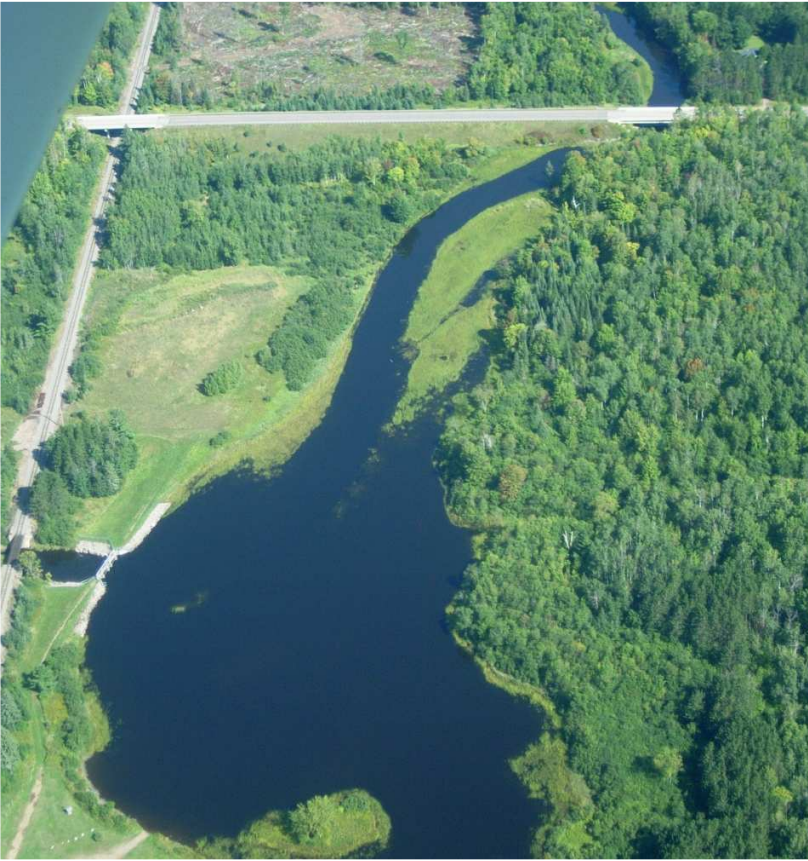
Figure179. Prentice Flowage, Price County, 2009.

This site is interesting in that it was found fortuitously in 2008. No other records had been reported, even though part of the bed is visible from HWY 8. It may be fairly new, but this is unknown. Nevertheless, the bed is fairly large and appears well established, though slightly small to be of interest to harvesters. Watch status is medium due to limited annual abundance information.

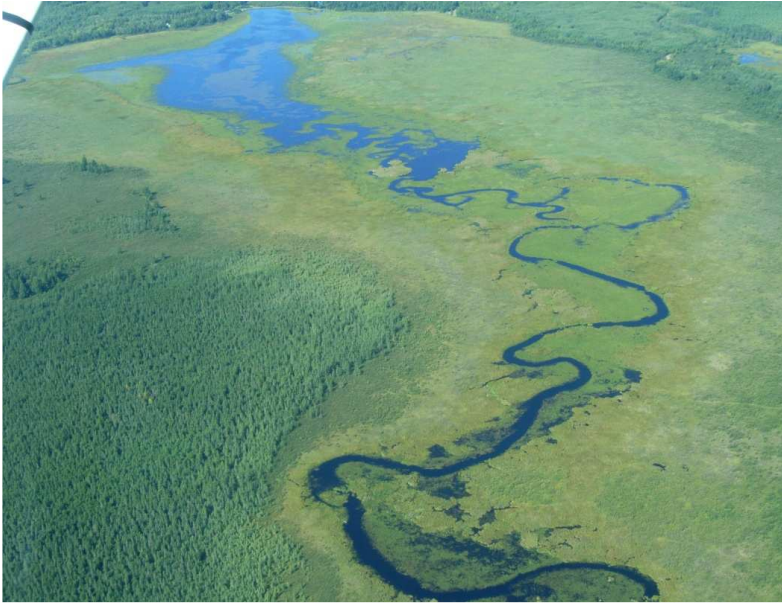
Figure182. Unnamed Flowage on the Jump River, Price County, 2009.

Although the bed on this flowage is quite large, GLIFWC did not become aware of its presence until 2004, when it was first flown over. Although this flowage is on the Surface Water Viewer, it apparently is new enough to not show up on some older maps. It is not well known to the public because it is entirely enclosed within a private parcel. GLIFWC has not been able to survey this site from the ground, but the bed is large enough to be identifiable from the air, and I have spoken to an individual who has harvested at this site. It is now know as the Jump River Flowage in GLIFWC files. Watch status is medium-high due to the limited annual abundance information.

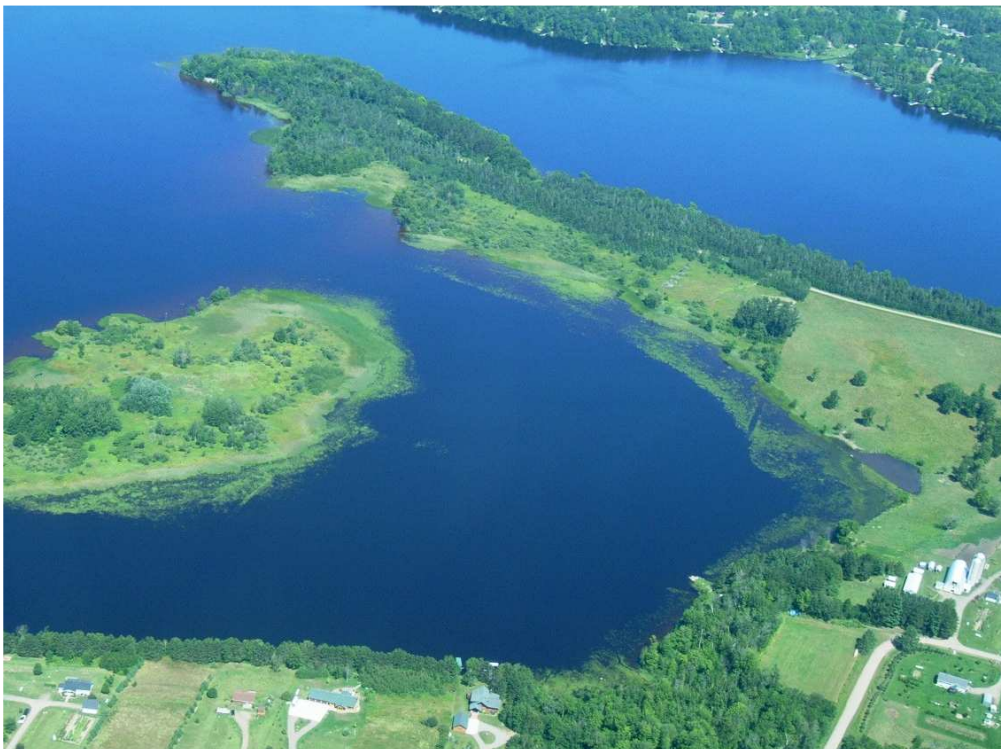
Figure184. Dairyland Reservoir, Rusk County, 2008.

The primary rice beds on the Dairyland Reservoir are in the bay east of Bunyon's Hat Island (shown above). Smaller beds can also be found near the shores in the vicinity of the CTY I Bridge further upstream (east). This flowage went through a major drawdown in 2007, and the vegetative community is likely still responding to that event. It may be interesting to monitor this lake in future years to see if any changes in rice abundance occur. Watch status is medium-high because annual abundance data is lacking.

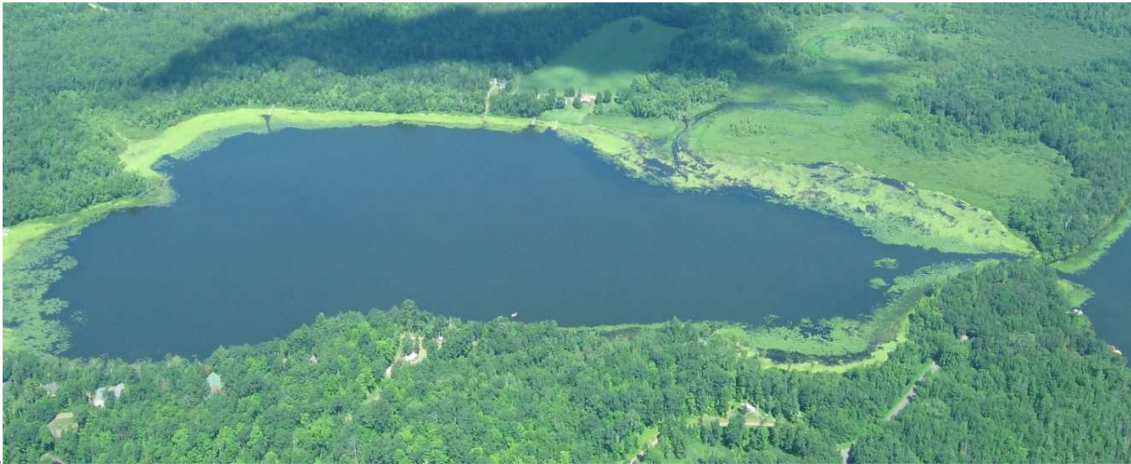
Figure185. Fireside Lakes, Rusk County, 2008.

The Fireside Lakes are 2 water bodies joined by a small narrows; they go by a single name, but have two WBIC codes. Rice can be found in fair abundance on the smaller, southwestern lobe shown in the photo. Although the bands are not very wide or dense and do not show up well in air photos, much of this lobe is ringed with rice, with the densest beds occurring where Swift Creek enters the north. Ground crews also found a scattering of individual plants on the north shore of the north lake in 2009, however, it is recommended that a greater abundance of rice is needed before this water body be considered a rice water. Watch status is medium-high because annual abundance information is limited.

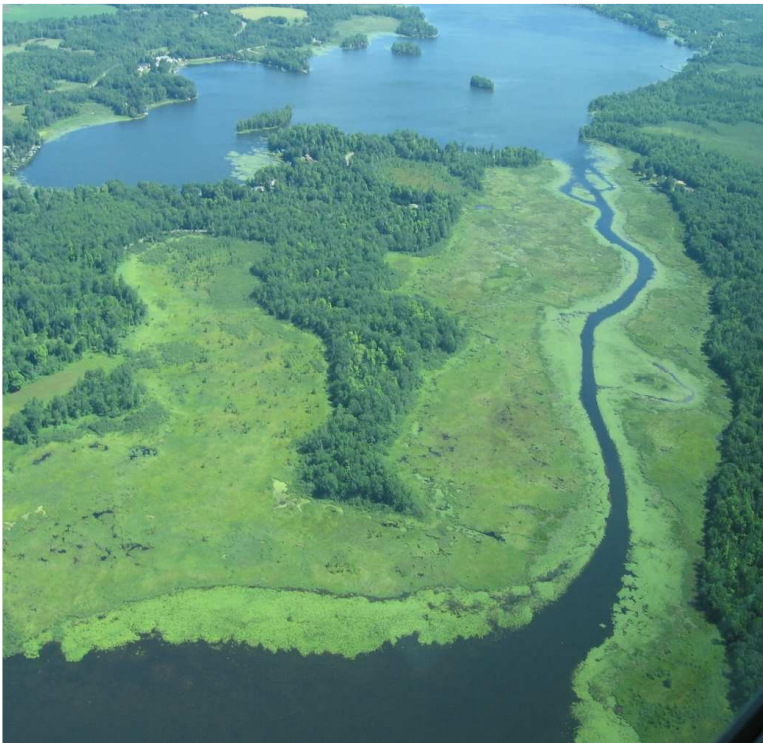
Figure186. Island Lake, Rusk County, 2008.

Rice can be found along the channel shown above, running between McCann Lake on the bottom of the photo, and Island Lake at the top. The Surface Water Viewer considers this area part of Island Lake. We are only aware of rice along this channel, not on other parts of Island Lake. Watch status is medium-high because annual abundance information is limited.

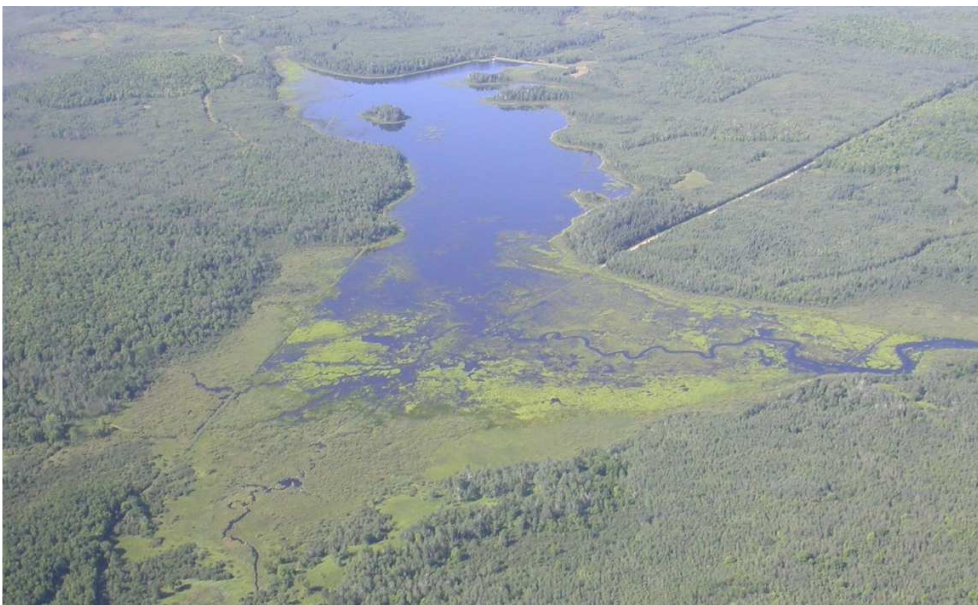
Figure 187. Lea Flowage, Rusk County, 2005.

Lea Flowage is known to support substantial rice beds some years, but it has not been regularly surveyed due to its relative remoteness from other sites. At the same time, that remoteness may increase the ecological value of having this bed on the landscape, and in 2005 a number of partners (including the DNR and GLIFWC) cooperated with the County, which owns the entire lakeshore, to rebuild the outlet structure and preserve this flowage. My impression is that more rice might grow here if water levels were held slightly lower, but this still remains an important site ecologically, and is utilized by harvesters as well. The largest beds are on the north end of the flowage. Watch status is medium-high because annual abundance information is limited.

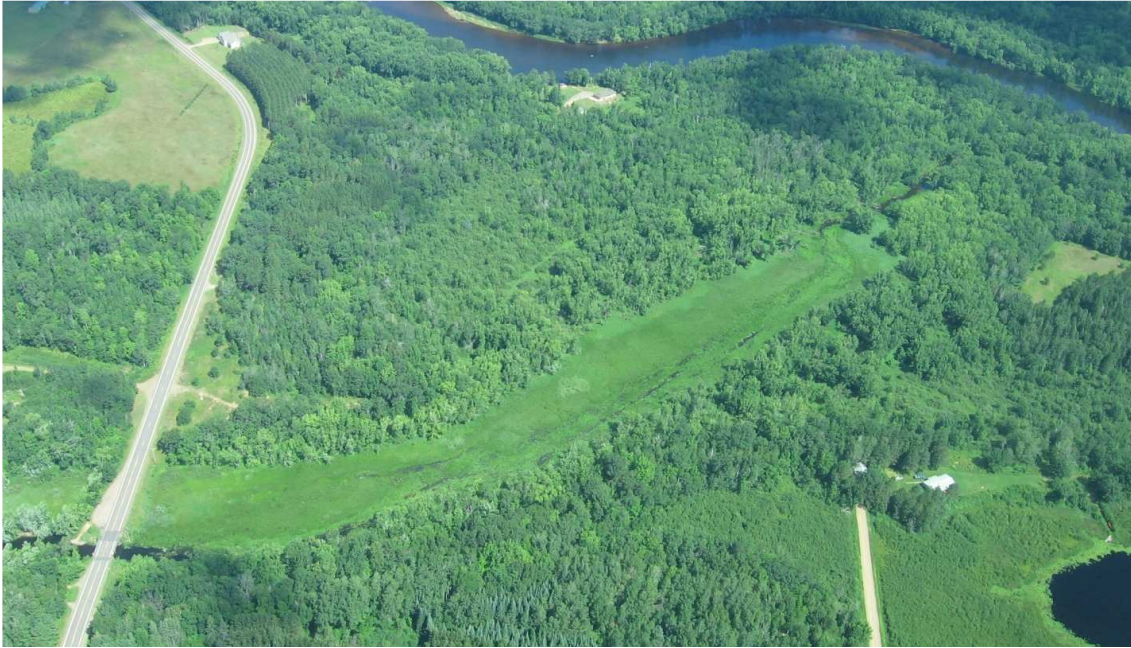
Figure 188. Rice Creek, Rusk County, 2008.

Not surprisingly, rice can be found on Rice Creek; it is particularly abundant between CTY D and the Chippewa River, but smaller amounts can also be found between CTY D and the Fireside Lakes to the west. This is one of the more robust stands in the area, but watch status is medium-high because annual abundance information is limited.

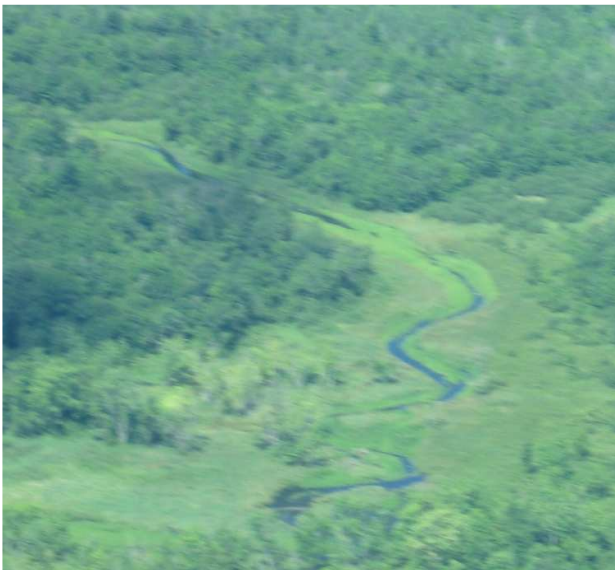
Figure189. Swift Creek, Rusk County, 2008.

Swift Creek is a fairly small creek that flows from Island Lake to the Fireside Lakes. It was not surveyed from the ground due to its small size and relative remoteness, but rice was observed growing on it during the 2008 air surveys in an area about a third of a mile upstream of the Fireside Lakes (poorly shown in the photo above). Rice may exist in other sections as well, but this has not been documented. Watch status is medium-high because annual abundance information is limited.

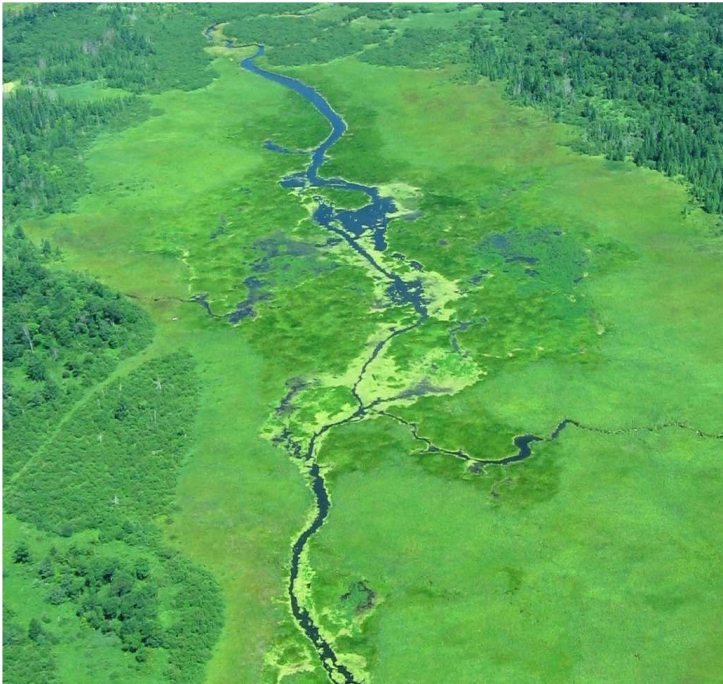
Figure 190. Ten Mile Creek, Rusk County, 2008.

Although GLIFWC records related to this site are limited, this bed apparently has existed for a long time; the road to the east is Rice Bed Road, and the area surrounding the bed is a State Wildlife Area. The bed is located about three-quarters of a mile north of CTY D, and three-quarters of a mile east of the west county line. This site is important to waterfowl and waterfowl hunters. Watch status is medium-high because annual abundance information is limited.

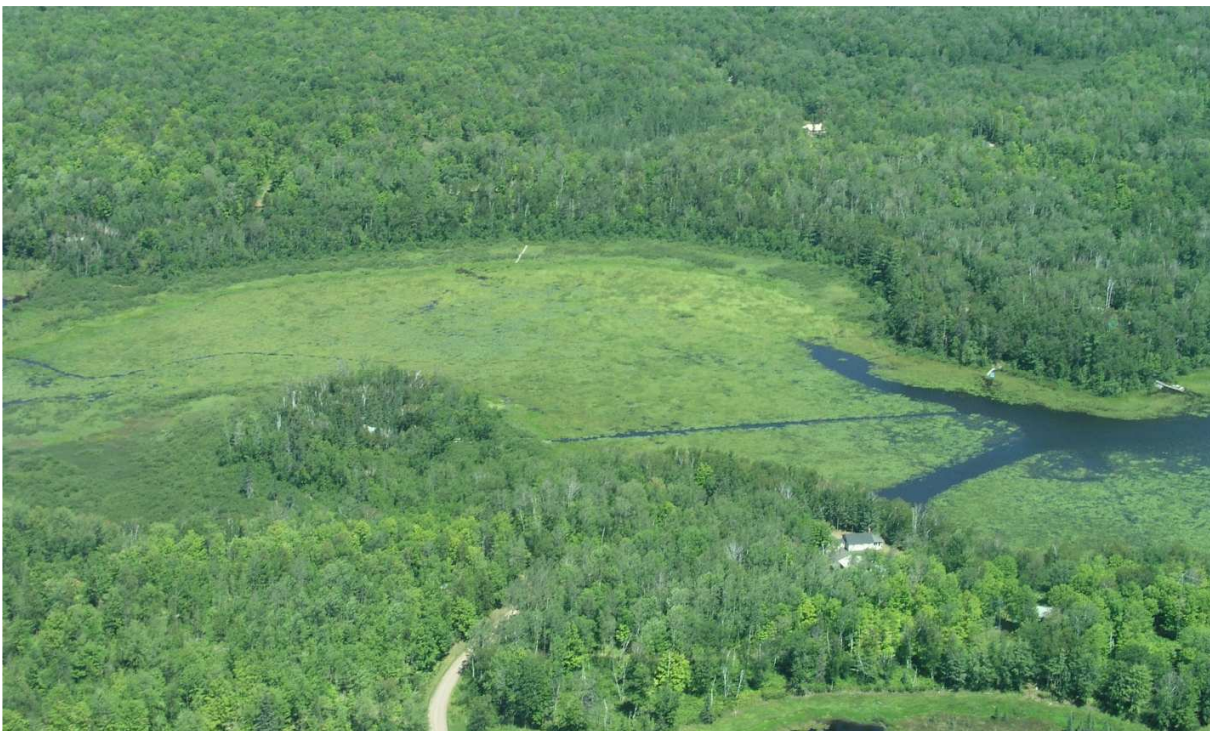
Figure 191. Barker Lake, NW bay, Sawyer County, 2007.

Barker Lake is one of several lakes on the East Fork of the Chippewa River. The biggest bed (shown above) is on the large bay on the far west side of the lake, where an unnamed creek enters from the west. Rice was also found in smaller amounts on the east end of the lake. While this bed seems to regularly receive some negative impacts from local boaters, the damage so far does not appear to have long-term significance. Harvest is reported with some regularity on Barker, but usually in modest amounts. Watch status is low because of site familiarity.

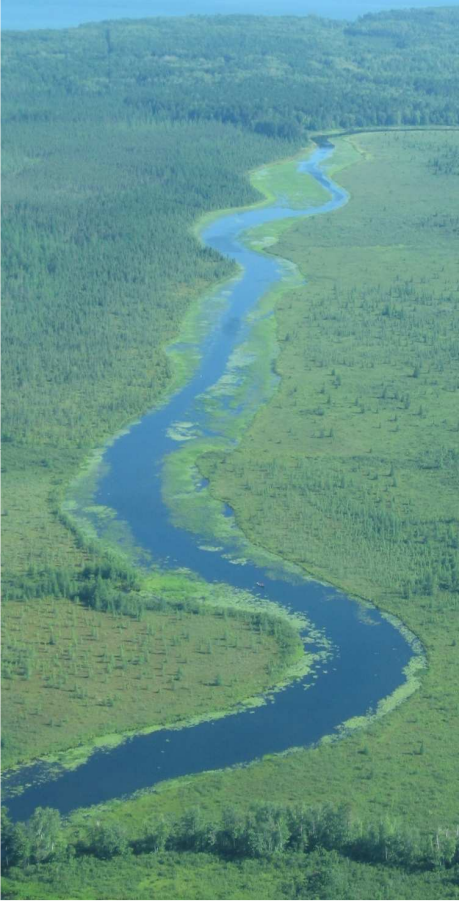
Figure 192. Billy Boy Flowage, Sawyer County, 2008.

The Billy Boy is a linear flowage located on the Lac Courte Oreilles Reservation. This water is protected and managed by the LCO Tribe. The best beds are on the north end of this undeveloped flowage. Although this bed likely is harvested, it does not turn up in harvest surveys because it is an on-reservation water. Watch status is low because of site familiarity.

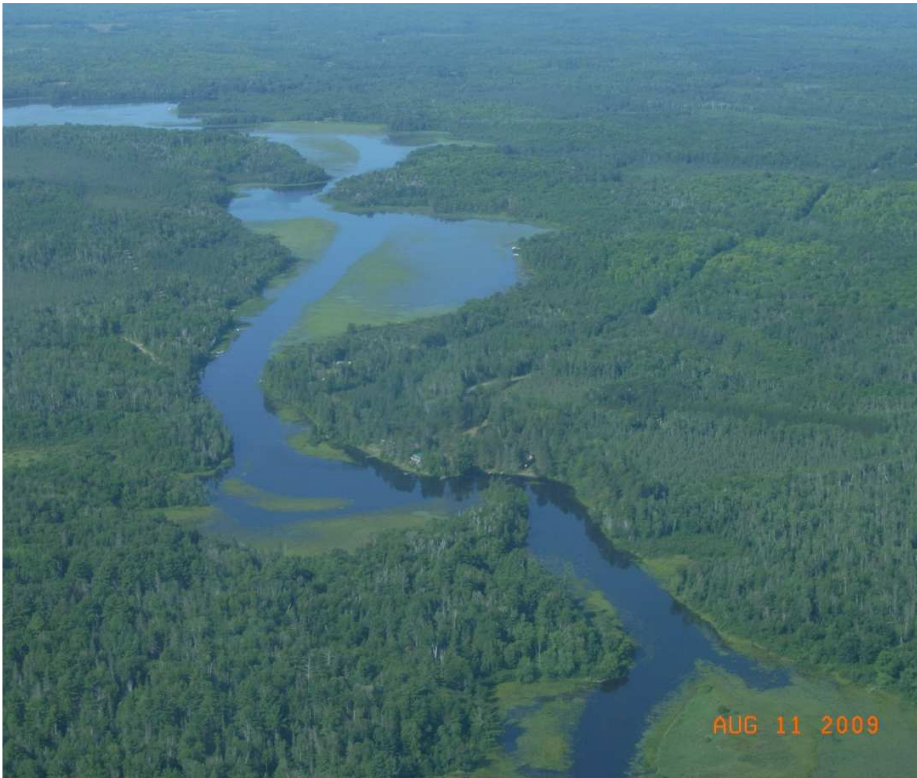
Figure 193. Blaisdell Lake, Sawyer County, 2008.

Blaisdell Lake is a widening of the East Fork of the Chippewa River. In years of high abundance rice can be found over much of the flowage, though density is not usually particularly high. Blaisdell is unusual in that it is one of the first beds in the state to mature, with some seed dropping weeks before other locations. It is not known if this is due to unusual genetics, site conditions, or both, but some have hypothesized that the general northeast-to-southwest orientation of the flowage may play a role by maximizing exposure to the sun during the warmest part of the day.

Although stands are sometimes harvestable, picking pressure tends to be light, as much of the seed has dropped before the typical harvest season is underway. Watch status is low because of site familiarity.

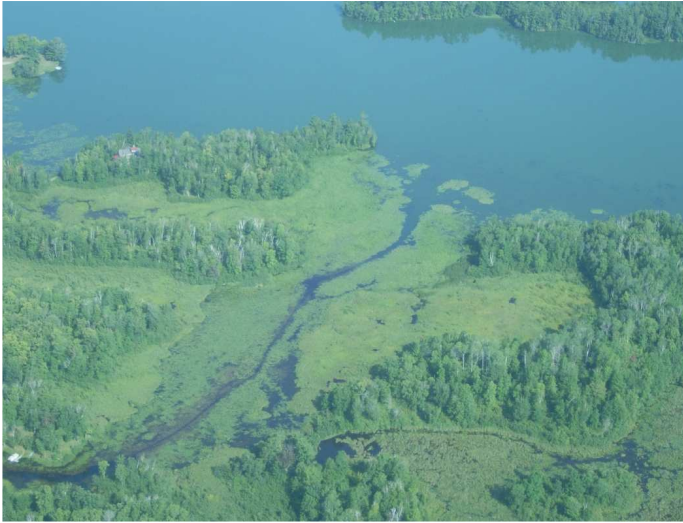
Figure 194. Lake Chetac at Unnamed Creek, Sawyer, 2009.

The primary rice beds on Lake Chetac are found on Bullpen Bay on the southeast side of the lake where several creeks enter. The Surface Water Viewer considers most of the area shown above as part of Lake Chetac; the WBIC for the unnamed creek which enters here is 2113400. Rice can also be found on Chetac proper at the mouths of Knuteson Creek and Malviney Creek just north of this site, as well as on those creeks themselves, and in a small bed on the very south end of the lake. Watch status is medium high because annual abundance data is limited.

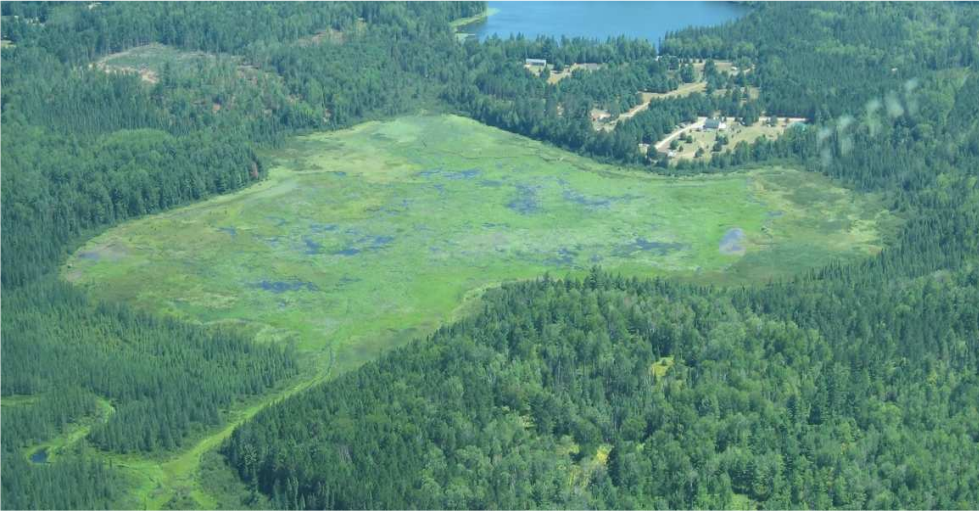
Figure 222. Frost Lake, Vilas County, 2007.

Frost Lake has a long history of supporting rice, and harvest on the site is date-regulated. However, the bed tends to be very mixed with other vegetation, and access to the lake is primarily through private property, so reported harvest has been fairly small. This is a great wildlife lake, capable of supporting rice across much of its surface. Watch status is low because of site familiarity.

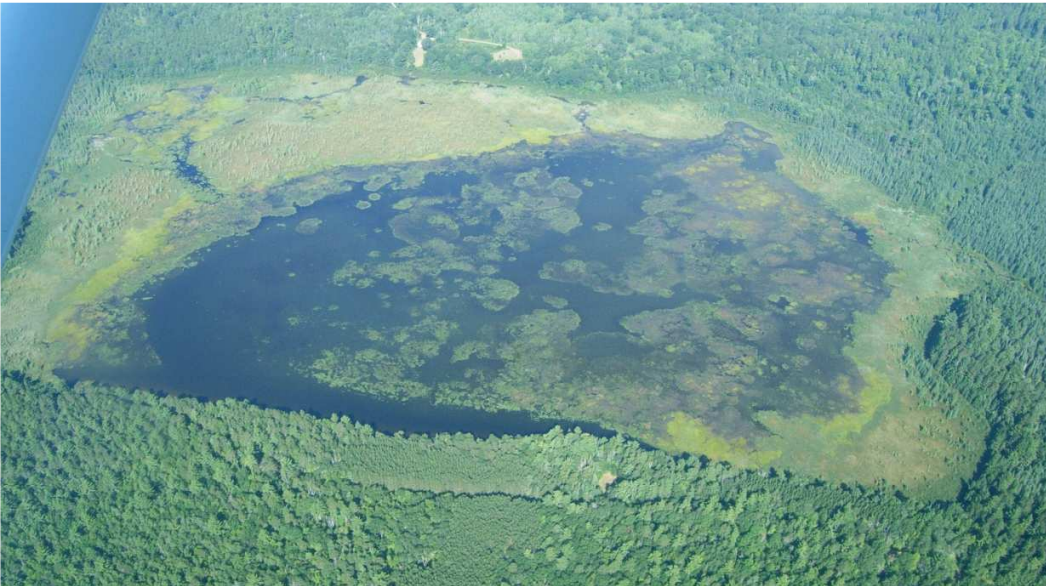
Figure 223. Grassy Lake, Vilas County, 2009.

DNR Wildlife Manager Ron Eckstein reported seeding this lake in recent years, but it is not clear at this time if this effort has produced a self-sustaining bed. Recommend keeping on the list of recognized rice waters at this time, under a medium-high watch status until better confirmation is established.

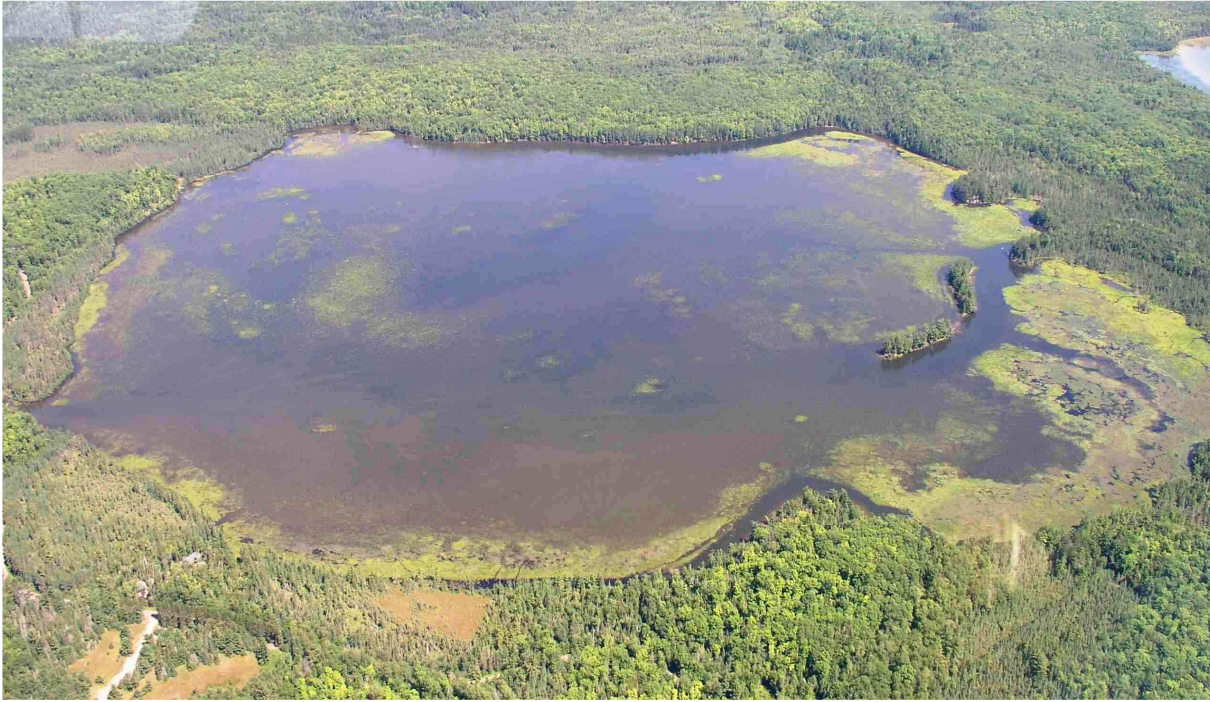
Figure 224. Irving Lake, Vilas County, 2003.

Irving Lake is an important rice water, whose harvest is date-regulated. In rare years rice covers a significant portion of the lake, but dense beds are usually limited to some shoreline patches and the far east end. Some ricers like the large grain size it produces, but reports of smut are also above average for this lake. Irving has sometimes been accused by residents of Ballard Lake (just downstream) of causing occasional low oxygen conditions in that lake, but an investigation funded by the DNR did not support this contention. Watch status is low because of site familiarity.
