**Wisconsin
Ceded
Territory
Manoomin
Inventory
Ver. 1.0**

**GLIFWC
Project
Report
2010-01
March, 2010**

**Peter David
Wildlife
Biologist**

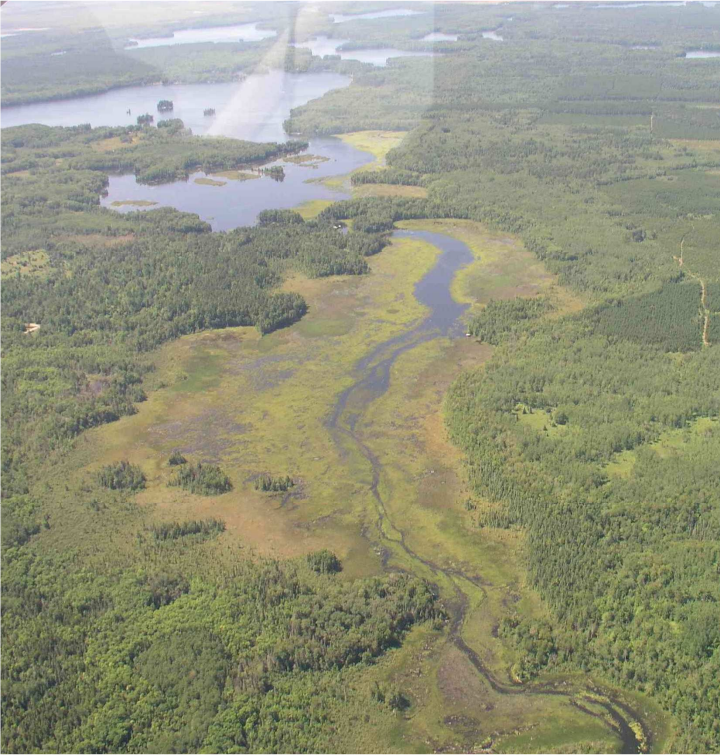
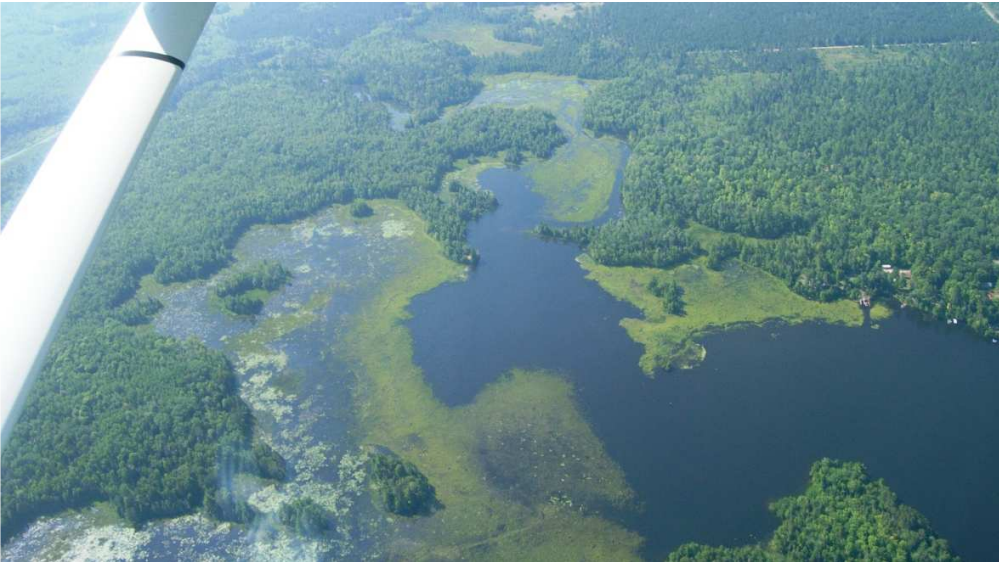
Figure 225. Island Lake, Unnamed Water Body, and Rice Creek, Vilas County, 2003.

Rice in this water system can be confusing to define. Large beds occur on the southeast portion of Island Lake. On the northeast end of the lake there are also substantial beds where Rice Creek enters. However, the Surface Water Viewer considers a separate waterbody to exist between the Creek and Island Lake; this is an unnamed site, with WBIC 5505819. Most of the northern rice is actually on this unnamed site or Rice Creek which flows into it, with very little on Island Lake proper.

These sites are important for harvesters, although harvest taken from the unnamed waterbody is currently being reported as coming from the creek or the lake. Sturgeon restoration efforts being considered that might alter operation of the Rest Lake Dam could influence water levels on this lake as well; close monitoring is suggested, but it is not thought that the dam operation changes currently being considered will be detrimental to rice. (Also see Rice Creek.) Watch status for both sites is low because of site familiarity.

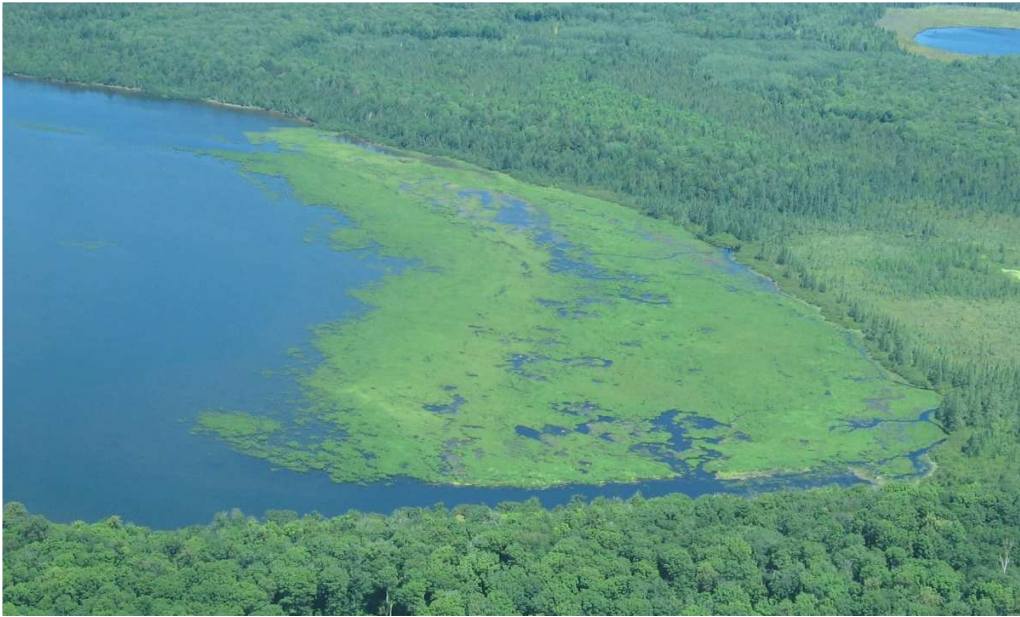
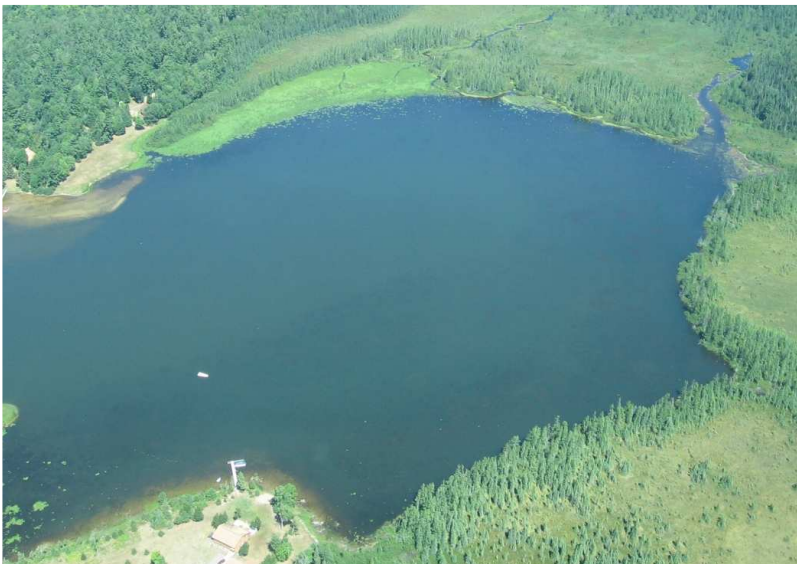
Figure 227. Lac Vieux Desert, Rice Bay, Vilas County, 2007.

Lac Vieux Desert (LVD) is located on the Wisconsin/Michigan border. Historically, rice reportedly grew in some areas on the Wisconsin side of the lake, but it is currently limited to a large bed in Rice Bay, and a smaller bed in Misery Bay, both located on the Michigan side of the lake. The Rice Bay beds represent the largest rice beds in Michigan's Upper

Although rice is currently found only on the Michigan side of the lake, it is worth listing here because LVD is the headwaters of the Wisconsin River, and the operation of the dam, located on the Wisconsin side, drives the amount of rice present on the lake. Management of the dam is controlled under a FERC license, and recent modifications to the license have been responsible to the recovery of the Rice Bay beds, which had largely disappeared in the 1950s due to high water. Invasive control efforts on the Wisconsin side could also potentially impact the entire lake. Watch status is high because water level management on this site is still potentially subject to change pending the success of on-going restoration efforts.

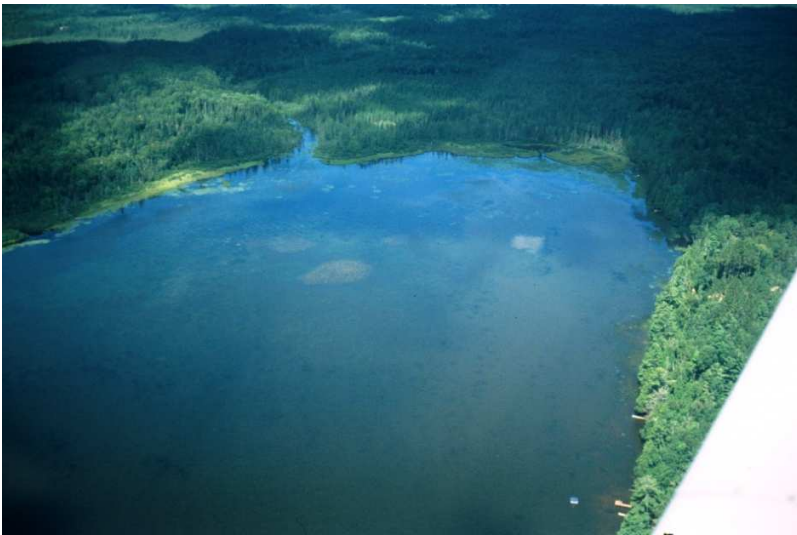
Figure 229. Little Portage Lake, Vilas County, 2000.

Although this bed is known to have existed for a long time, GLIFWC has surveyed Little Portage Lake only infrequently. The bed appears to be limited to the north bay of the lake, but data is lacking to determine how extensive this bed might be in a good year. Limited anecdotal information suggests this location might be in decline. Watch status is medium-high due to a lack of annual abundance information

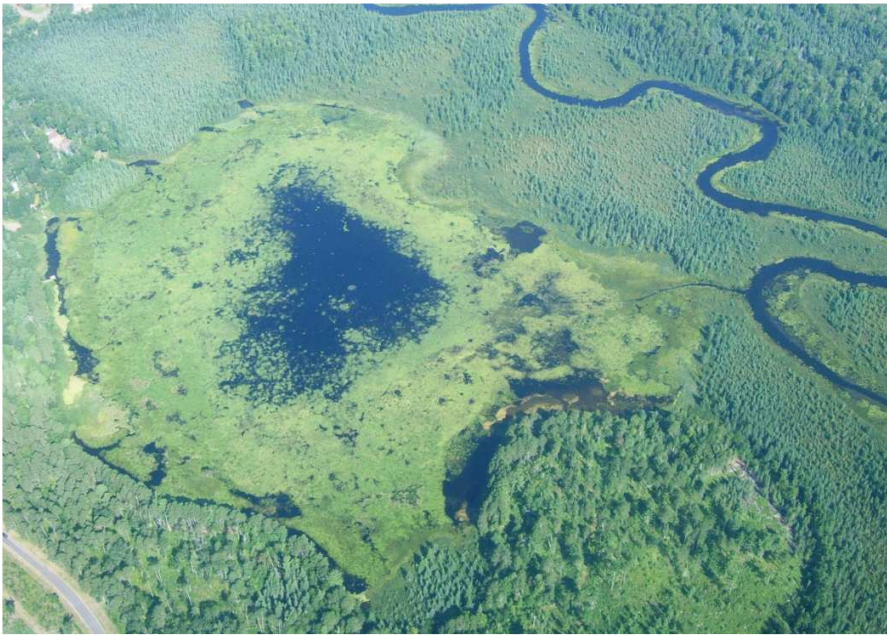
Figure 230. Little Rice Lake, Vilas County, 2009.

Little Rice Lake is found just outside of Boulder Junction. As the name suggests, it has a long history of supporting rice, and harvest on the lake is date-regulated. However, because it is a fairly small lake, and can be difficult to access when lake levels are low, harvest reports are not significant. Rice can be found nearly anywhere on this lake in years with a good crop. Watch status is low because of site familiarity.

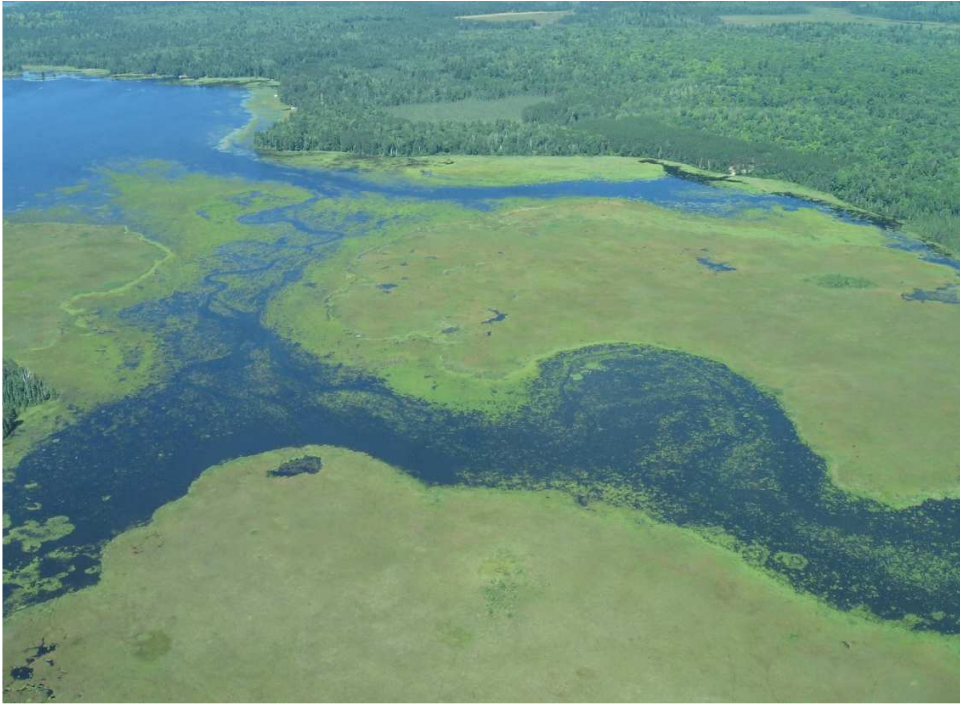
Figure 232. Lower Ninemile Lake, Vilas County, 2007.

Rice beds on Lower Ninemile Lake appear to be increasing in recent years, perhaps in association with a period of below-average precipitation. There are differing reports of how long this rice has been present, and whether it was seeded or became established naturally, but it does seem clear that the abundance is much greater than it had been in the past.

This site is being discovered by harvesters, and is growing in significance in harvest reports. Some local landowners are not pleased with the rice presence, and have expressed some interest in controlling it and/or removing it in areas to maintain boating access. It might be valuable to hold a rice harvesting/finishing seminar for local landowners, to encourage their stewardship of this resource. Watch status is medium-high because of the evolving nature of the beds at the present time.

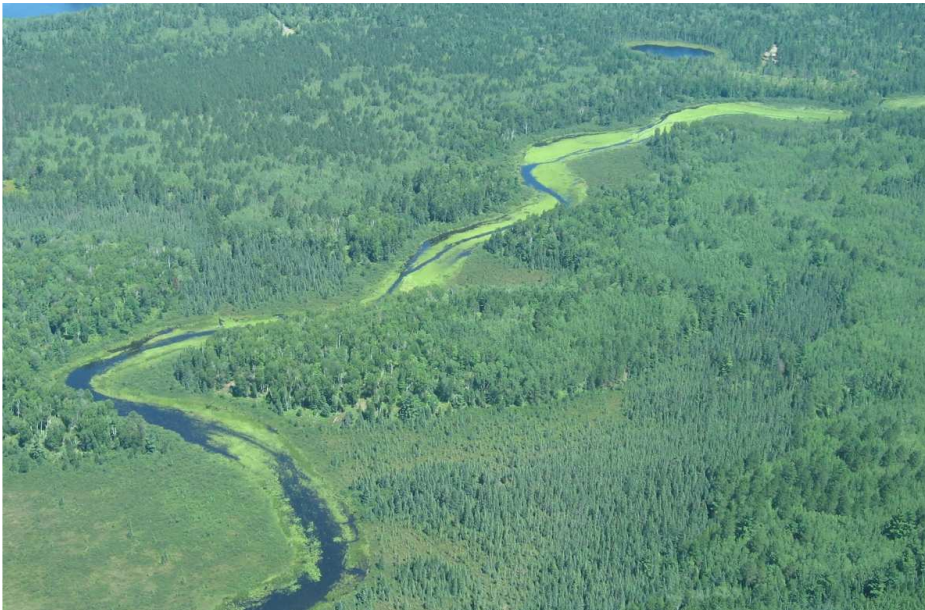
Figure 233. Manitowish River, Vilas County, 2007.

Rice beds exist in several sections of the Manitowish River. The most significant beds in Vilas County occur between the tributary from Little Rice Lake upstream to the area below the Fish Trap dam (shown above). This site receives more harvesting pressure than most river sites in the state. Small patches of rice likely exist in other areas, including the last river mile before the Iron County line. Watch status is low because of site familiarity.

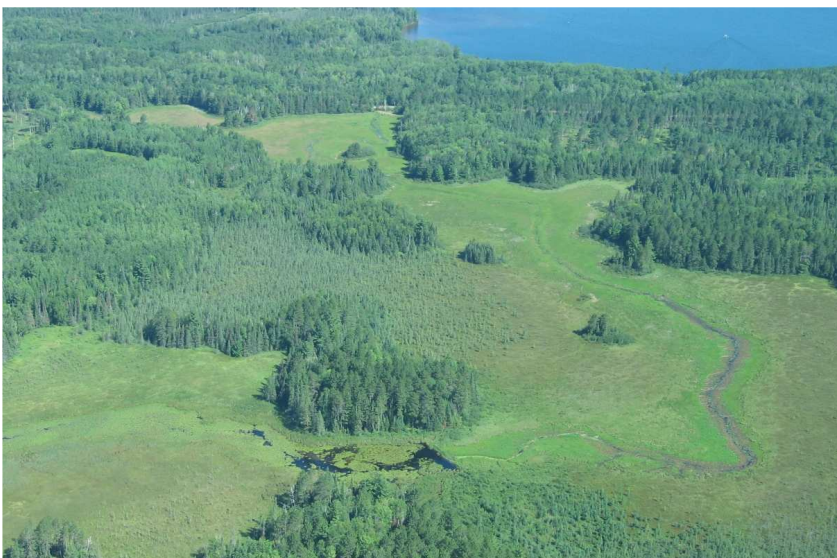
Figure 234. Mann Creek Flowage, Vilas County, 2007.

The Surface Water Viewer currently shows Mann Lake (WBIC 2332000) as a rice water; it is not and should be removed. Mann Creek Flowage is unnamed on the Surface Water Viewer, but it is located on Mann Creek between Mann Lake and Trout Lake. This site, seeded by the DNR, supports abundant rice when water levels are sufficient. Site has had occasional problems with beavers impacting water levels. Watch status is medium-high until additional annual abundance information can be gathered.

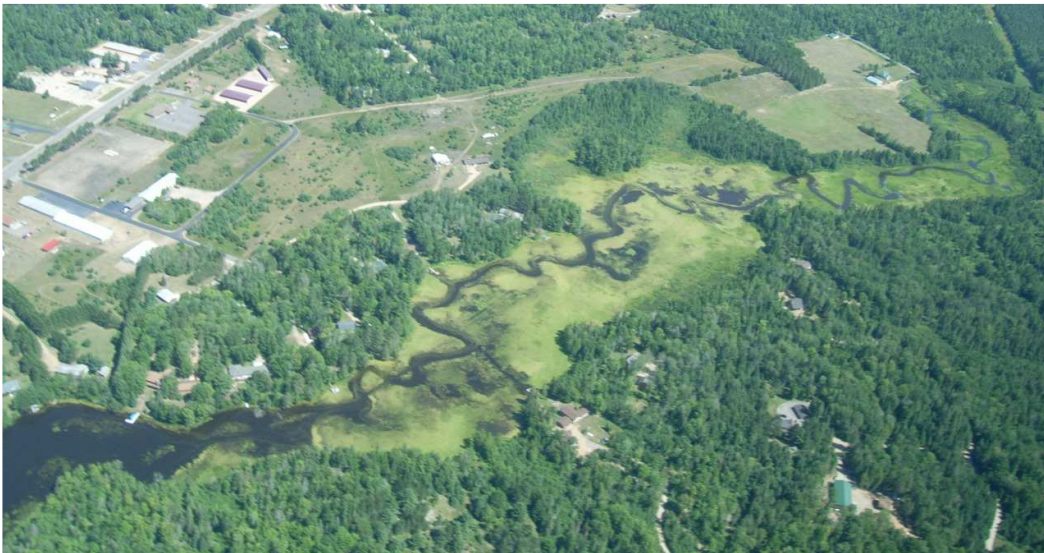
Figure 235. Mud Creek, Vilas County, 2008.

The section of Mud Creek supporting rice is located just southeast of Eagle River, just upstream from where the creek passes under HWY 70/17. This bed seems to be doing well, though damage from recreational boaters is sometimes apparent from the air. The site is infrequently harvested, perhaps due to relatively small seed size. Watch status is low because of site familiarity.

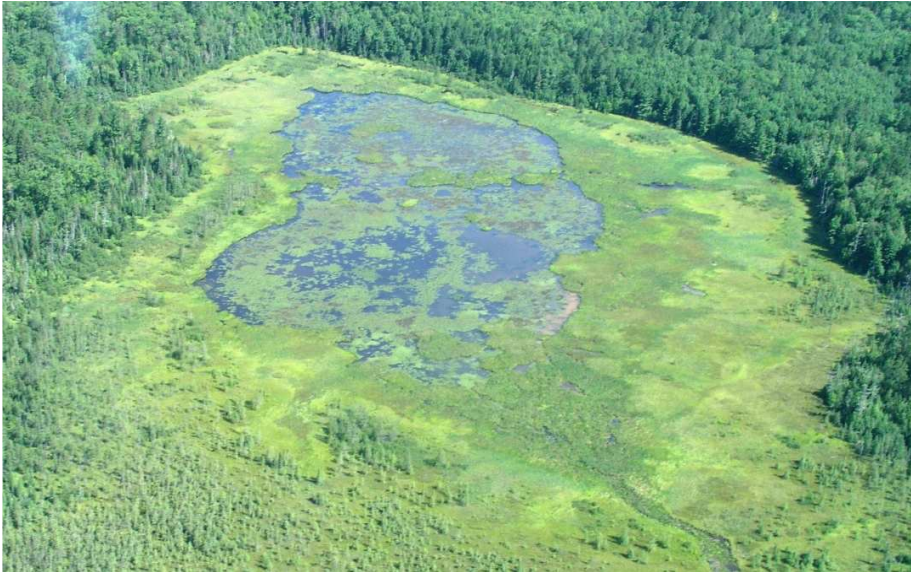
Figure 236. Mud Lake, Vilas County, 2006.

This lake, known locally as Mickey's Mud Lake, has produced very little rice in the last decade, but frequently had good stands in the 1990s - sometimes nearly covering the lake. The cause of this decline is unknown, but it is likely related to hydrology. The County has expressed interest in possibly seeding this site or restoring it in some other way. It should be a high priority for restoration efforts. Harvest on the lake is date-regulated. Watch status is high because of restoration need.

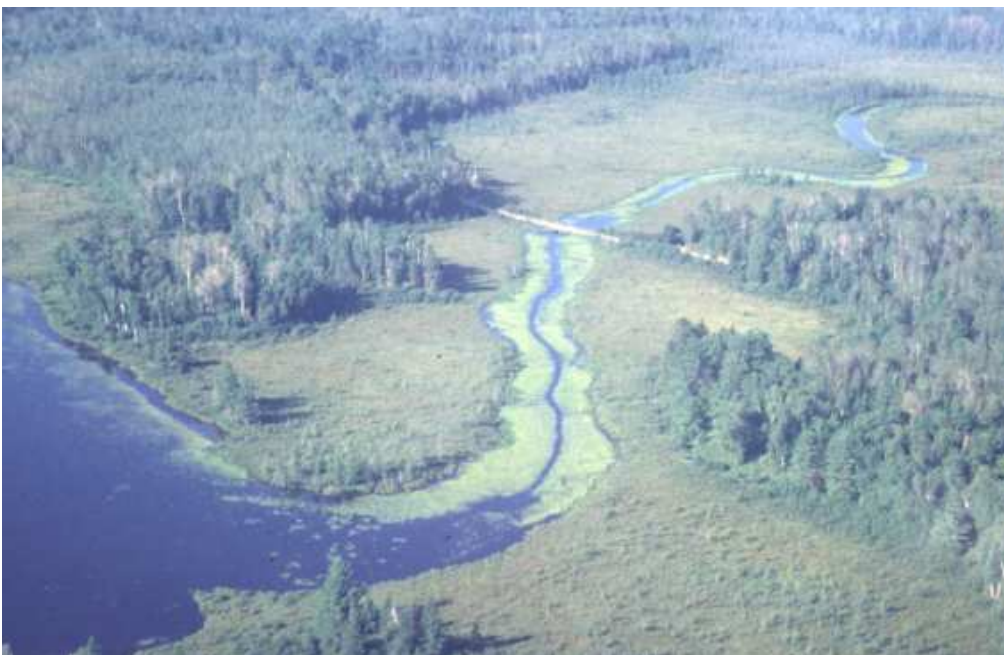
264. Nixon Creek (WBIC 2341100).

The most significant rice beds on Nixon Creek occur just downstream from Nixon Lake. These beds often do well even when the beds on adjacent Nixon Lake do poorly. They are occasionally harvested alone or in conjunction with the lake. While the river is technically not date-regulated, people often seem to comply with the date postings for the lake when ricing this section of the creek. Watch status is low because of site familiarity.

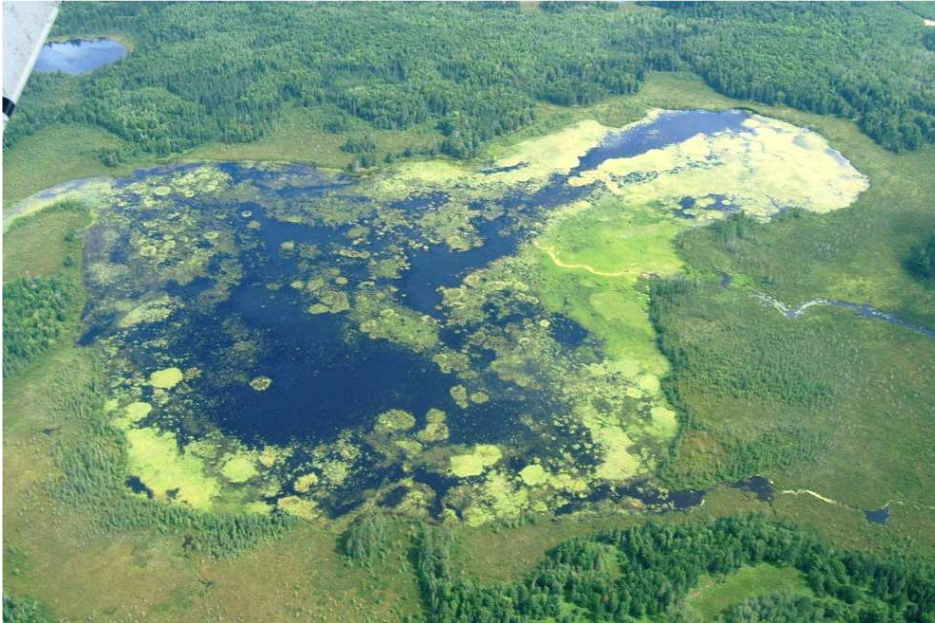
Figure 238. Nixon Lake, Vilas County, 2008.

Nixon Lake has a long history of supporting rice, reflected in part in that harvest here is date-regulated. However, recent crops had been quite poor until Ron Eckstein, DNR, worked to replace the culvert on Nixon Creek just below the lake. This appears to have restored the hydrology of the area, and a good bed has appeared for the first time in recent history on the lake at the Partridge Creek inlet. Harvest from the lake and creek is reported more frequently than might be expected given their size. Watch status is low because of site familiarity.

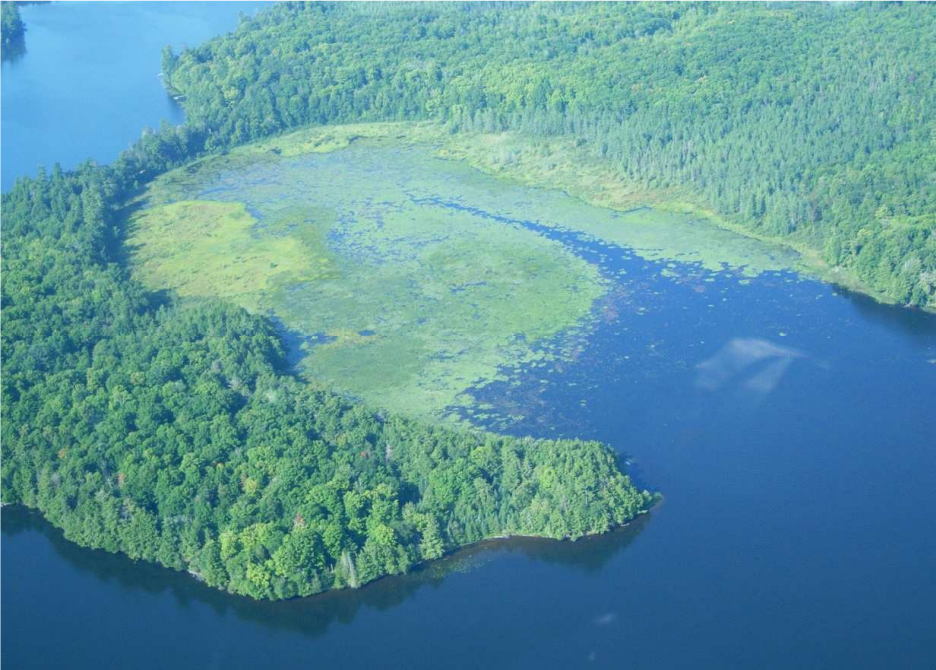
Figure 239. Palmer Lake, Vilas County, 2009.

While GLIFWC does not have a lot of familiarity with this site, Palmer Lake has shown up occasionally on harvest surveys, and a bed can be found on the large bay on the west end of the lake. There are also anecdotal reports that a small amount of rice can be found on the northwest end of the lake near the mouth of the Ontonagon River. Watch status is medium-high until additional annual abundance information can be gathered.

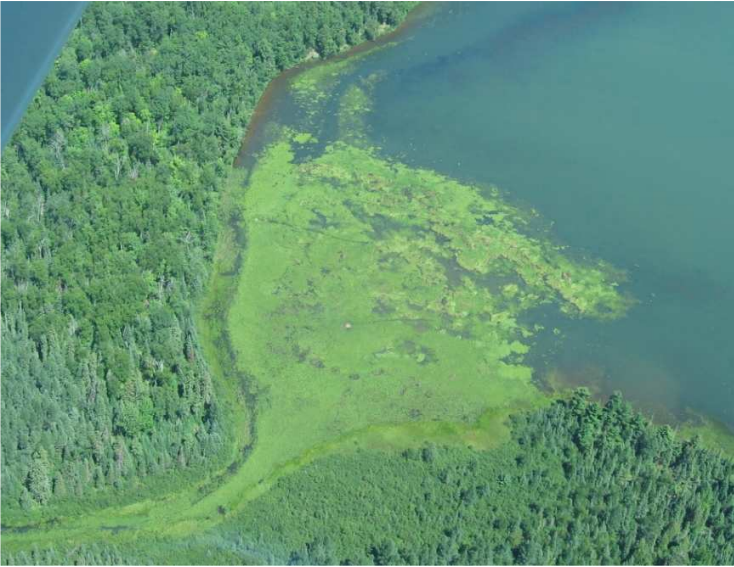
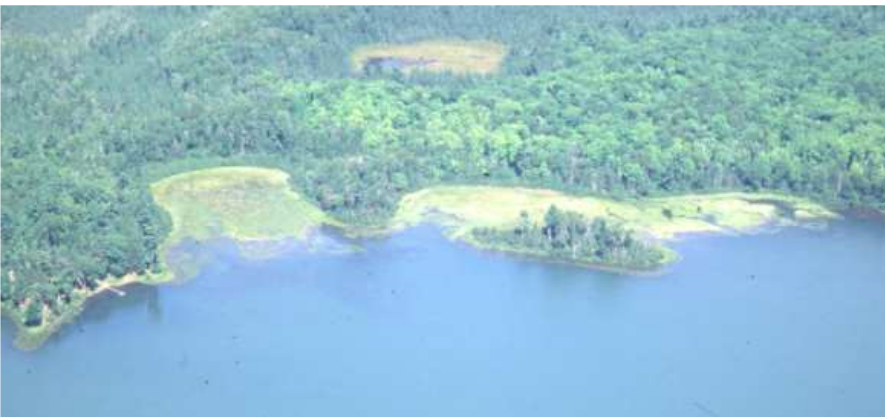
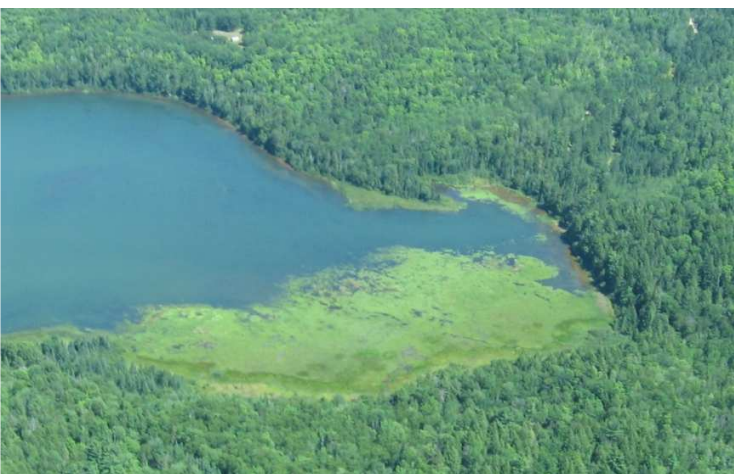
Figure 240. Partridge Lake, West, Vilas County, 2007.

Partridge Lake is rather unusual in having 3 distinct areas of rice: on the east end, on the north central shore near the single property owner, and, generally the largest, on the west end outlet. This lake may occasionally be negatively impacted by beaver. The site is of some harvesting significance, but it seems to be under-reported in the tribal harvest figures. Watch status is low because of site familiarity.

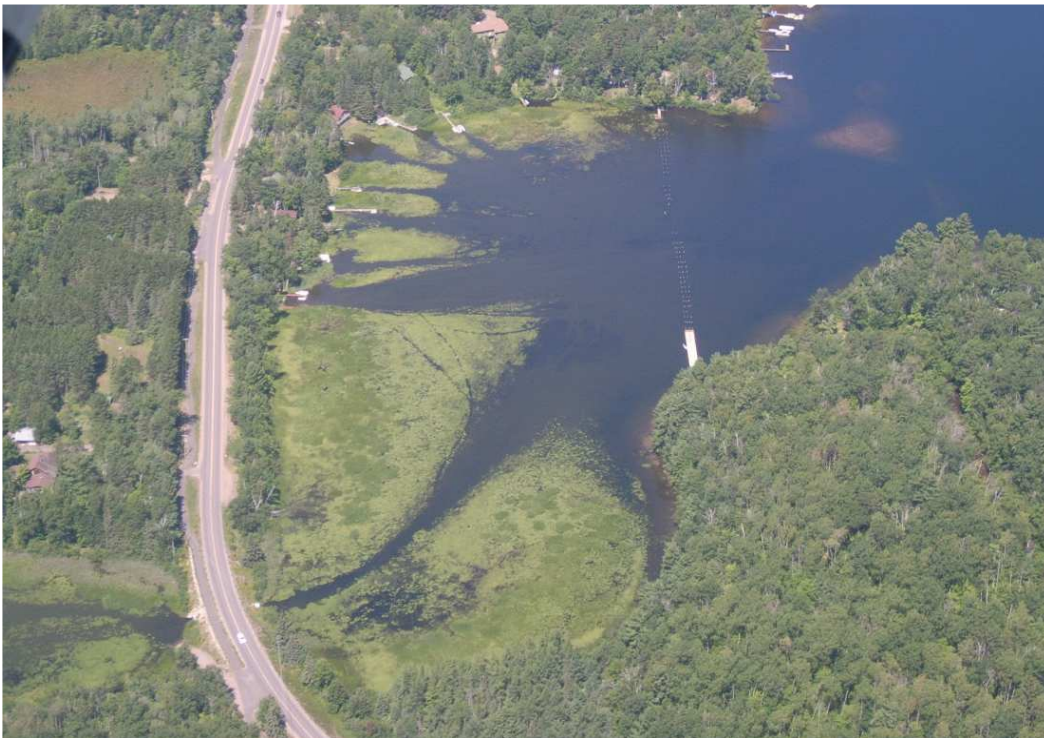
Figure 243. Plum Lake, adjacent to West Plum Lake, Vilas County, 2008.

Plum Lake supports a substantial bed of rice on the far west end of the lake, in the bay adjacent to West Plum Lake. This bed has been quite consistent, even in years when the bed on West Plum has been poor. As is evident in the photo, some local landowners have tended to remove excessive amounts of rice from in front of their property, far more than is needed to maintain navigation access. Although harvest on West Plum is date-regulated, harvest on Plum technically is not, though it seems like many local ricers apply the date-regulation to both waters. Watch status is low because of site familiarity.

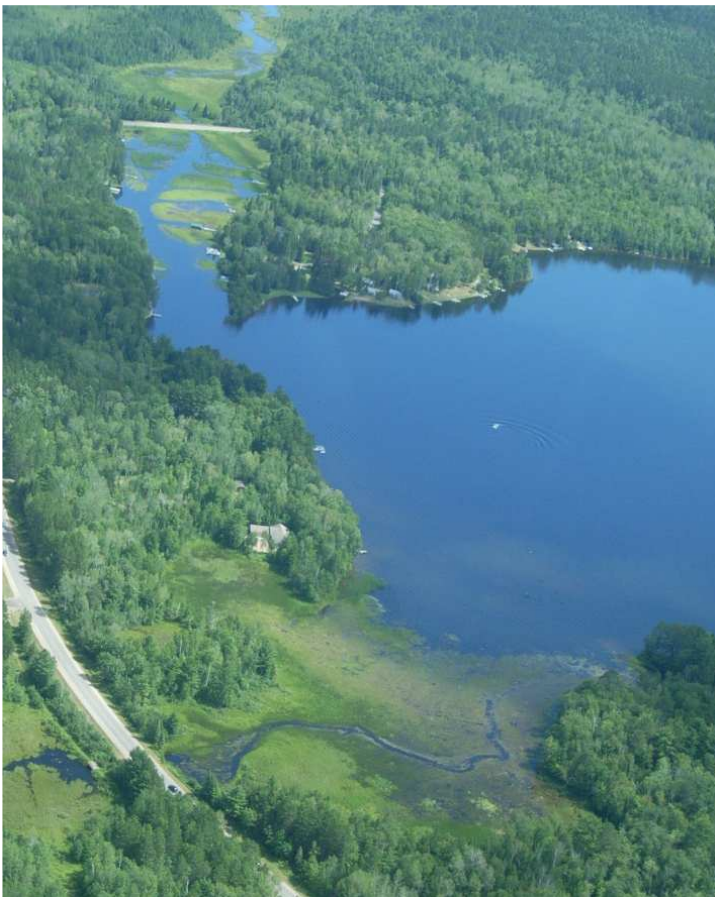
Figure 244. Rest Lake, Vilas County, 2008.

There are 2 primary rice beds on Rest Lake: one the northeast part of the lake where Papoose Creek enters, and the other on the northwest bay (visible to the bottom of the photo above). Extensive removal by adjacent landowners has taken place almost annually on the northeast bay, creating a patchwork of open channels, but rice has continued to persist where not actively removed. The DNR has not been able to prevent this removal because this “lake” is actually a

Currently, some modification of the operation of the Rest Lake Dam is being considered for the benefit of sturgeon spawning in the Manitowish River downstream. While it is not anticipated that negative impacts will occur from the changes currently being considered, watch status should be medium-high if any modifications be made until it is shown there are no negative impacts.

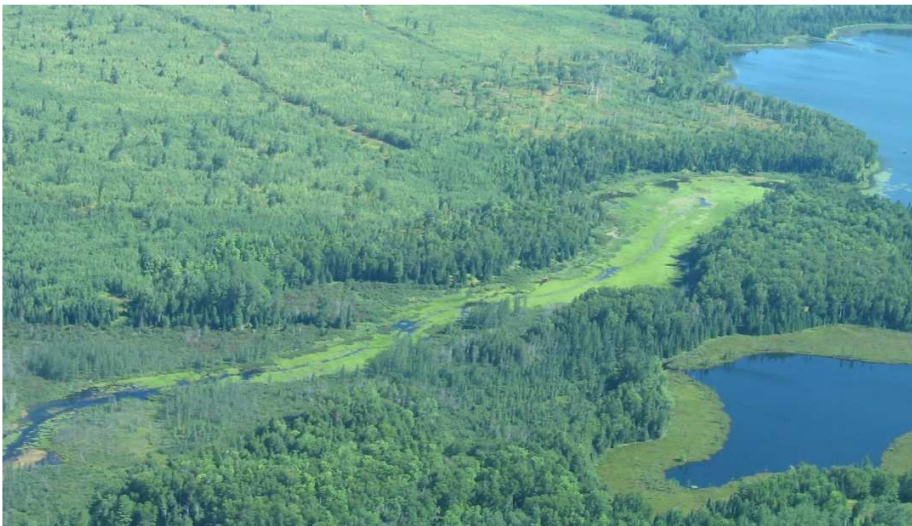
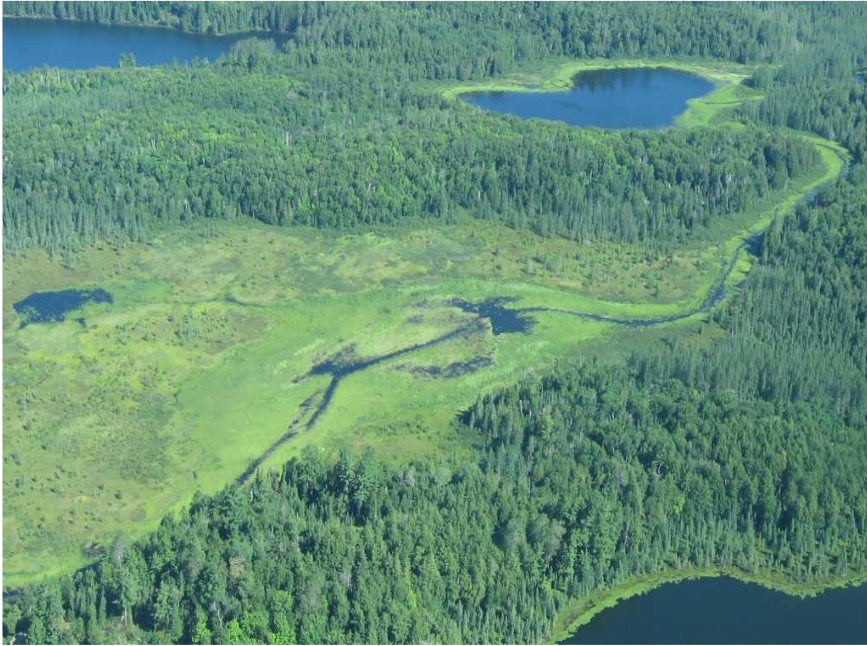
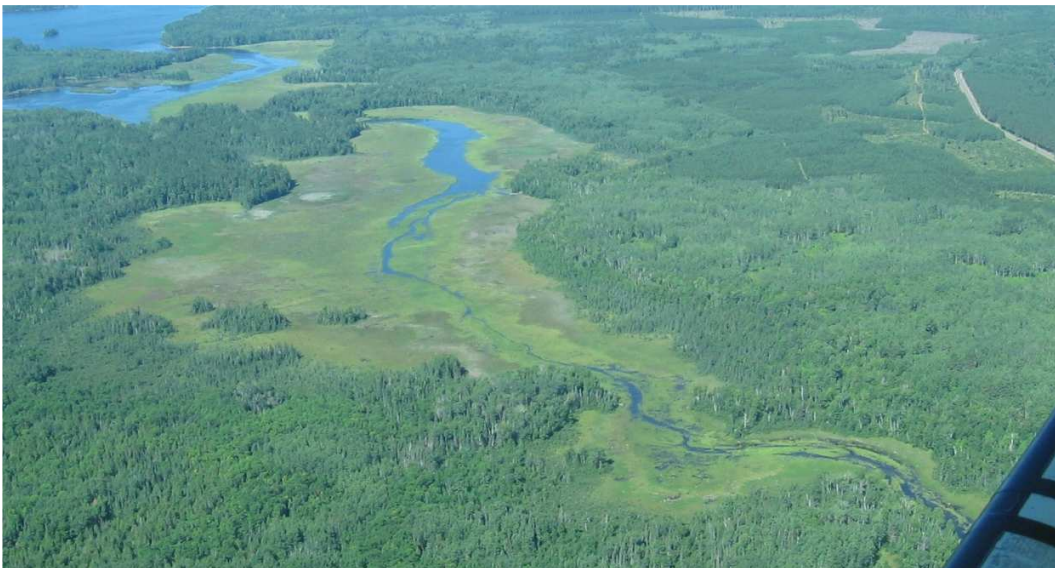
Figure 245. Rice Creek, West of Round Lake, Vilas County, 2007.

As the name suggests, Rice Creek supports significant amounts of rice. However, the section currently marked on the Surface Water Viewer (above Round Lake) is not known to support appreciable amounts of rice except very close to its mouth on Round Lake. The section between Round Lake and Big Lake supports substantial beds, and included along this section is a small, unnamed (Duck) lake, visible in the upper right of Figure 242. Rice is also abundant on the section between CTY K and the unnamed waterbody above Island Lake. (Also see Island Lake/Unnamed Waterbody.) Watch status for both sites is low because of site familiarity.

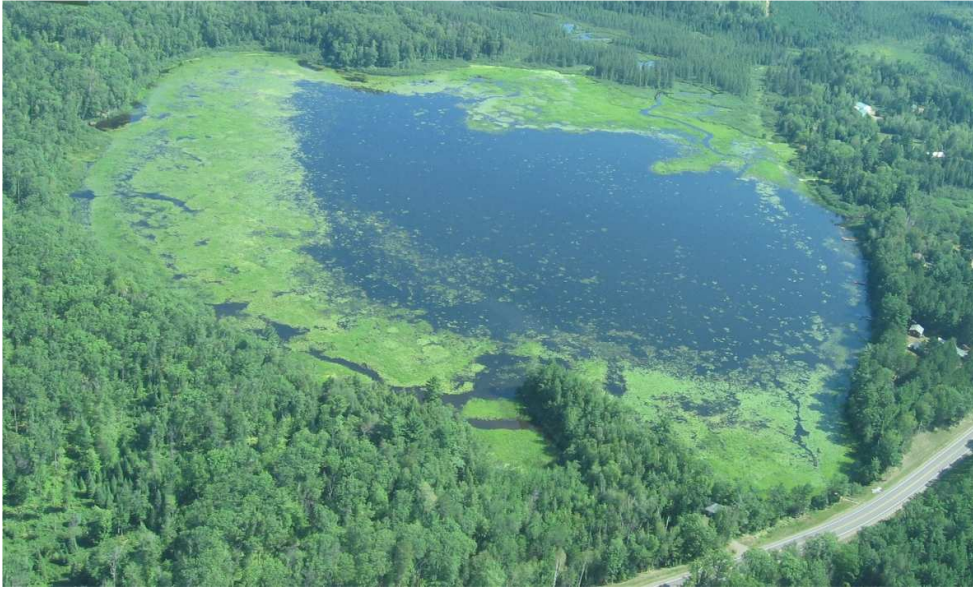
Figure 248. Rice Lake, Vilas County, 2006.

As the name suggests, Rice Lake has a long history of supporting rice, and harvest on the site is date-regulated. However, Rice Lake has not turned up in harvest surveys as frequently as might be expected from its location just outside of Eagle River, perhaps because this site reportedly tends to mature very unevenly. Watch status is low because of site familiarity.

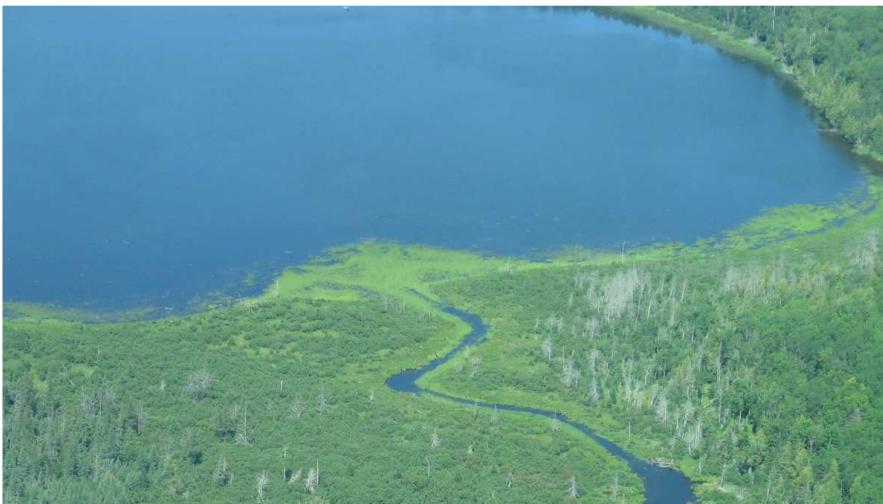
Figure 249. Round Lake, Vilas County, 2006.

There is consistently a bed of rice on Round Lake in the vicinity of the Rice Creek inlet. Good beds also occur on the outlet, but these are largely confined to the creek rather than the lake proper. (See Rice Creek.) Watch status is low because of site familiarity.

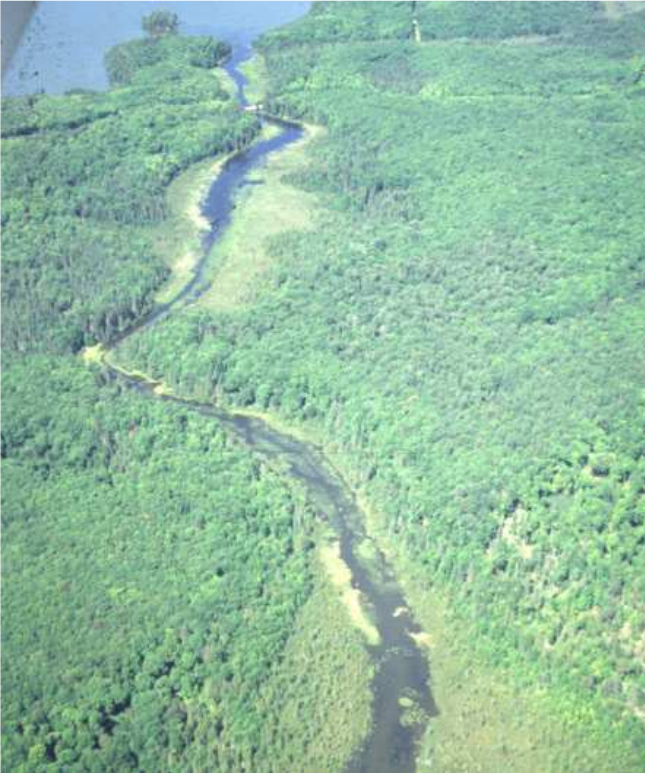
274. Spring Creek (WBIC 2964700).

Figure 250. Spring Creek, Vilas County, 2001.

There are two Spring Creeks in Vilas County; the one currently designated a rice water on the Surface Water Viewer (WBIC 5509522) does not support rice; this one does, but it is believed to be limited to the area between Spring and Mamie Lakes. This bed seems to show more annual variability in production than most riverine sites. Some years the rice also appears to be masked by mats of duckweed in air photos. Watch status is medium-low, but some additional information on annual abundance would be beneficial.

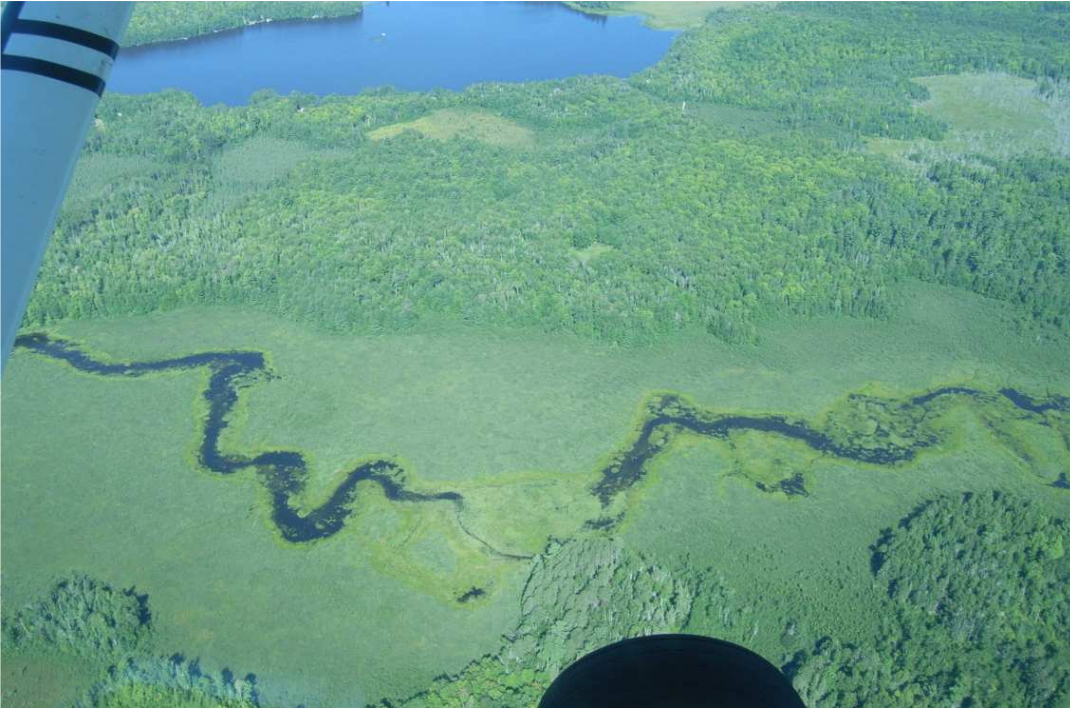
275. Squaw Creek (WBIC 2271200).

Figure 251. Squaw Creek, Vilas County, 2008.

Squaw Creek is located in the southwest corner of Vilas County; it also continues on for a short distance in Oneida and then Price counties. Rice is scattered in patches of varying size over the last 3 or so river miles before leaving the county, a stretch that is in a State Natural Area. Watch status is low because of site familiarity.

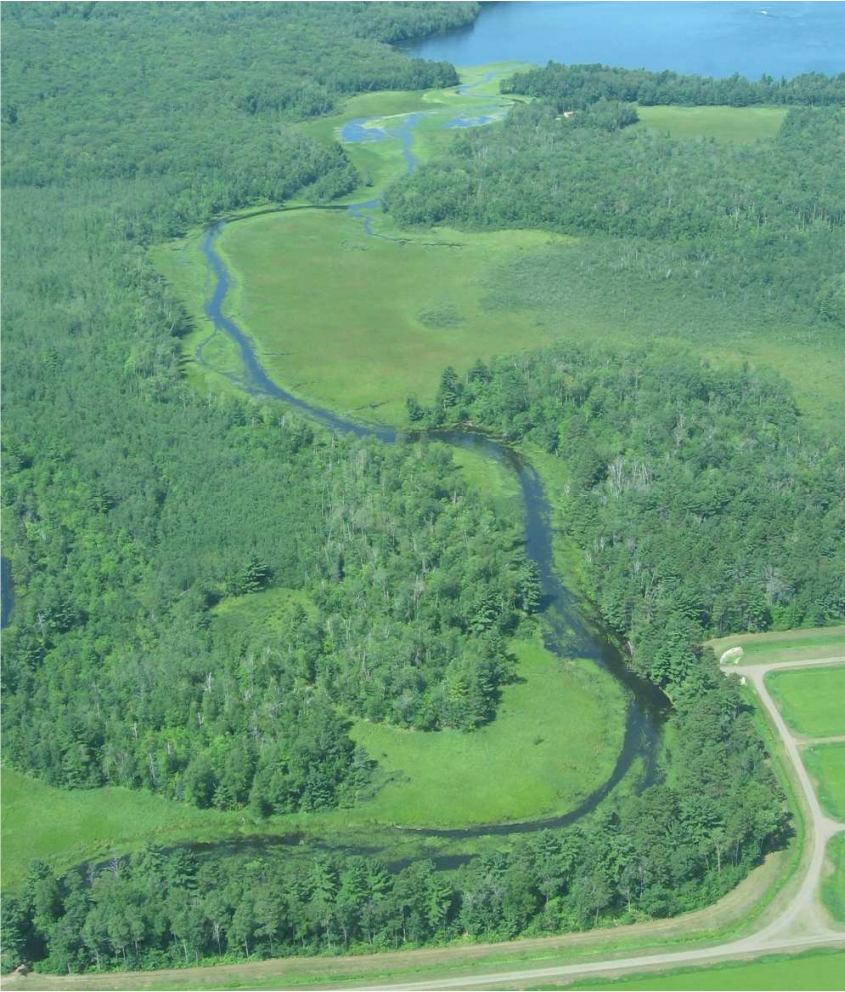
276. Trout River (WBIC 2329500).

Figure 252. Trout River, Vilas County, 2006.

Rice is found in many sections of the Trout River, including the area above Wild Rice Lake (shown in part above), between Wild Rice and Alder Lakes, and between Alder and Manitowish Lakes. The exact locations of smaller beds are not well documented, but this system appears to hold rice in most areas with suitable habitat. Many of the best beds are within the Lac du Flambeau Reservation, and are protected and managed by the tribe. Watch status is medium-low, but some additional information on distribution, especially below Manitowish Lake, would be useful.

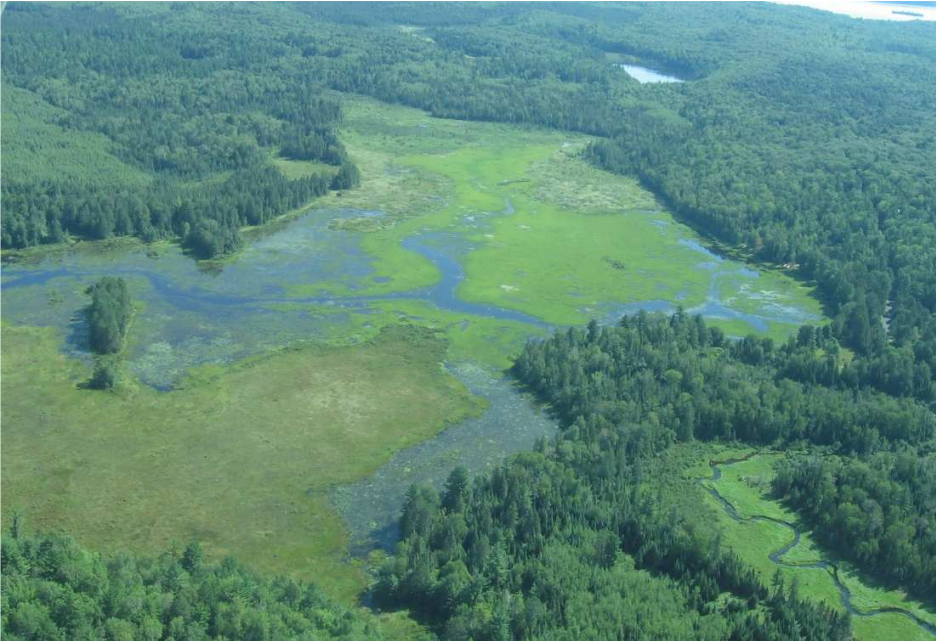
277. Upper Ninemile Flowage (WBIC 1608300).

Figure 253. Upper Ninemile Flowage, Vilas County, 2006.

Upper Ninemile Flowage has supported rice for decades, although it is unclear just when rice became established on this site. It is heavily harvested. The most common negative impacts may come from some of the local landowners, who reportedly sometimes sandbag the outlet in an effort to raise water levels. Most of the lakeshore is in National Forest ownership. Watch status is low because of site familiarity.

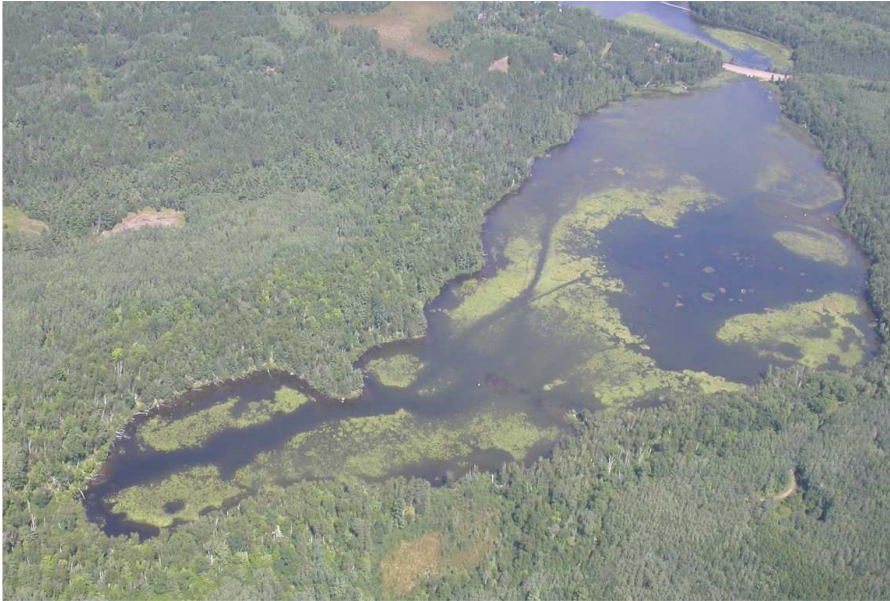
279. West Plum Lake (WBIC 1592500).

Figure 254. West Plum Lake, Vilas County, 2005.

West Plum Lake might be considered the far western lobe of Plum Lake, separated by the CTY N Bridge, but each has its own WBIC code. This lake has a long history of supporting rice, over a substantial portion of its surface in optimal years, and harvest on the site is date-regulated. For most of the past decade, this lake has not done very well, better beds being located on the adjacent portions of Plum Lake. In 2009, however, West Plum Lake showed some rebound in abundance. Watch status is medium because of possible decline.

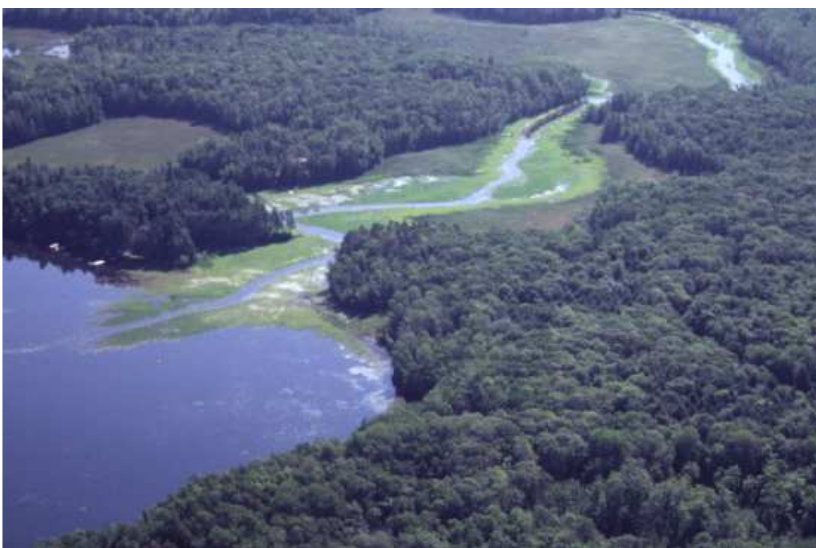
280. Wild Rice Lake (WBIC 2329800).

Figure 255. Wild Rice Lake at Inlet, Vilas County, 2004.

The best rice beds on Wild Rice Lake are found in the vicinity of the Trout River inlet (shown) and outlet; little if any rice is known to exist on other parts of the lake. The name suggests rice may have once been more plentiful, but GLIFWC is unfamiliar with any distribution other than as described above. It may be that some beds were lost when water levels were raised downstream with the Rest Lake Dam. Watch status is low because of site familiarity.

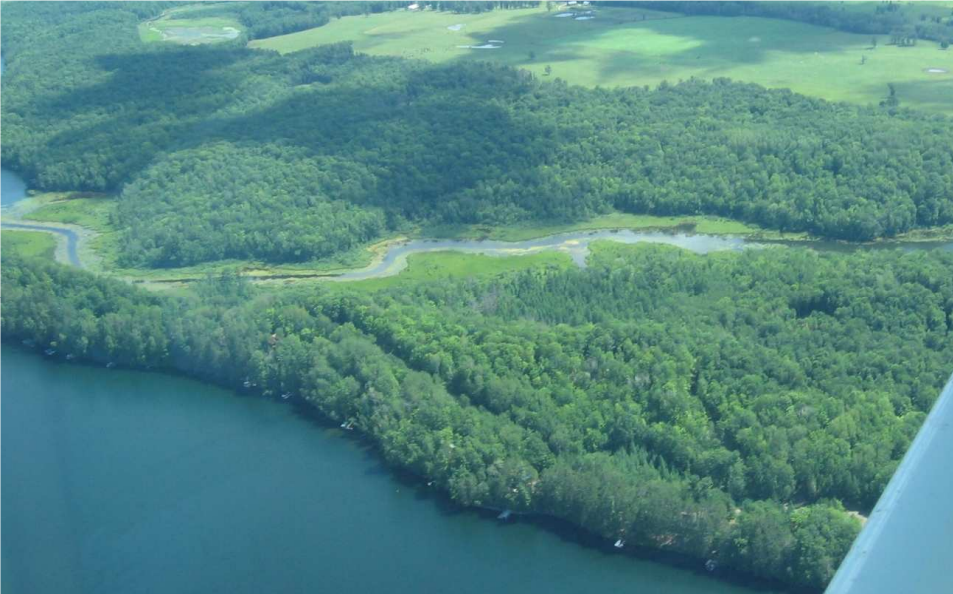
282. Balsam Lake (WBIC 2112800).

Figure 257. Balsam Lake, Washburn County, 2008.

A bed of rice is found on Balsam Lake on the channel that runs along the east side of the lake, which eventually terminates in a wider bay north of HWY 48. Little if any rice exists on the larger, primary lobe of the lake. This lake has a medium watch status because it has been surveyed relatively infrequently and additional abundance information would be useful.

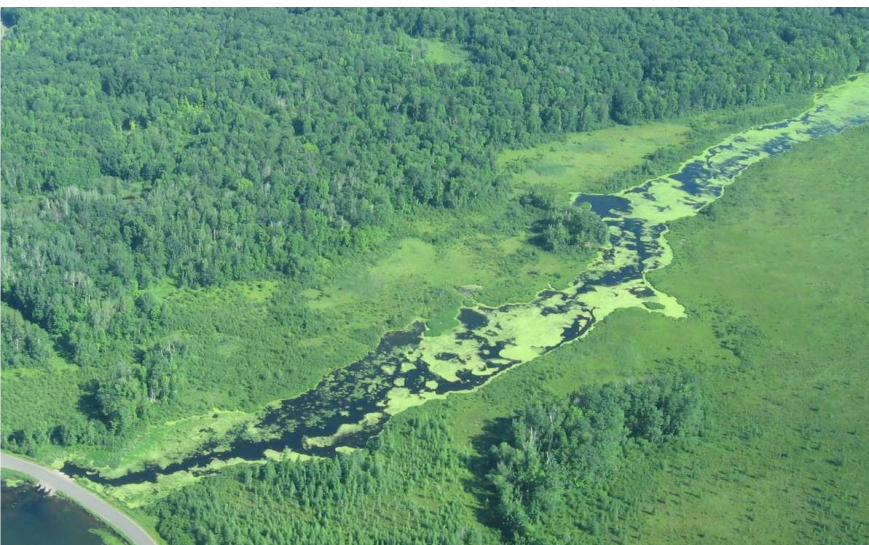
283. Bear Creek (WBIC 2106200).

Figure 258. Bear Creek, Washburn County, 2008.

Several acres of rice have been documented on Bear Creek between Kekegama and Bear Lakes by the St. Croix Tribe. Some of this is visible in the photo above just north of Bear Lake, which is partially visible at the lower left; other patches are too small to show up well from the air. This creek has a medium watch status because it has been surveyed relatively infrequently and additional abundance information would be useful.

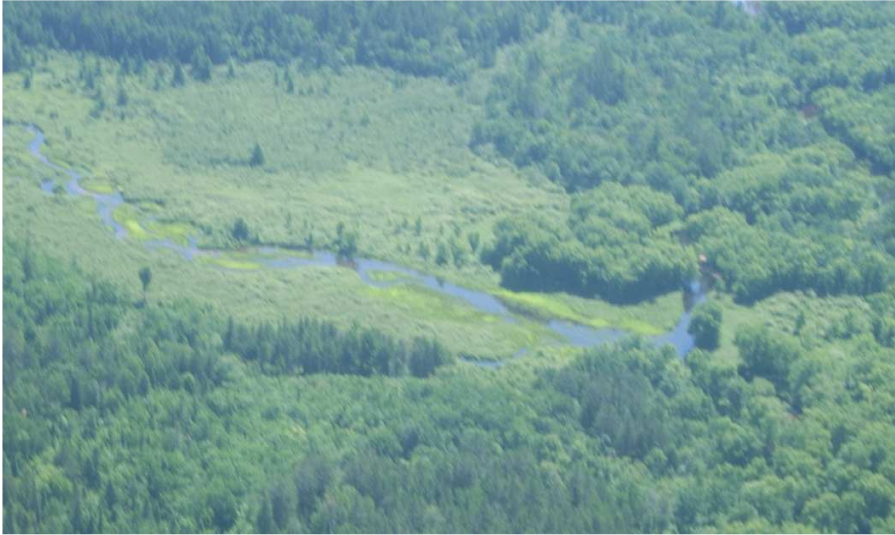
284. Bergen Creek (WBIC 2694300).

Figure 259. Bergen Creek, Washburn County, 2008.

We investigated this site and the adjacent sections of the Totagatic River after receiving reports it had been seeded by a private landowner. Rice was found in the last quarter mile of this creek before it enters into the Totagatic. The landowner indicated the bed varies in size from year to year, but appears to be well established. This creek has a medium watch status because it has been surveyed relatively infrequently and additional abundance information would be useful.
