**Wisconsin
Ceded
Territory
Manoomin
Inventory
Ver. 1.0**

**GLIFWC
Project
Report
2010-01
March, 2010**

**Peter David
Wildlife
Biologist**

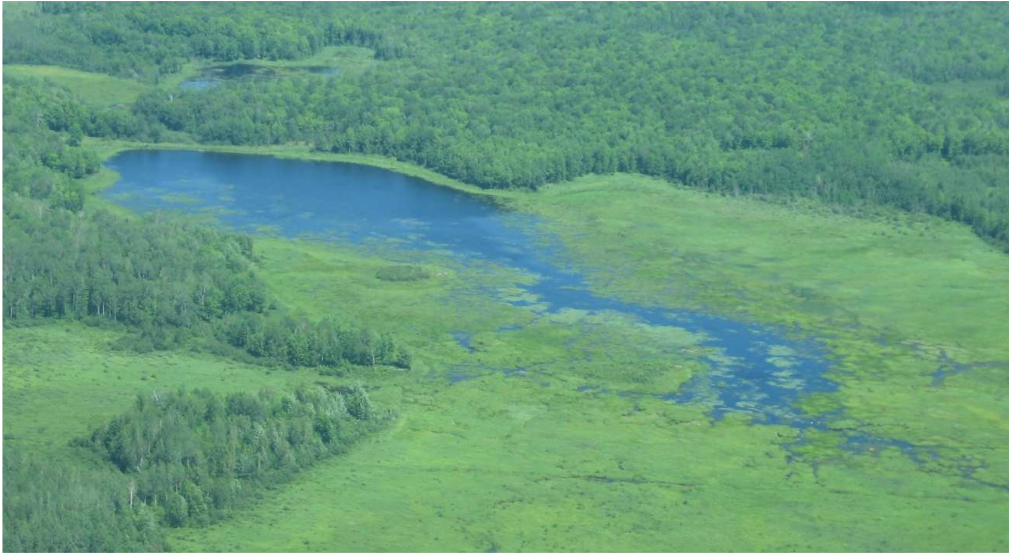
285. Black Brook Flowage (WBIC 2698300).

Figure 260. Black Brook Flowage, Washburn County, 2008.

Black Brook Flowage was successfully seeded cooperatively by GLIFWC and the DNR. This is an undeveloped, publicly owned flowage. Due to its relative remoteness, the bed benefits wildlife more than harvesters, though harvest has occasionally been reported. Watch status is medium low, but some additional abundance information would be helpful.

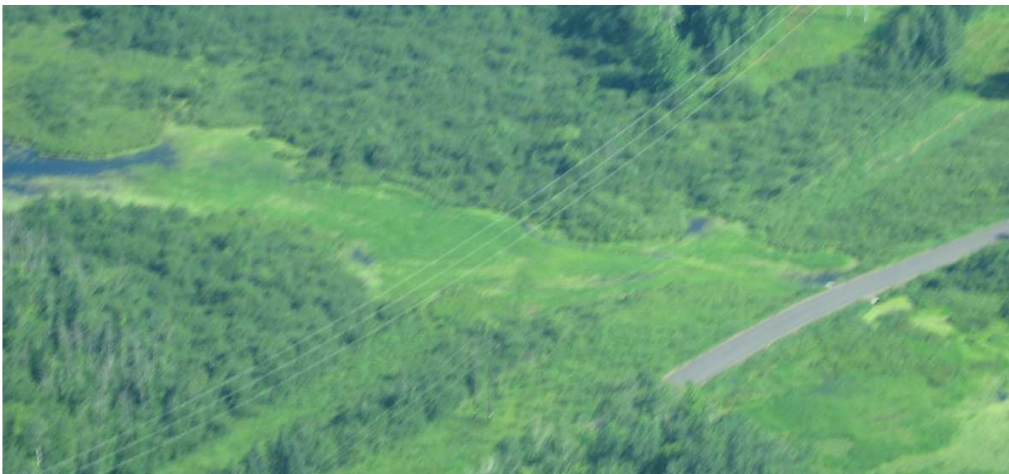
286. Boyer Creek (WBIC 2105300).

Figure 261. Boyer Creek, Washburn County, 2008.

Rice is thought to exist on several sections of Boyer Creek; the one shown above is just west of Shallow Lake Road, west of Bear Lake. Rice also exists near the mouth on Bear Lake, and likely in other sections as well. In the photo above, the bed is so dense it is difficult to discern the width the creek at this area. Watch status is medium due to a lack of annual abundance information.

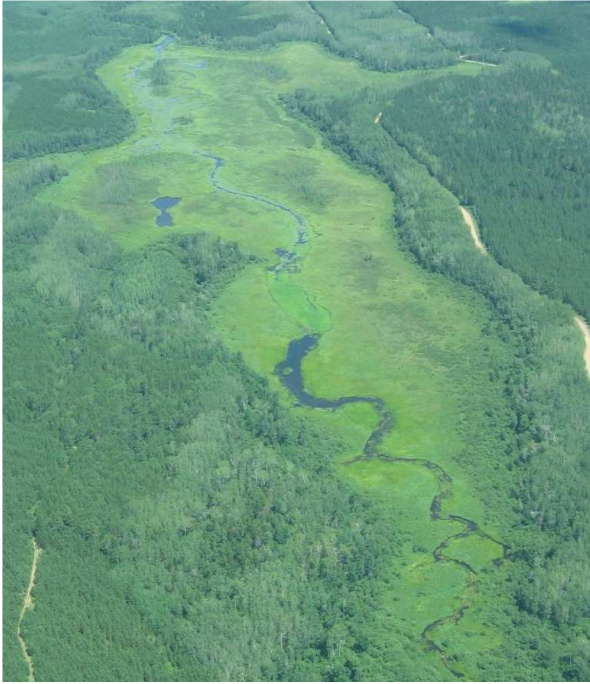
87. Casey Creek Flowage (WBIC 2708800).

Figure 262. Casey Creek Flowage, Washburn County, 2008.

The Casey Creek Flowage was successfully seeded cooperatively by GLIFWC and the DNR. The bed of rice here is limited to just a few acres, but has been self-sustaining for a number of years. It is somewhat difficult to identify the bed in the photo above, but the primary area is right in the middle of the image, where the meander of open water is obliterated by the rice stand. This flowage is on public land, and while the stand is a bit small for harvesting, it enhances wildlife use of this area. Watch status is low due to site familiarity.

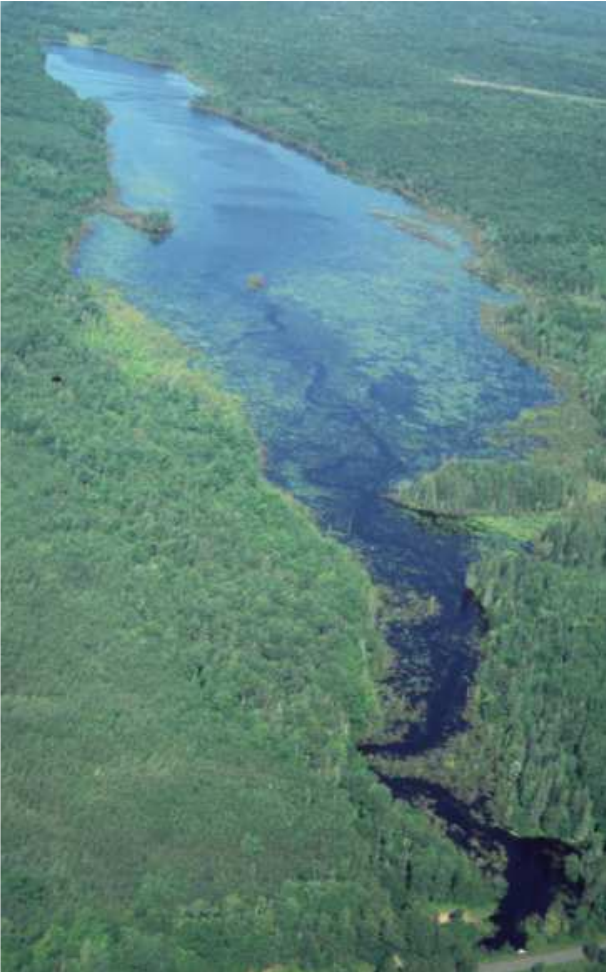
288. Chippanazie Flowage (WBIC 2722400).

Figure 263. Chippanazia Flowage, Washburn County, 2002.

Also occasionally referred to as the Cranberry Flowage, this site tends to have a relatively sparse bed, primarily on the east end of the flowage. It has not been important to harvesters, but does make the site more valuable to wildlife. Flowage is surrounded by county land. The bed seems to be declining in recent years, and might benefit from some water level management, such as an overwinter drawdown. This should be a medium-high watch site for both rice presence, and potential management efforts.

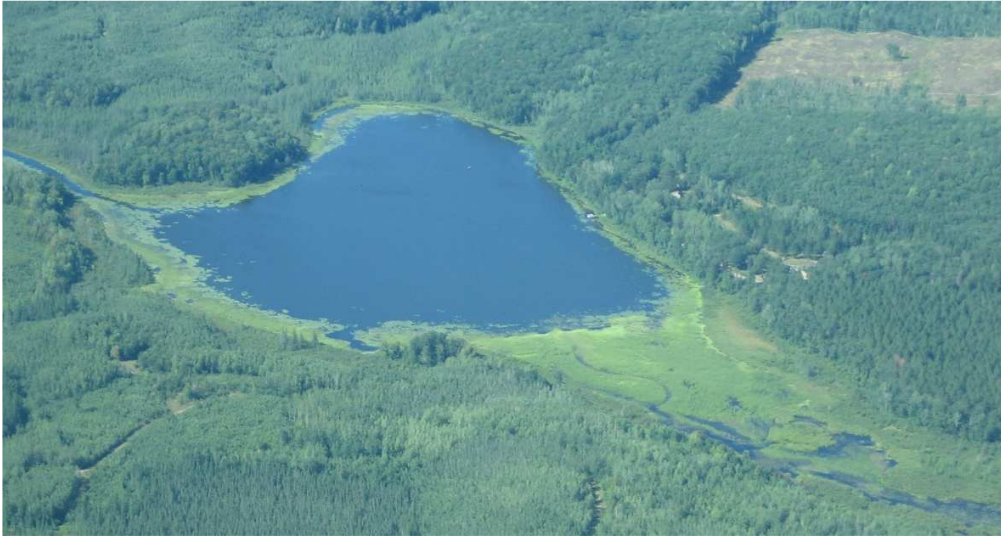
289. Dilly Lake (WBIC 2712800).

Figure 264. Dilly Lake, Washburn County, 2007.

Dilly Lake has long supported rice, and it is generally harvested whenever stands are good. The biggest bed occurs on the east side of the lake near the Potato Creek inlet, but a narrow band can nearly ring the lake some years. Rice also grows along Potato Creek where it leaves the lake. Watch status is low due to site familiarity.

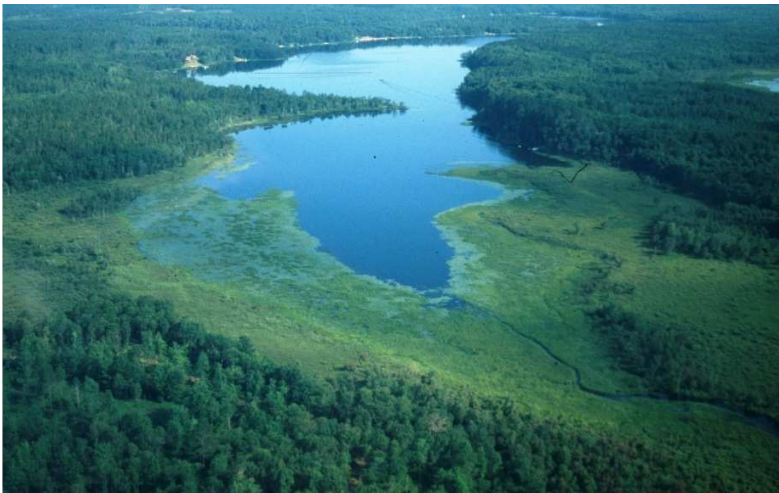
290. Gilmore Lake (WBIC 2695800).

Figure 265. Gilmore Lake, Washburn County, 2000.

Gilmore Lake has long supported rice, but the bed is limited to the north end of the lake, near the outlet to the Totagatic River. Although this bed often appears to be harvestable, and harvest at the site is date-regulated, it rarely turns up in harvest surveys, perhaps because it is a long paddle from the public access to the rice bed. Interestingly, the outlet reportedly sometimes acts as an inlet; during flood conditions on the Totagatic River, flow has reportedly reversed, causing the level of Gilmore Lake to jump. This is probably detrimental to the rice beds when it occurs. Watch status is low due to site familiarity.

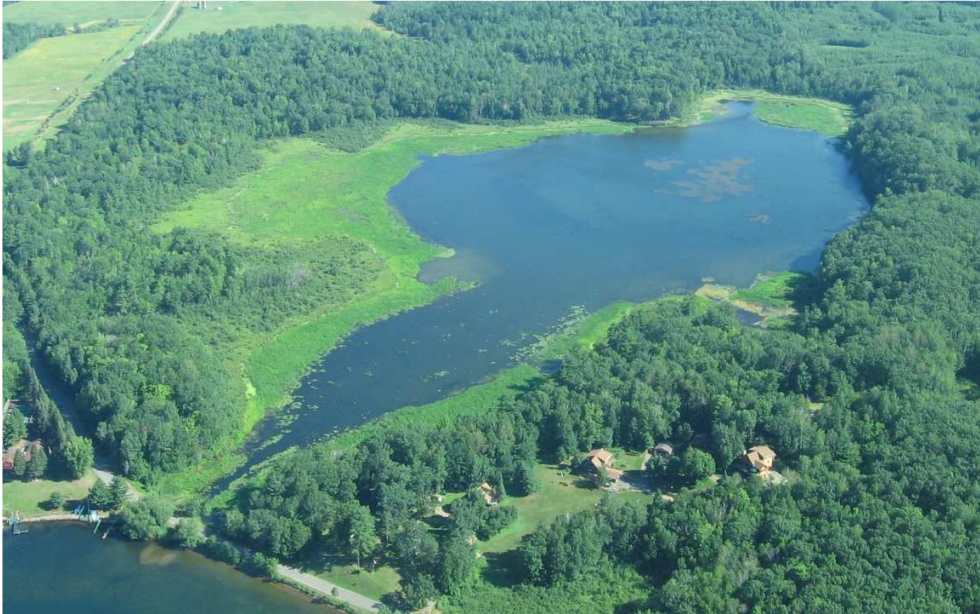
291. Little Mud Lake (WBIC 2107100).

Figure 266. Little Mud Lake, Washburn County, 2008.

Little Mud Lake has long supported rice, and the harvest on this site is date-regulated. However, for some reason harvest from this site seems to be under-reported. Rice can be found around most of the shoreline in good years, but this band is much thicker on the northwest side of the lake. Watch status is low due to site familiarity.

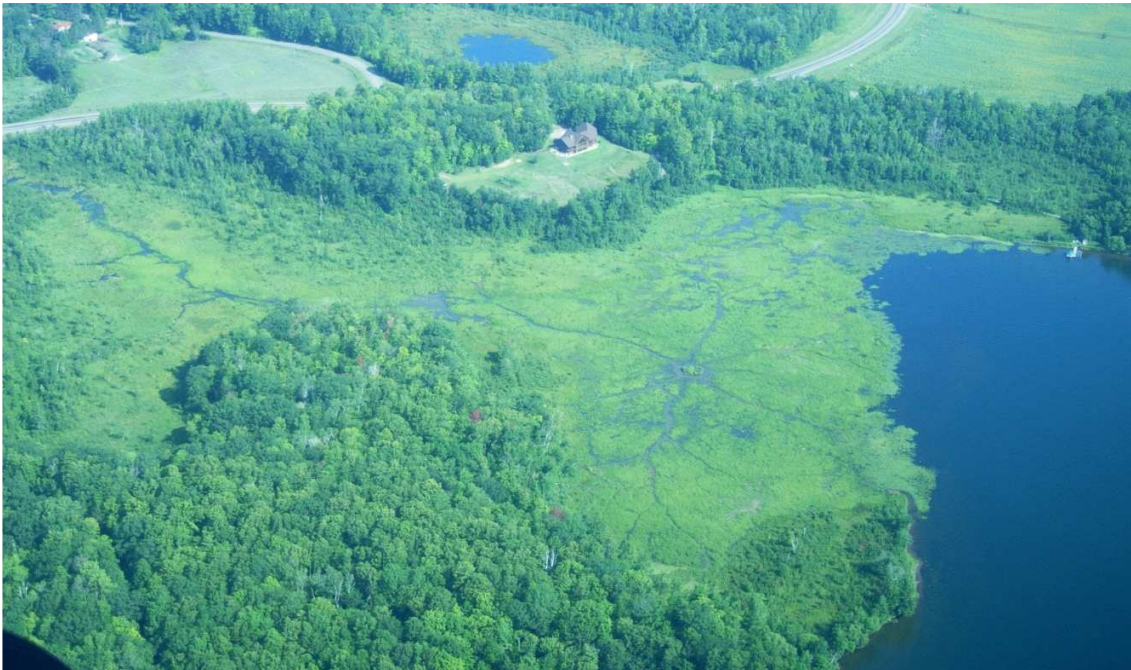
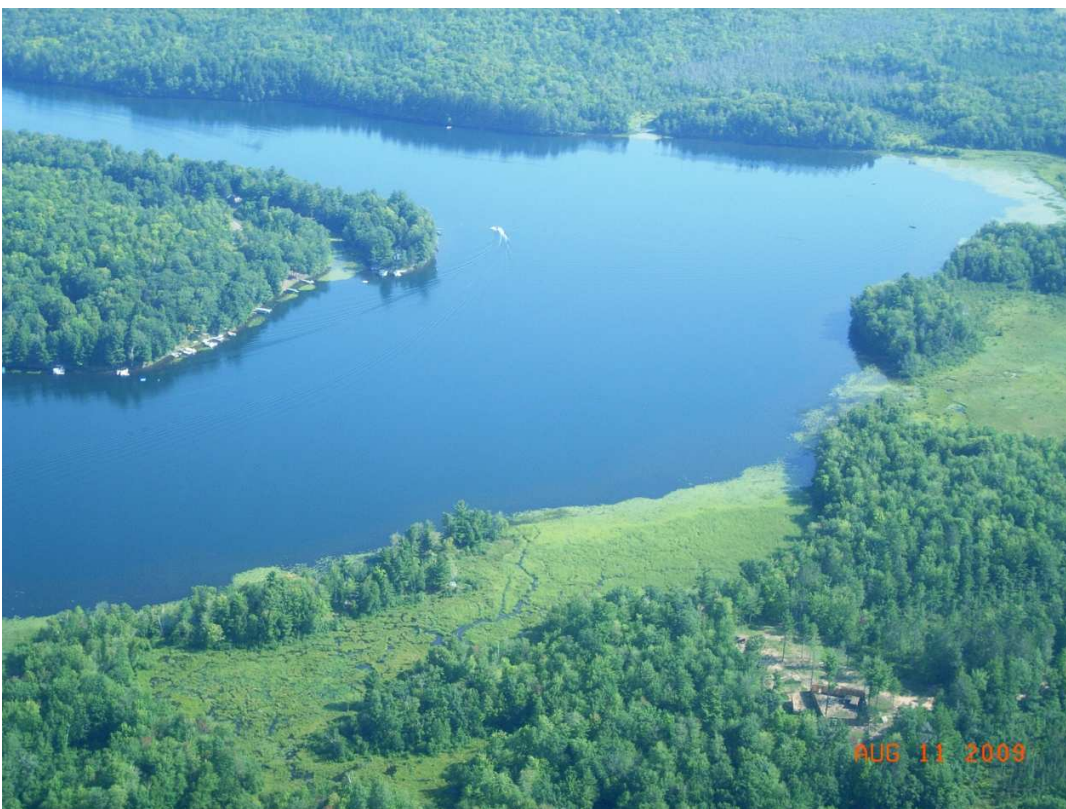
292. Long Lake (WBIC 2106800).

Figure 267. Long Lake, West of Rice Island, Washburn County, 2009.

Figure 268. Long Lake, South, Washburn County, 2009.

Long Lake has supported rice beds for a very long time, and harvest on the site is date-regulated. Rice occurs in several locations, but the biggest bed is usually west of Rice Island. Although rice accounts for a fairly small portion of the

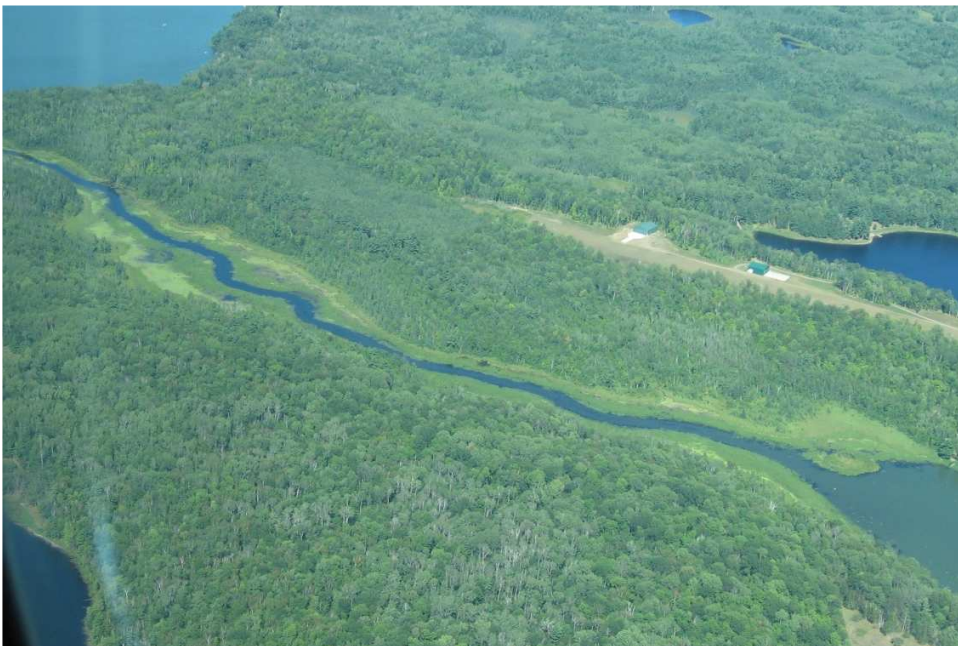
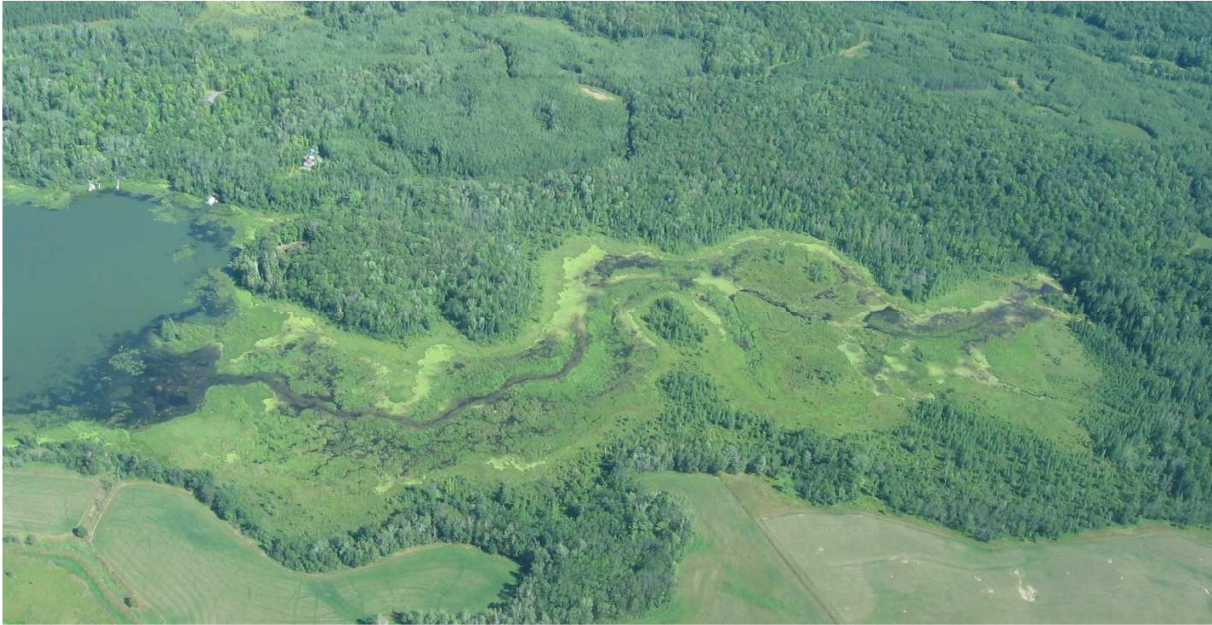
294. Mud Lake (WBIC 2107700).

Figure 269. Mud Lake, North, Washburn County, 2007.

Figure 270. Mud Lake, South, Washburn County, 2007.

Mud Lake has a long history of supporting rice, and harvest on this site is date-regulated. However, like nearby Little Mud Lake, harvest for this site seems to be under-reported. There are 2 primary beds on this linear lake, one on the northern narrows that connect this lake to Long Lake, and the other at the south end shallows. Watch status is low due to site familiarity.

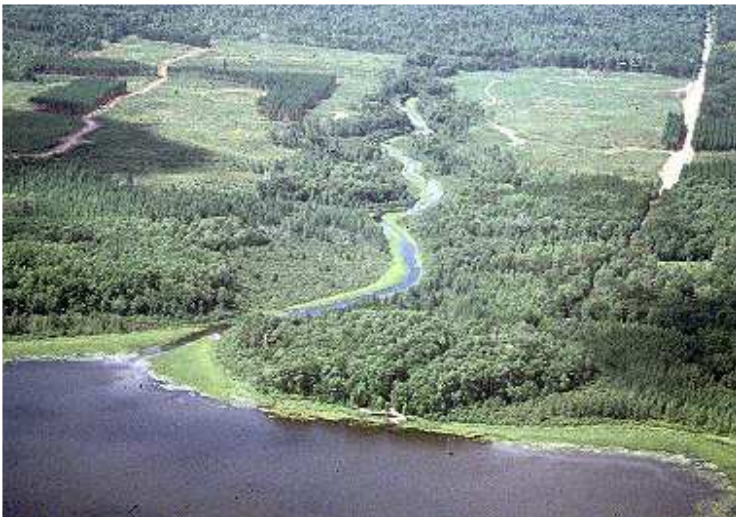
295. Potato Creek (WBIC 2712200).

Figure 271. Potato Creek, Washburn County, 1992.

Potato Creek has not been surveyed in its entirety for rice, but given the presence of rice on its headwater, Potato Lake, it's likely that rice could be found in most areas with suitable habitat. Substantial beds are well documented at the inlet, and especially outlet, of Dilly Lake (shown above). Further downstream, Potato Creek joins Little MacKay Creek 1-2 miles above the Trego Flowage. While the Surface Water Viewer considers the water below this juncture to be Little MacKay

Creek, many locals consider it part of the Potato. Regardless of name, this section is also known to support rice (see Little Mackay Creek for more information). Watch status is low due to site familiarity.

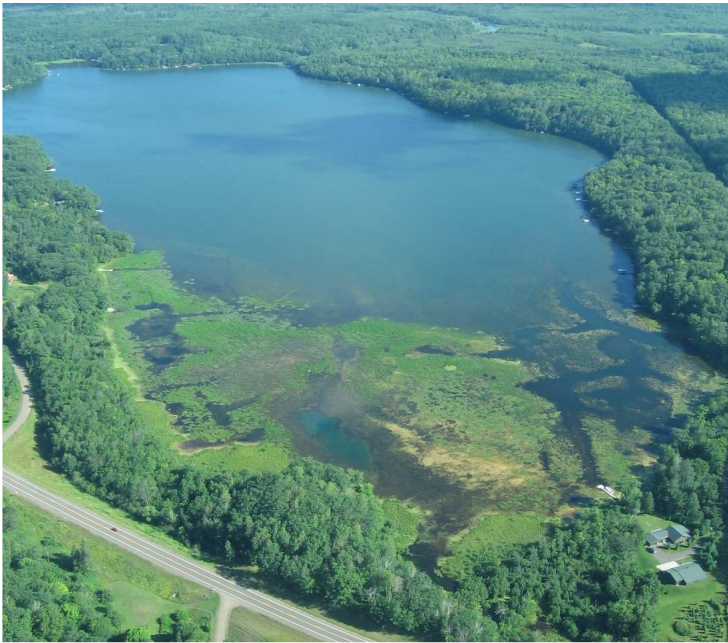
296. Potato Lake (WBIC 2714500).

Figure 272. Potato Lake, Washburn County, 2008.

Potato Lake has long supported rice beds. Harvest is reported regularly, but in relatively small amounts. The primary bed is on the south end of the lake (visible above), but a much smaller bed usually can be found in the very small bay on the northwest end of the lake. There have occasionally been reports of excessive rice removal by some landowners on the south end of the lake, and complaints about this from others on the lake who value the rice. Watch status is low due to site familiarity.

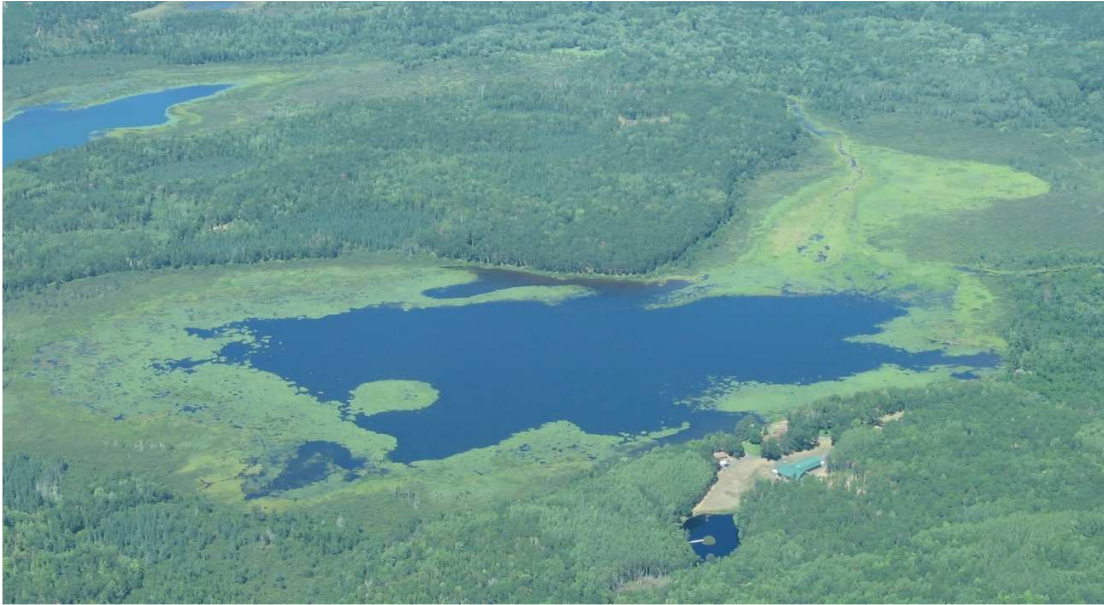
297. Rice Lake (WBIC 2696000).

Figure 273. Rice Lake, Washburn County, 2007.

As the name suggests, Rice Lake has a long history of supporting rice beds. Harvest on this lake is date-regulated, and in the past it has been an important site for harvesters. However, the private resort on this lake which previously offered an access point was bought out, and the private access closed. The only remaining access is via a fairly long and difficult trip along Shell Creek. As a result, public harvest has dropped, and it would be preferable to remove this lake from the list of date-regulated waters since it is difficult to monitor and post.

The primary rice bed on this water is on the northeast end, where Shell Creek enters and exits; this stand is essentially shared with Shell Creek itself. Smaller amounts of rice also occur in scattered areas on other parts of this largely undeveloped lake. Watch status is low due to site familiarity.

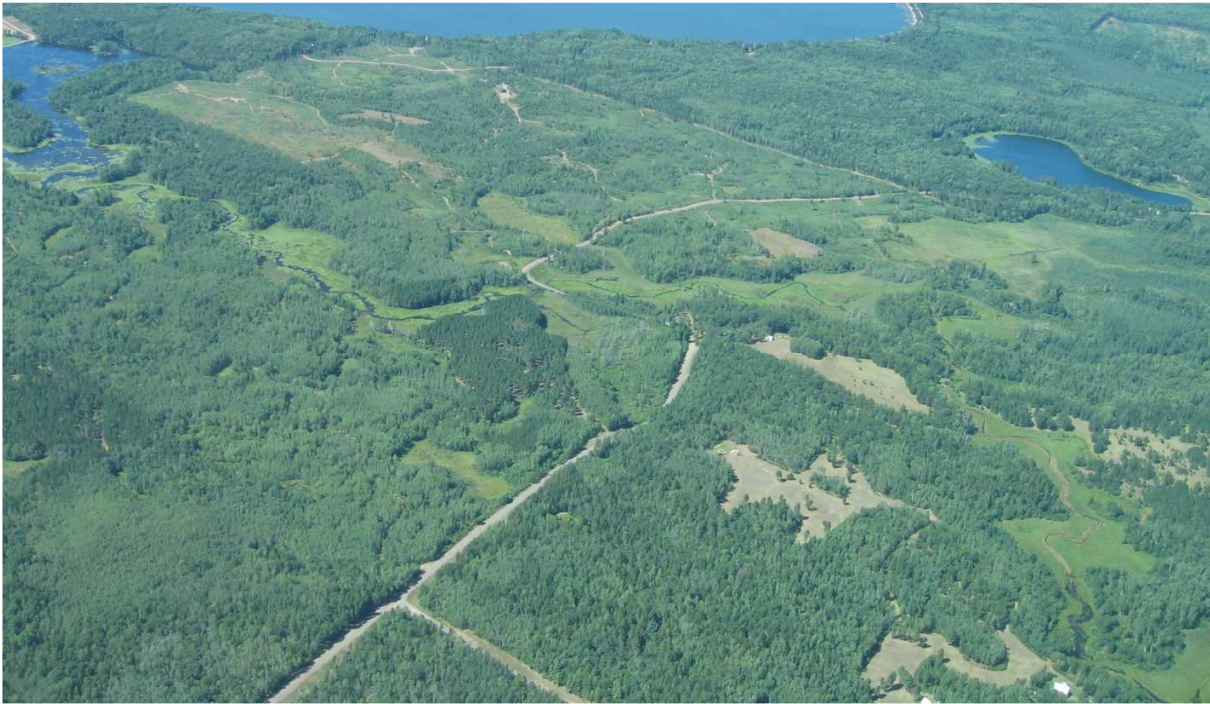
298. Rocky Ridge Creek (WBIC 2707200, 2706200).

Figure 274. Rocky Ridge Creek, Washburn County, 2007.

This is another site where confusion appears to exist regarding the name of this creek. While local usage and most maps refer to this as Rocky Ridge, the Surface Water Viewer considers it unnamed, or McKenzie Creek. Regardless of naming, rice is found on the sections of this waterbody identified by the WBICs provided above. (Note these numbers have been modified from earlier listings.) Although not particularly obvious in the photo, rice is found in abundance on Rocky Ridge Creek over most of the section shown above. This is roughly the final 2.5 miles of this creek before it crosses into Burnett County. Described another way, rice can be found on most of the creek below the crossing of Fox Road to the county line. Watch status medium until additional annual abundance information is gathered.

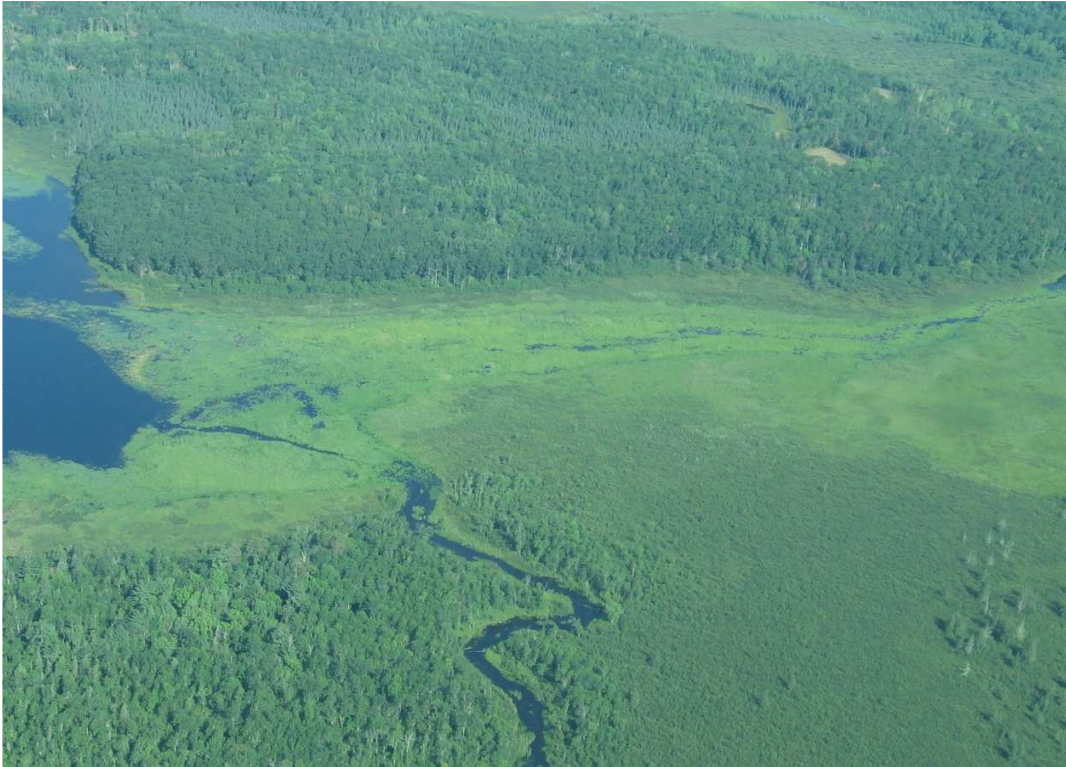
299. Shell Creek (WBIC 2695900).

Figure 275. Shell Creek, Washburn County, 2006.

Shell Creek enters and exits Rice Lake in the area shown above. Whether the rice is considered to exist primarily on the lake or the creek depends on interpretation, but it is probably best to include both water bodies on the list of recognized rice waters. See Rice Lake for additional information. Watch status is low due to site familiarity.

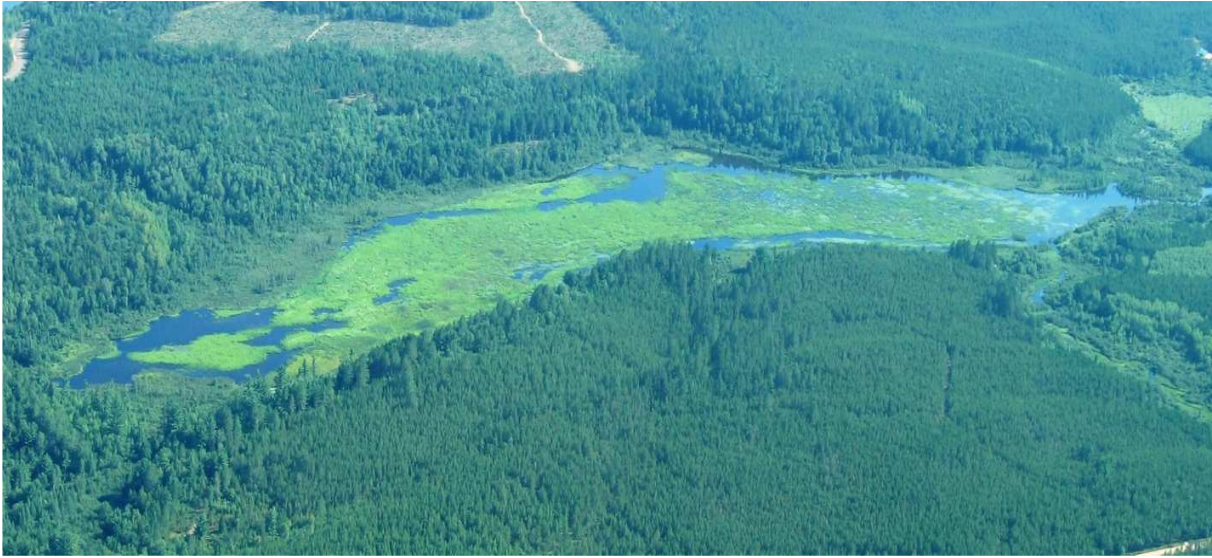
301. Spring Lake (WBIC 2691200).

Figure 276. Spring Lake, Washburn County, 2006.

Spring Lake has a long history of supporting rice, and harvest on this site is date-regulated. Spring Lake has had a somewhat complicated management history, and rice abundance has fluctuated more widely than on most sites. Abundance seemed to decline after the natural outlet of the lake was changed; it was moved east by the DNR towards some springs in the lake in hopes that cooler water would flow out for the benefit of trout on the outlet. This may have disturbed the natural circulation of water and nutrients in the lake.

The St. Croix Tribe has worked to restore the natural lake outlet, and reduce some of the competing vegetation that became established on the lake in the years the rice did poorly. The lake responded with some spectacular crops (such as the one shown above) but the crop has also essentially failed in the last 2 years, so the long-term health of this stand remains in some question. Watch status is high because of the great variability of production in recent years.

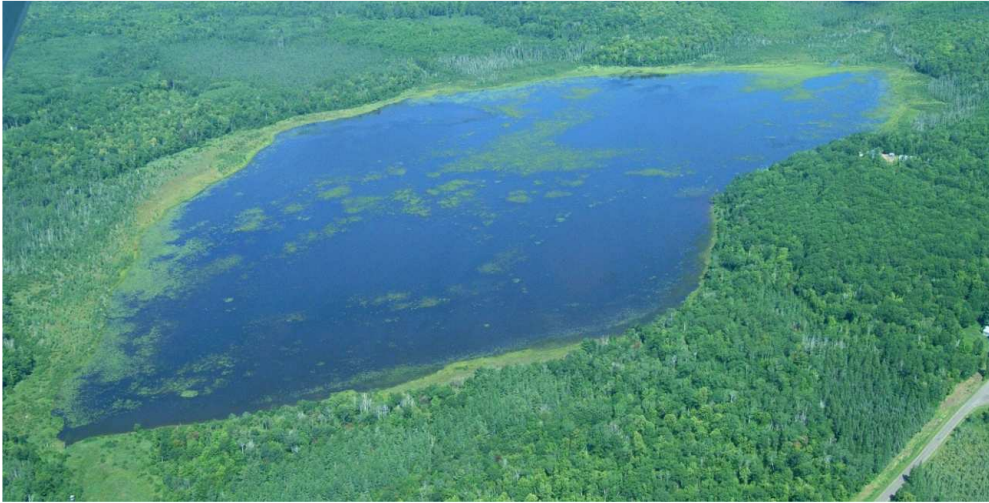
Figure 277. Tranus Lake, Washburn County, 2009.

Tranus Lake has a long history of supporting rice, and harvest on the lake is date-regulated. The crop in the early 1990s was generally poor, but has improved in the last few years due to careful beaver control on the outlet stream by APHIS staff. The 2009 crop was the best in many years, though some of these beds are still too thin to show up well in air photos. However, a significant portion of the total surface of the lake had rice present. This is a site where beaver management can be critical, because the lake is normally on the high side of suitable water depths; even a small increase in lake depth due to a beaver dam on the outlet can make most of the lake unsuitable. Watch status, other than for beaver impacts, is low due to site familiarity.

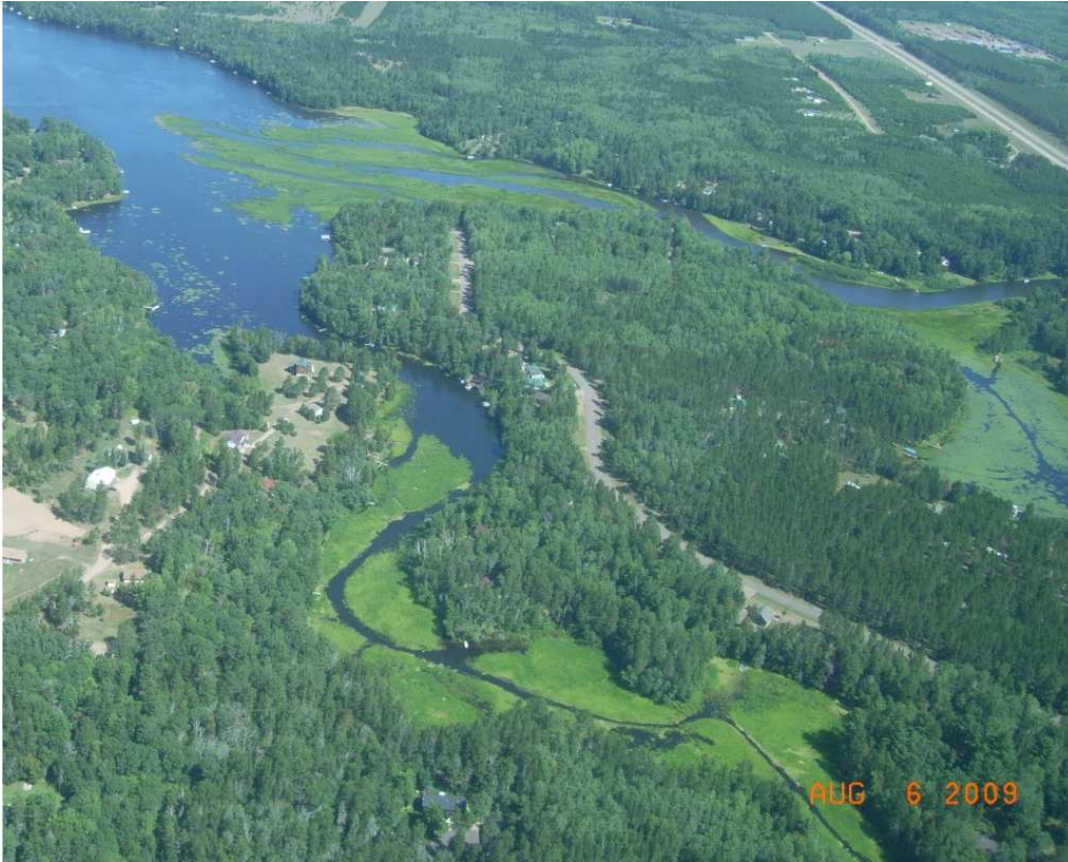
Figure 278. Trego Lake, Washburn County, 2009.

Significant rice beds exist on Trego Lake (really a flowage), and they seem to be expanding in recent years, perhaps due to the natural accumulation of sediments at the primary inlets (the Namekagon River and Little Mackay/Potato Creeks) on the east end of the flowage. Rice is largely limited to this area of this long flowage. (The Surface Water Viewer currently depicts the west end of the flowage, rather than this area on the east end, as a rice water.) Harvest reports have been increasing as ricers become more aware of this location.

The lake association has recently received permits to conduct some dredging near the rice beds to maintain a navigation channel. This action should be monitored, but if the permit restrictions are adhered to, the impacts on the rice bed are expected to be minimal. Watch status medium-high because of the apparent expansion of this bed in recent years.

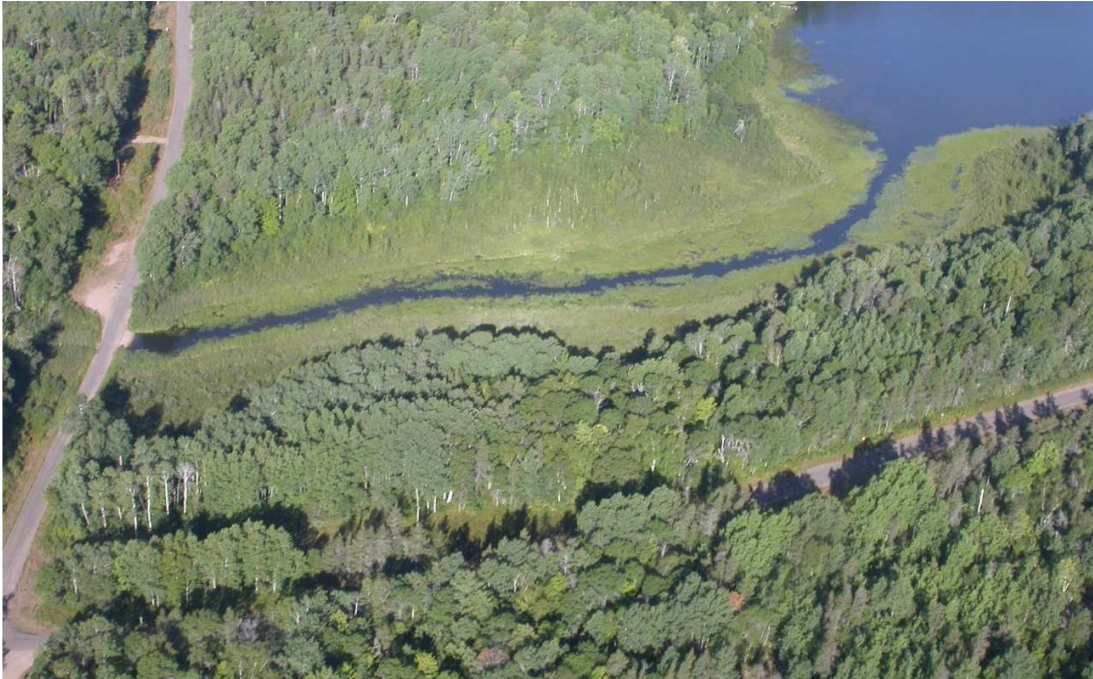
Figure 279. Whalen Lake, South end, Washburn County, 2005.

The south end outlet of Whalen Lake supports the harvestable stand of rice shown above. While this site might be interpreted to be part of Whalen Creek, the Surface Water Viewer considers this part of Whalen Lake. Concern about the protection of this bed was raised recently by local landowners when the land on the east side of this section (to the bottom in the photo above) was recently subdivided into several small parcels. No construction has occurred to date on these parcels, but it will be worth monitoring this site to document any impacts which might occur, thus the site was given a medium watch status.

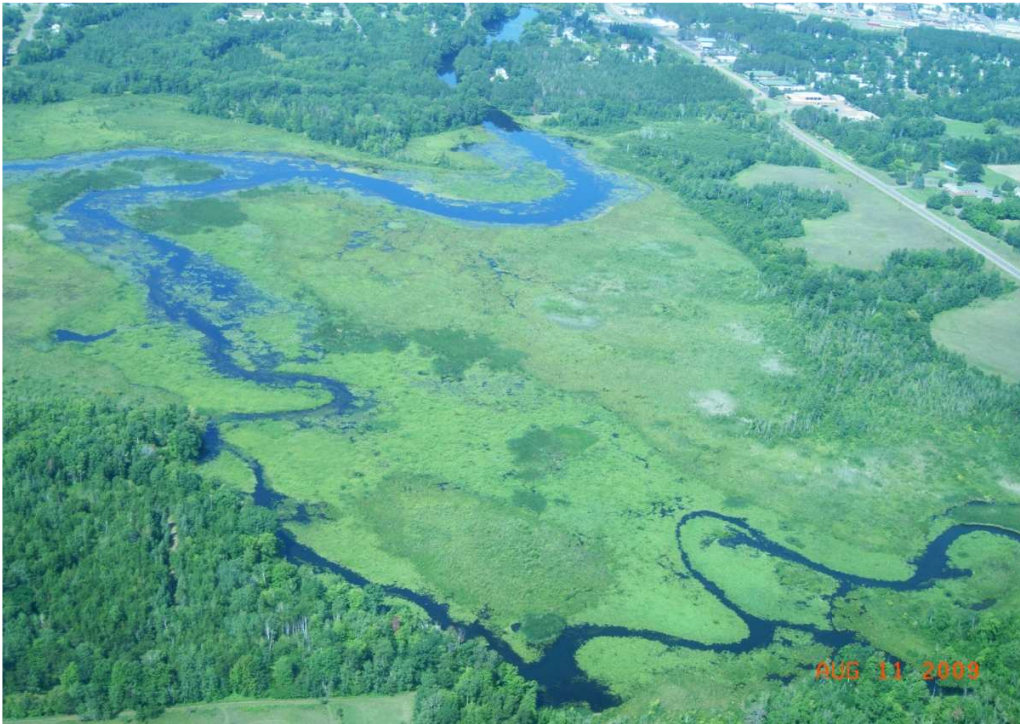
Figure 280. Yellow River, East of Spooner, Washburn County, 2009.

The Yellow River has rice beds in several locations in Washburn County. The eastern-most occurs just east of Spooner, and west of where the Yellow River passes under HWY 70, on what is generally referred to as part of the Yellow River Flowage, near the junction with Beaver Brook. Rice beds at this location reportedly declined following an extensive drawdown on the flowage, but abundance in 2009 was better than in other recent years, so the bed may be recovering on its own.

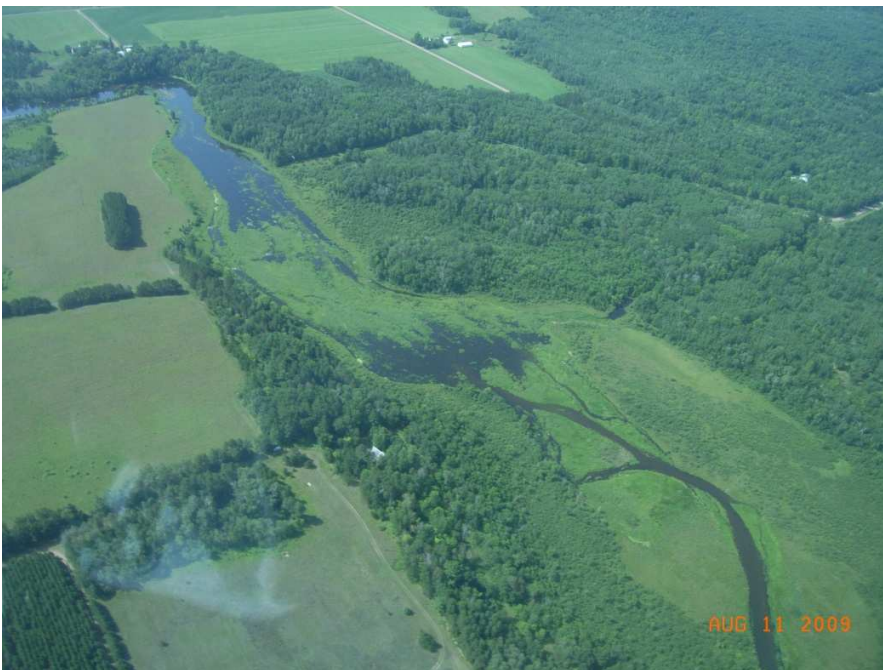
Figure 281. Yellow River, above green Valley Road, Washburn County, 2009.

The other beds are located west of Spooner, over a section that begins about a river mile above the Green Valley Road Bridge, and continuing to the Hector Dam Road Bridge. Likely, there are small beds scattered in other locations as well, in addition to the beds further down stream in Burnett County.

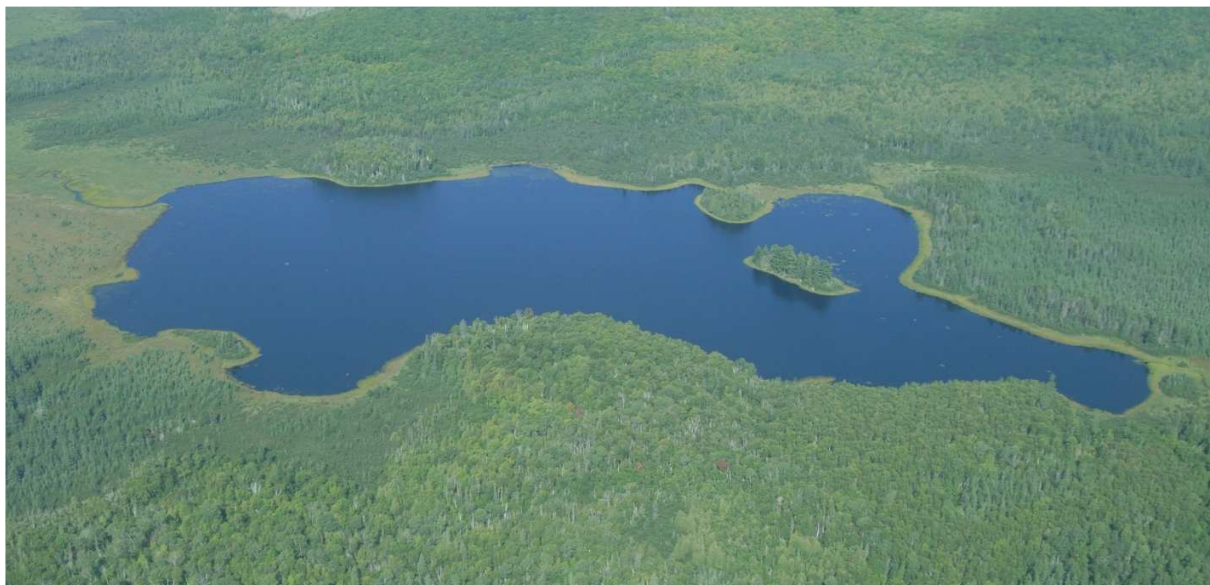
Figure 5. Hoffman Lake, Ashland County, 2009.

We were unable to confirm the presence of rice on this lake. There are reports that this relatively remote lake had been seeded by DNR staff, but we were unable to locate ground access to this site to conduct a survey. No rice was apparent in a 2009 aerial survey, but it is possible that a small amount exists on the outlet stream. I recommend not considering this a rice water at this time, but conducting a ground survey in the future if access can be gained.

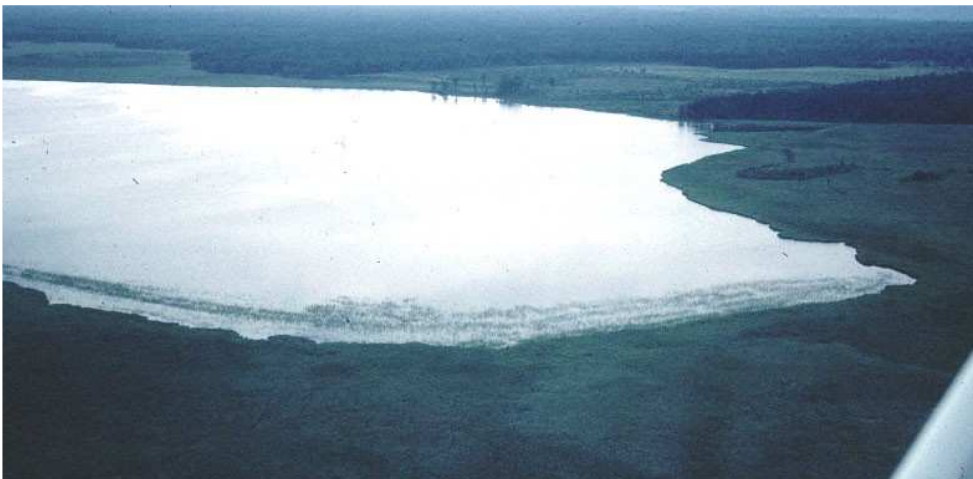
Figure 2. Fish Lake, Burnett County, 1995.

Fish Lake, located on the Fish Lake State Wildlife Area, initially responded to seeding efforts that took place in the mid 1990's (see picture above). This seeding was done, in part, because of reports of beds historically existing on these waters. However, the seeding efforts did not produce self-sustaining beds, perhaps because of high water resulting from a wet cycle in the years that followed the seeding effort, and a somewhat limited ability to control water levels on this

lake. Although this site may still offer appreciable restoration potential, no rice has been observed for roughly a decade, and it is likely appropriate to remove this site from the list of recognized rice waters at this time.

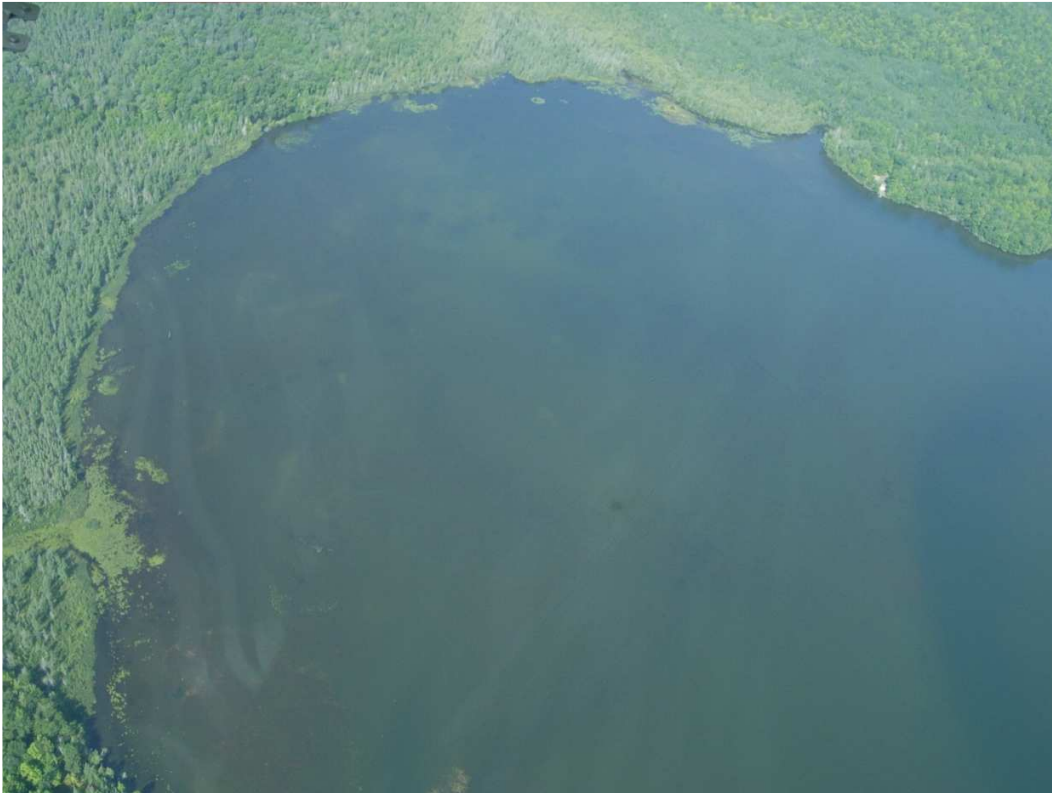
Figure 3. Halsey Lake, West End, Florence County, 2009

This lake is reported to have historically held rice, and at least one seeding attempt has been made here, but no rice was observed in 2008 or 2009 surveys. Some restoration might be possible, especially along the southwest end of the lake,

but it might take some reduction in water levels to make it possible. The bottom may also be too flocculent to be optimal for rice growth.

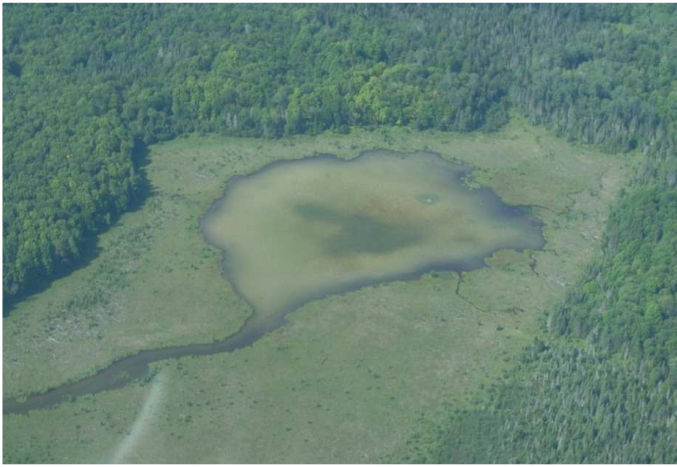
Figure 4. Little Porcupine Lake, Florence County, 2009.

This lake was a 2009 addition to survey work, on reports that it may have been seeded, but no rice was observed, and water quality appears questionable. Field crews also report the bottom as sandy, so future seeding is not recommended.

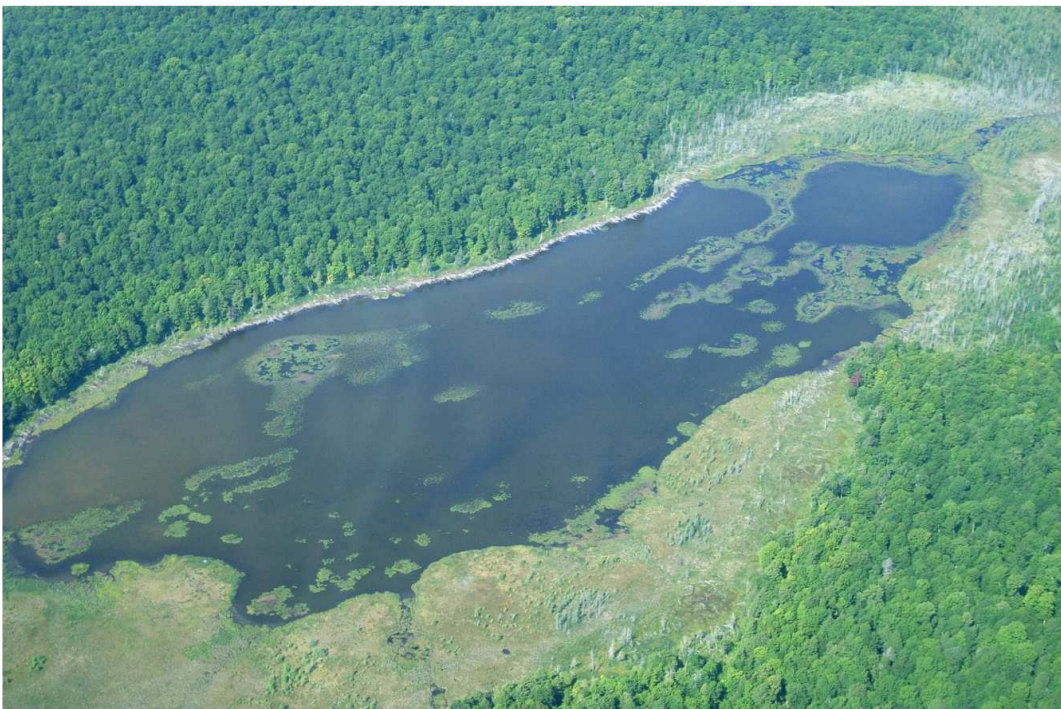
Figure 5. Robago Lake, Florence County, 2009.

Robago Lake has been seeded in recent years, and Jeremy Holtz and GLIFWC both reported an initial take in 2009. Additional seeding took place in the fall of 2009 to expand the initial success (which was generally too thin to show up well in the air photo). While we hope this lake will eventually support a self-sustaining rice bed, I would not consider it to be an established rice water at this time. This site should remain under a high watch status.

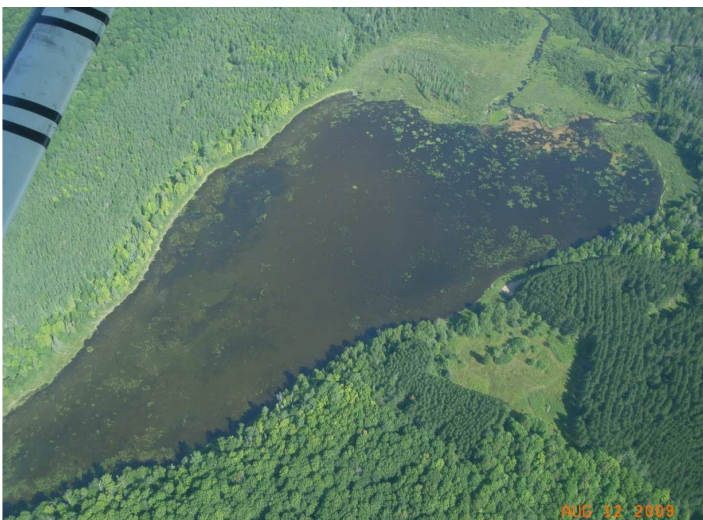
Figure 6. Lilypad Lake, Forest County, 2009.

This lake was surveyed because of a report that it had once been seeded by the Forest Service. No rice was observed in a 2009 air survey, and a local resident reported never observing rice here. I would not consider this a rice lake, but it may be worth re-evaluating the site for seeding, especially near the north end where Lilypad Creek enters and exits.

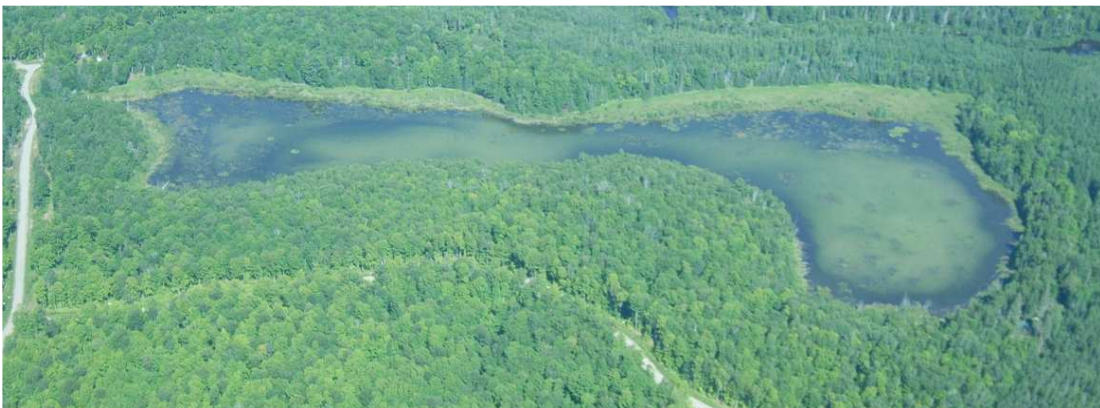
Figure 7. Revolver Lake, Forest County, 2008.

This site was once seeded, but no rice is known to exist at this time. It should be removed from the list of rice waters.

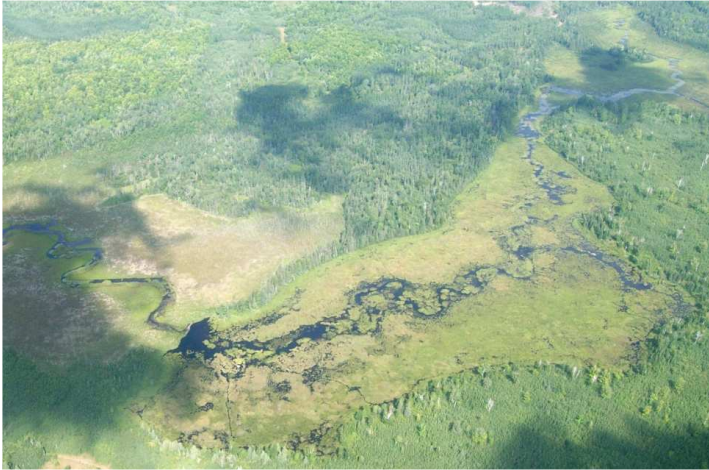
Figure 8. Springstead Creek, Iron County, 2009.

While conducting air surveys in 2009 of nearby Rice Lake (WBIC 2265000), which is located about ½ mile to the east, a possible rice bed was observed on a beaver impoundment on Springstead Creek. Unfortunately, this creek is too small to navigate, and we were unable to gain access across private land to confirm the presence of rice from the ground. While there is a fairly high likelihood that rice is present, I would not consider this a rice water until ground confirmation is made. High watch status.
