**Wisconsin
Ceded
Territory
Manoomin
Inventory
Ver. 1.0**

**GLIFWC
Project
Report
2010-01
March, 2010**

**Peter David
Wildlife
Biologist**

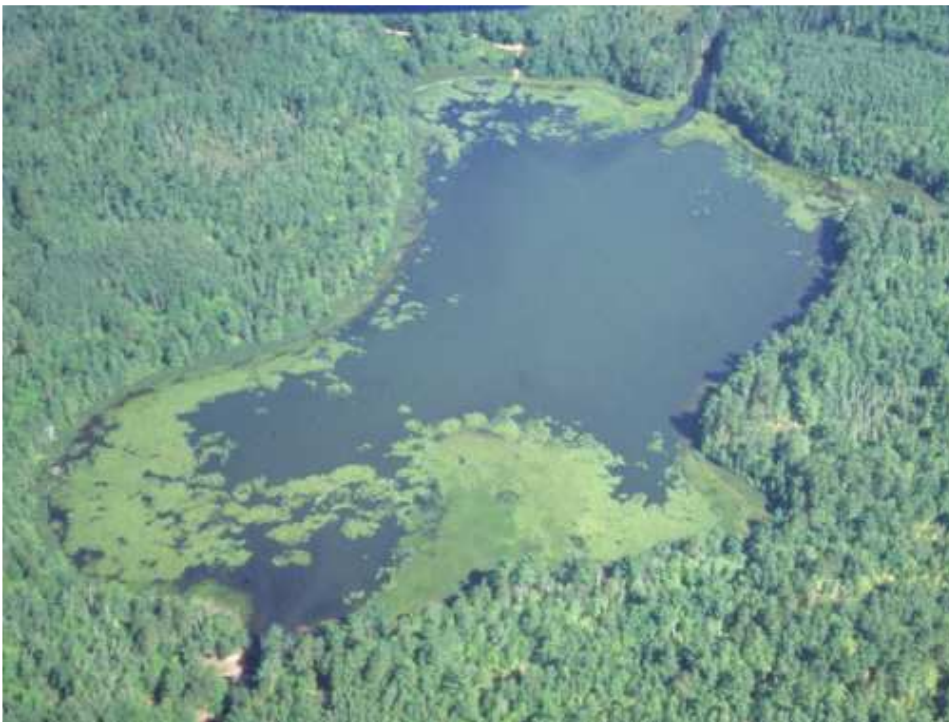
Figure 9. Dog Lake, Oneida County, 2005.

This lake was investigated on rumors that rice may be present. Less than 25 plants were observed in a 2008 ground survey, while the lake could not be surveyed in 2009 due to road construction. No rice is evident in a 2005 air photo.

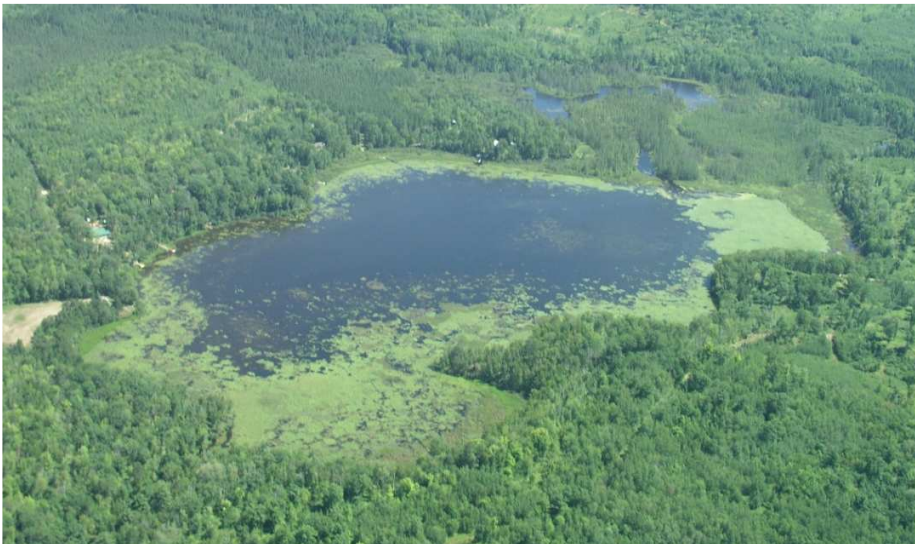
Figure 10. Goodyear Lake, Oneida County, 2007.

This lake was surveyed because of sporadic reports of rice, but no rice was observed in 2008 or 2009 ground surveys, nor was any apparent in a 2007 air survey. However, a small amount of additional monitoring might be warranted given the frequency of older reports.

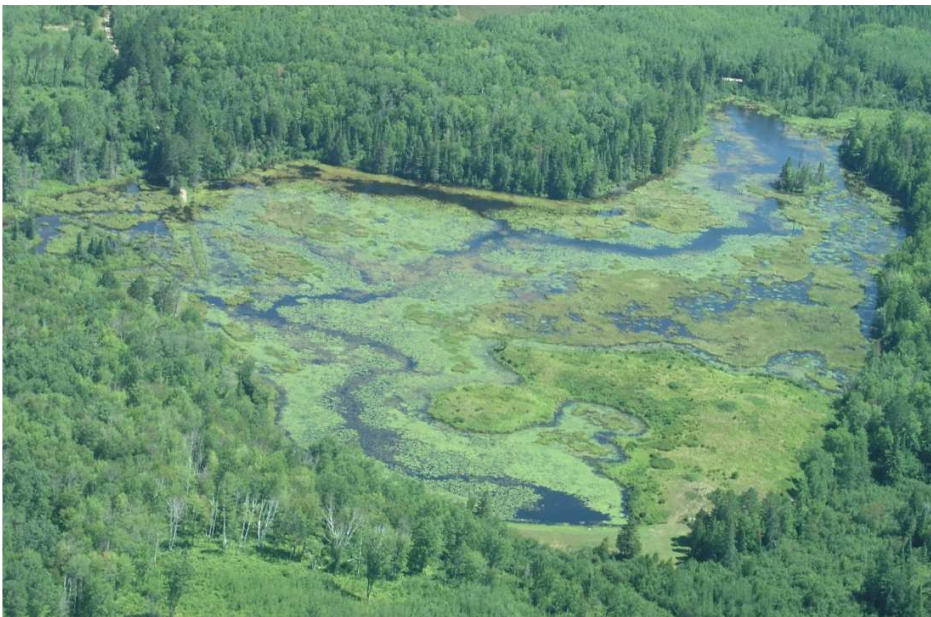
Figure 11. Spruce Lake, Oneida County, 2007.

Spruce Lake is on the existing list of recognized rice waters. However, no rice has been observed in recent years, and solid confirmation of it ever being present is lacking. I recommend removal from the list unless rice presence is documented.

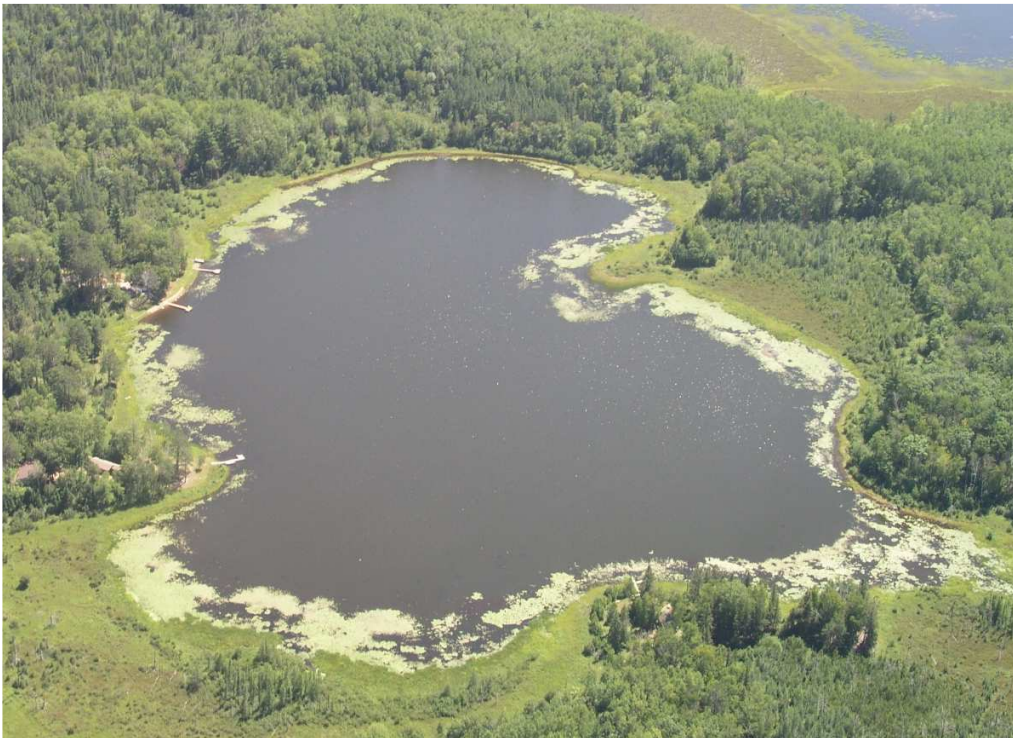
Figure 126. Stag Lake, Oneida County, 2007.

This lake once supported rice according to Brian Biermier, USDA-APHIS, and has been seeded in recent years in an effort to re-establish some of the historic presence of rice. It is directly downstream from Roe Lake (partially visible in the upper right in the photo), which now supports a good stand as a result of seeding and beaver control. However, surveys in 2008 and 2009 found only a very small amount presence of rice, consisting of small, scattered patches along the north shore (and not clearly visible in the photo above). I would not consider this a rice water at this time, but would continue to monitor the site in future years to determine if seeding efforts take hold.

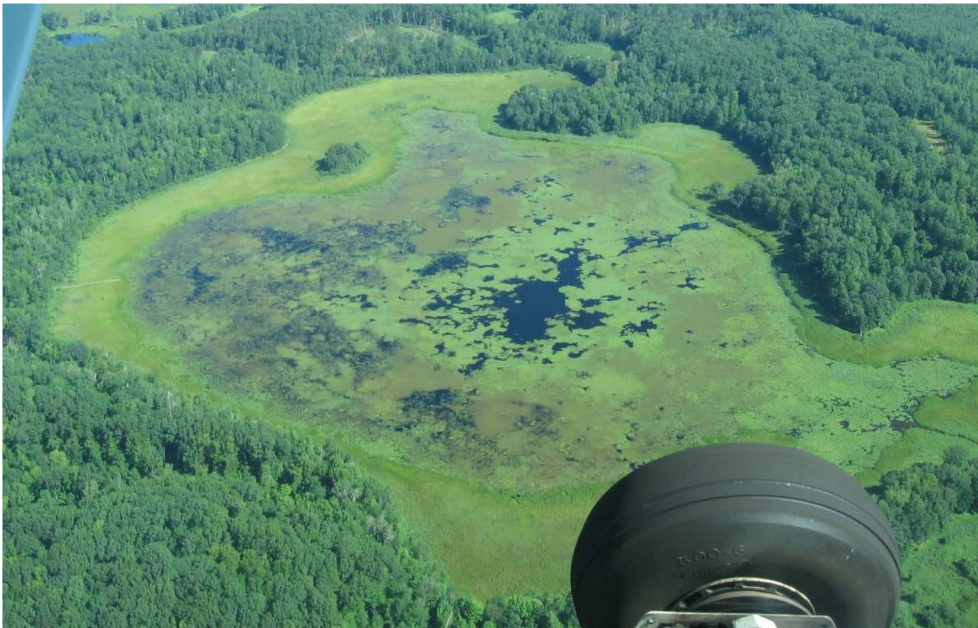
Figure 13. Mackie Lake, Polk County, 2008.

Paul Kooiker, DNR, reported that rice previously existed on this small, undeveloped lake, but we found no evidence in ground surveys from 2008 or 2009. However, the lake was likely unusually low both survey years due to extended drought. These conditions sometimes reduce competing vegetation, so it would be interesting to monitor Mackie Lake in the future when water levels return to see if rice might reappear.

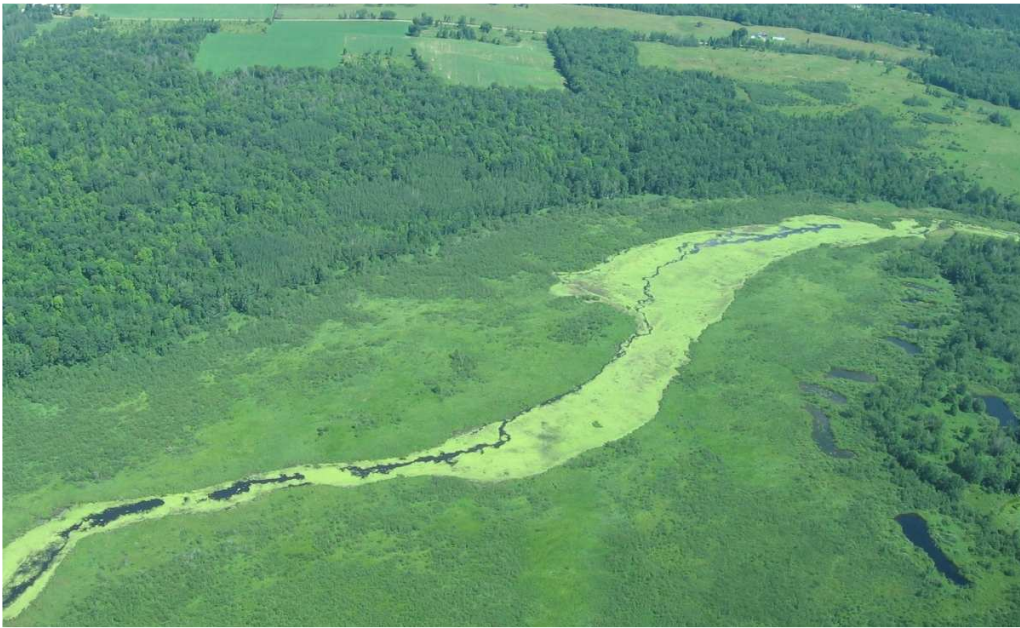
Figure 14. Potato Creek Flowage, Rusk County, 2008.

A GLIFWC survey of this site in 1985 found 15 acres of rice, but no rice was observed in 2008 or 2009 surveys, when most of the surface was covered by duck weed. Flowage might have been negatively impacted by drought conditions during the recent surveys, however. It may merit rechecking this location under more normal water conditions. This flowage is not shown on some maps, but it is located along Potato creek NE of Potato Lake.

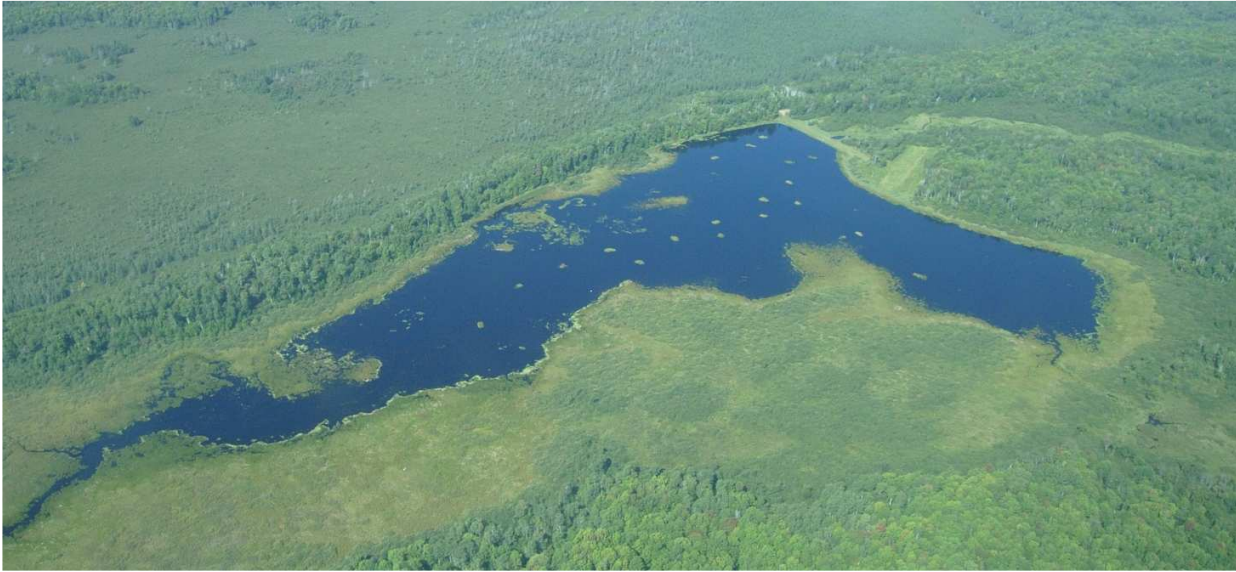
Figure 15. Upper Steve Creek Flowage, Taylor County, 2009.

This site is currently on the list of recognized wild rice waters due to past seeding attempts. Thus far, these attempts appear to have been unsuccessful, but the site was seeded again in 2009 by the Forest Service, with GLIFWC cooperation. It has been somewhat puzzling that past seedings have not been successful, since abundant beds were established on Lower Steve Creek Flowage just a few miles downstream in the same watershed. The flowage is being held at a slightly lower level with this seeding attempt. Recommend removing from the list of recognized water until a bed is shown to be established.

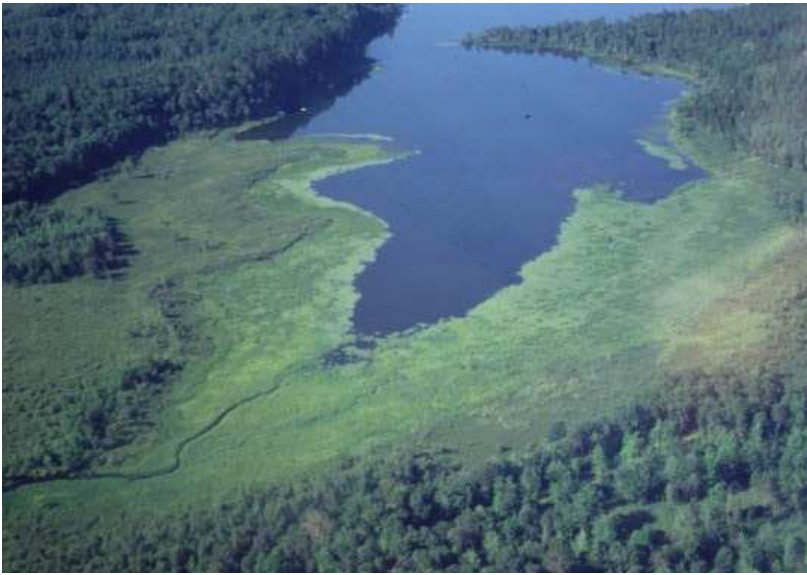
Figure 16. Gilmore Creek, Washburn County, 2001.

This site was reported by James Varro, DNR, who reported rice on “Gilmore Creek”, above Gilmore Lake. This short creek, which connects Gilmore Lake with the Totagatic River, is unnamed on the Surface Water Viewer. In addition, upon further inspection, it was discovered that the Viewer considers the area with rice to be part of Gilmore Lake. As a result, I recommend not adding this creek to the list of recognized rice waters. See Gilmore Lake on the list of recognized rice waters for more information.
